NSTX Armor High Heat Flux (HHF) Tests

performed September 1998

Richard Nygren, Sandia National Laboratories

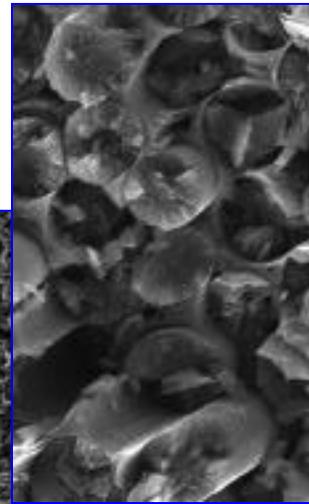
~10X
CCD

Physical evidence of change is subtle.
Surface has darker "matt" appearance.
Microcracks are numerous before test.
