XP: “Revealing the reason of LLD damage with” a potential impact on ITER Be tiles design”

Leonid E. Zakharov, Michael Bell, Henry Kugel, Michael Viola, Steve Sabbagh

NSTX Research Forum

PPPL, Princeton NJ, March 17, 2011

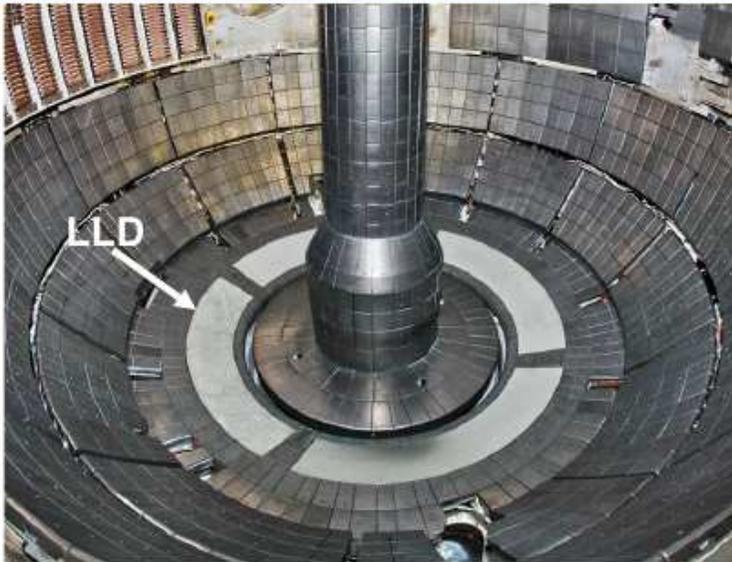
LLD plate covered with lithium
Significant over-flow evident consistent
with evaporating 2 x fill capacity

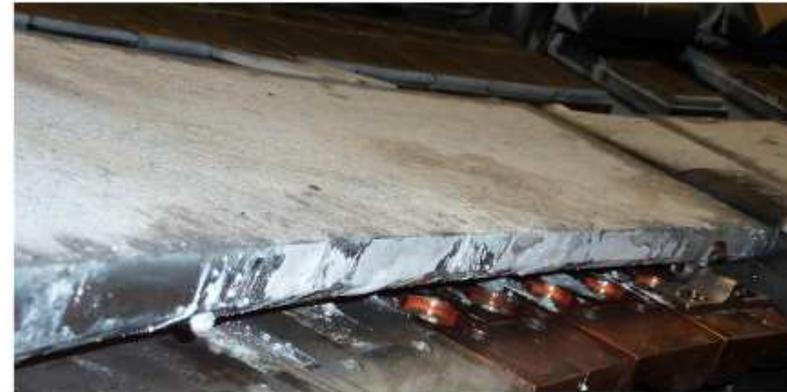
- Plasma surface heating raised the LLD surface temperature to $\sim 200 - 250$ °C.
- No significant moly surface damage or moly influx observed.
- Damage discovered after operations. Plasma disruptions caused mechanical support and arcing damages. Explains why electrical heaters failed. Air heater has worked well but the heating tubes were arc damaged.
- LLD plates being reinstalled with improvements in the mechanical support structure and grounding. No active heaters but will utilize plasma heating.

We propose to make the LLD installation design consistent with the following guidance.

- 1. Make several ground points for each LLD sector.***
- 2. Arrange the value of the resistance of grounding at a minimal level (TBD) tolerable for the OH solenoid performance and PF-Coil control of equilibrium.***

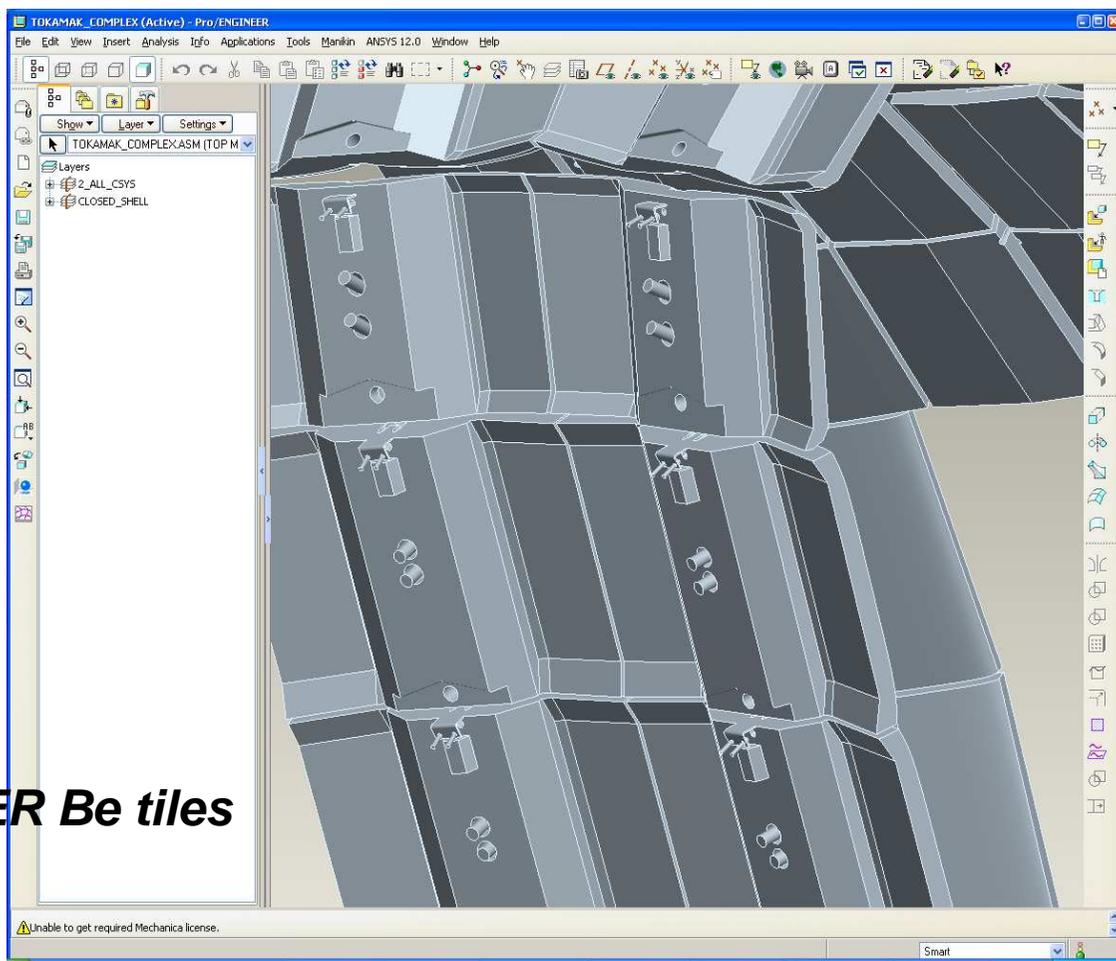
ITER Be tiles are designed at present identically with LLD-10

If disruptions and Hiro currents are responsible for the damage of LLD on NSTX, the effect on Be tiles in ITER could be devastating.
