Update on Analysis of the OH Coil Fault on 4/24/2015

**NSTX-U Team Meeting
MBG Auditorium, PPPL
5/1/2015**

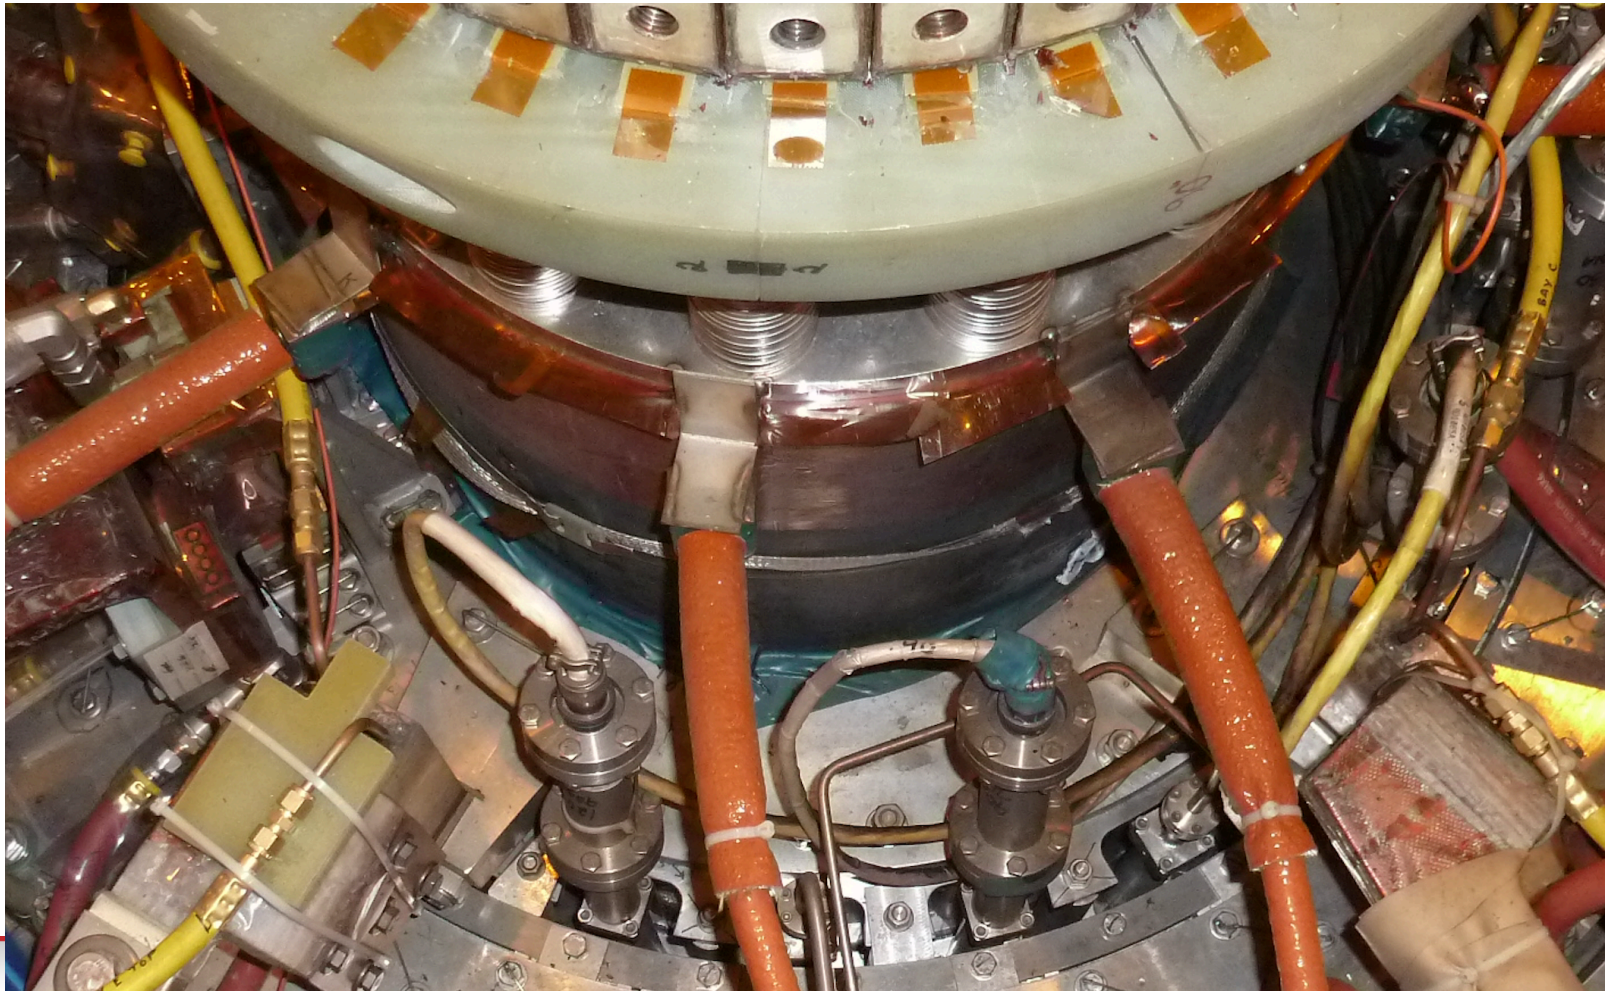
Post-Fault
Photo, on
Undamaged
Side of the
CS

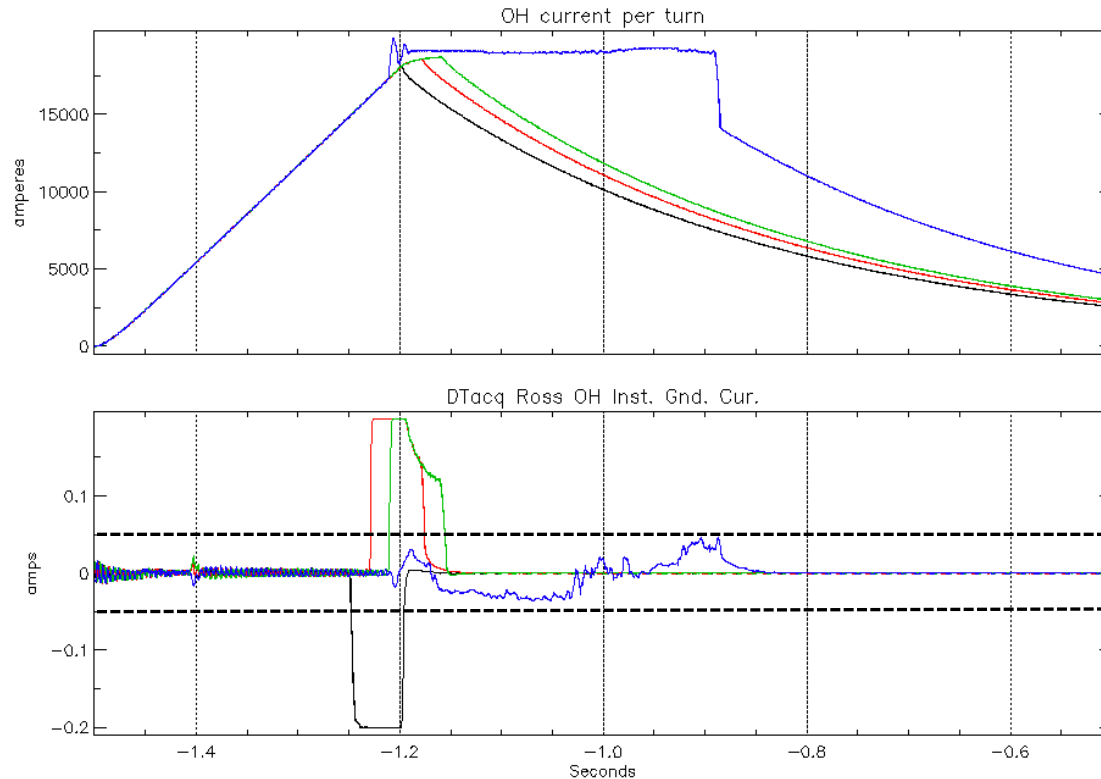
Ground Currents Were Much Different on 200190

- Instantaneous ground fault detector would not have detected any problem or terminated the shot
- This was a different beast than the previous ground fault trips.
 - Less ground current, but much more damage.
 - So what changed?...will come back to that in a few slides.

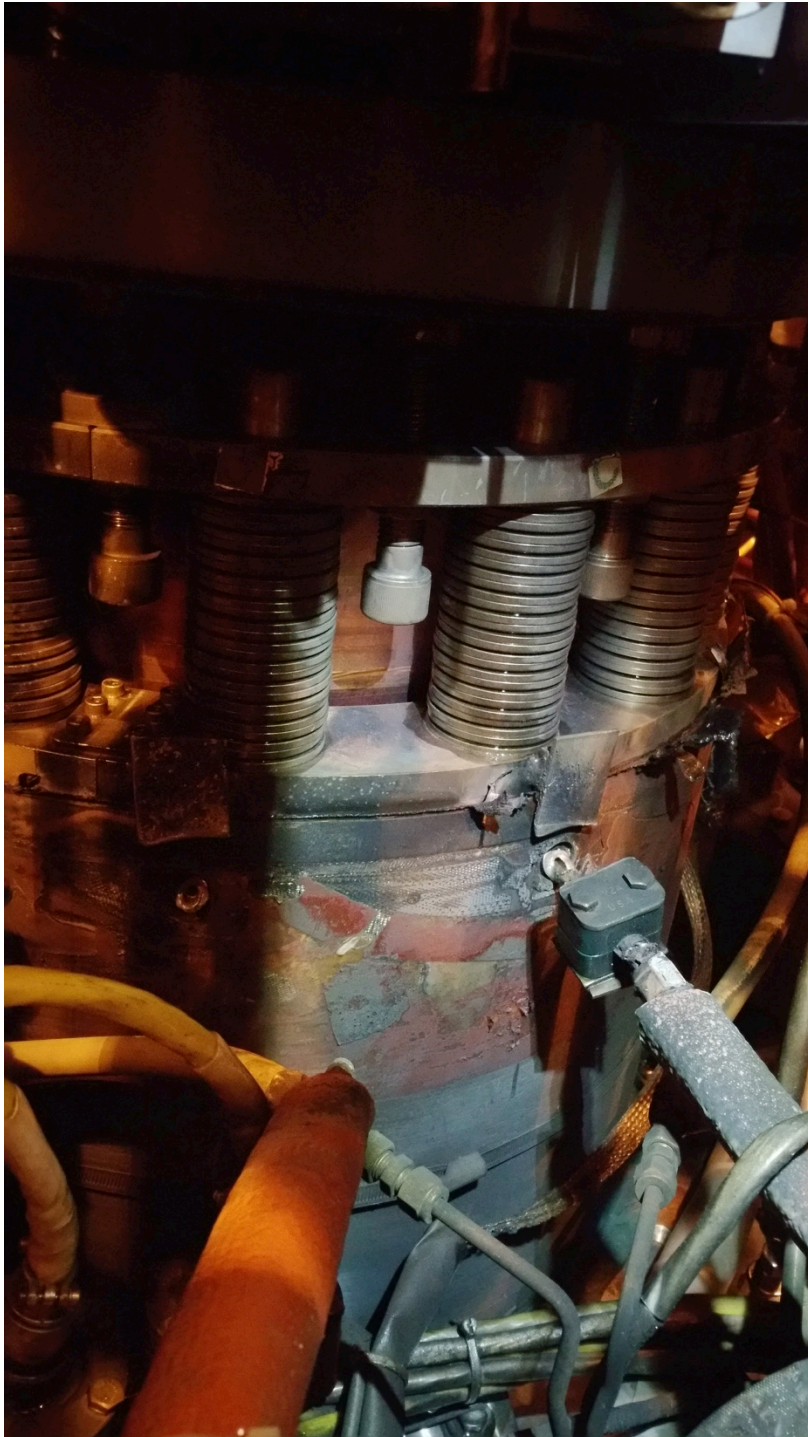
- Damage to water fittings & hoses was most obvious.
 - 4 of 8 upper water feeds severely damaged.
- Considerable soot covering many components on the north-west side of the CS.
- Quickly formed a working hypothesis:
 - The arc was formed between the water fitting on the coil, the bottom of the spring stack, and then another water fitting.
 - The arc + washer stack essentially shorted out the part of the coil.
- Hypothesis gained further traction when it was found that the Belleville stack had not been grounded.
 - No ground means no FCPC ground fault trip on final fault.

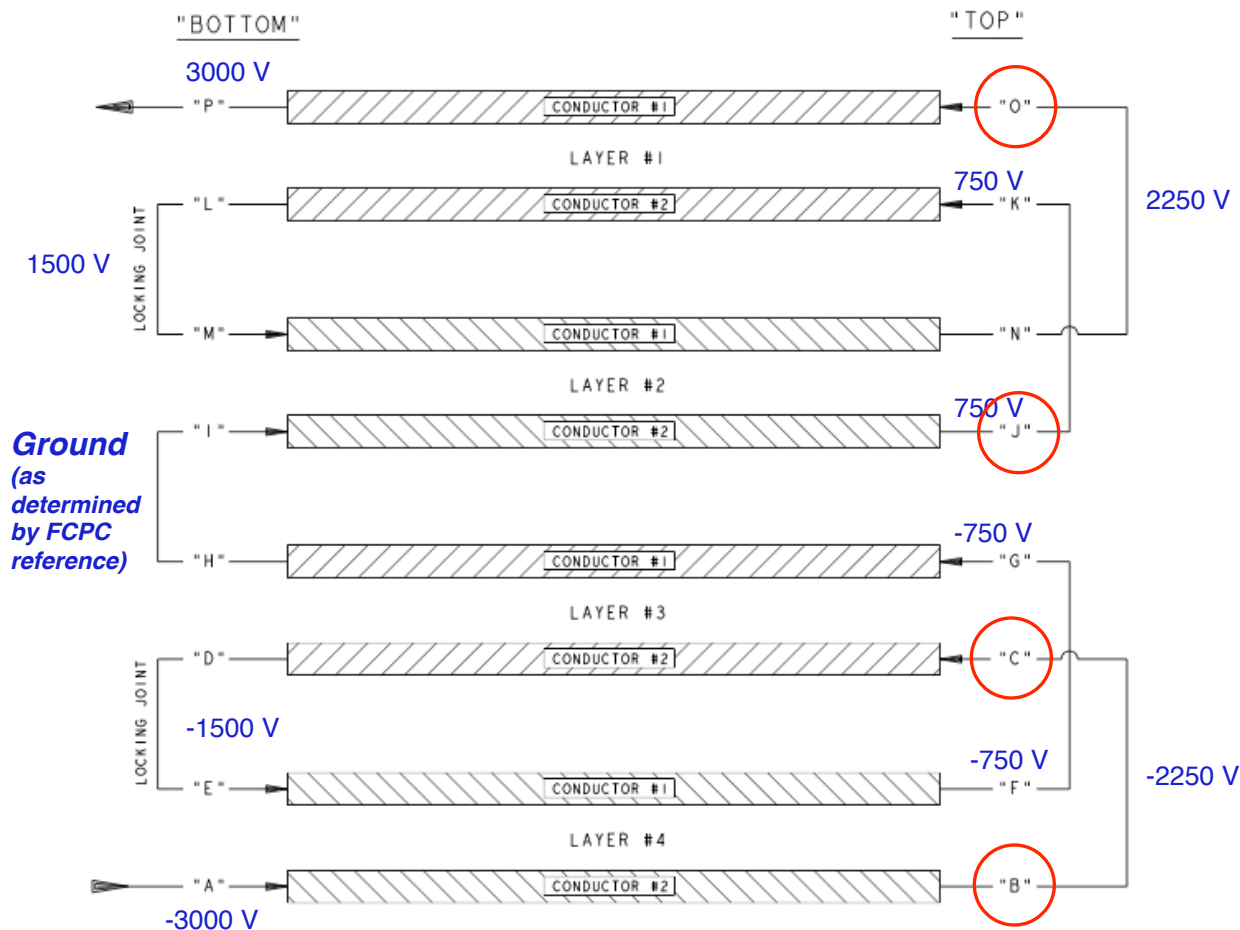
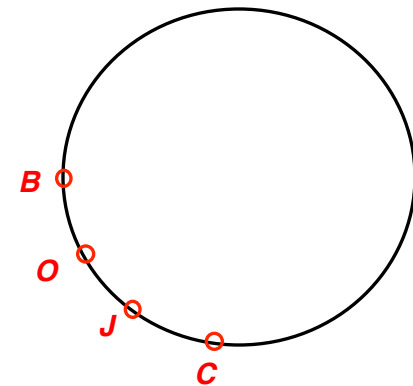
Inspection Revealed That the Arc Included the Two Highest Voltage Water Feeds

Red indicates where there was damage

Message
Conceptualize the arc as shorting out $\frac{3}{4}$ of the length of the coil.

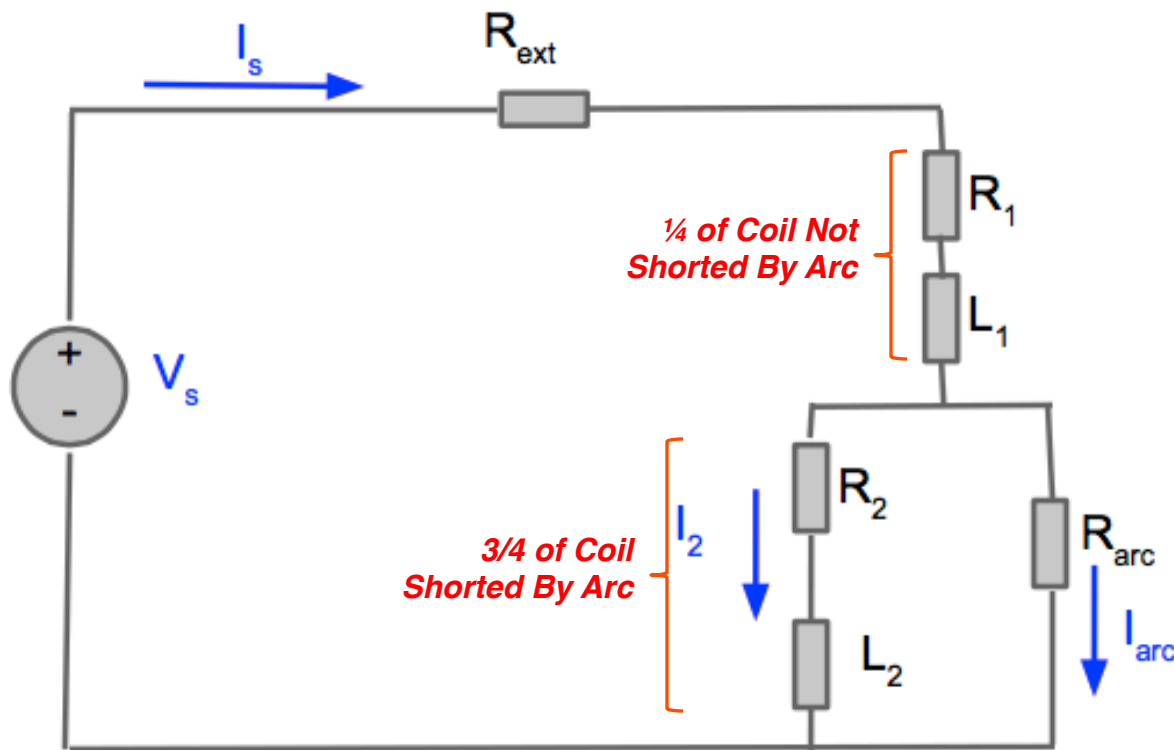
This Hypothesis For the Arc Is Corroborated by Simple Modeling.

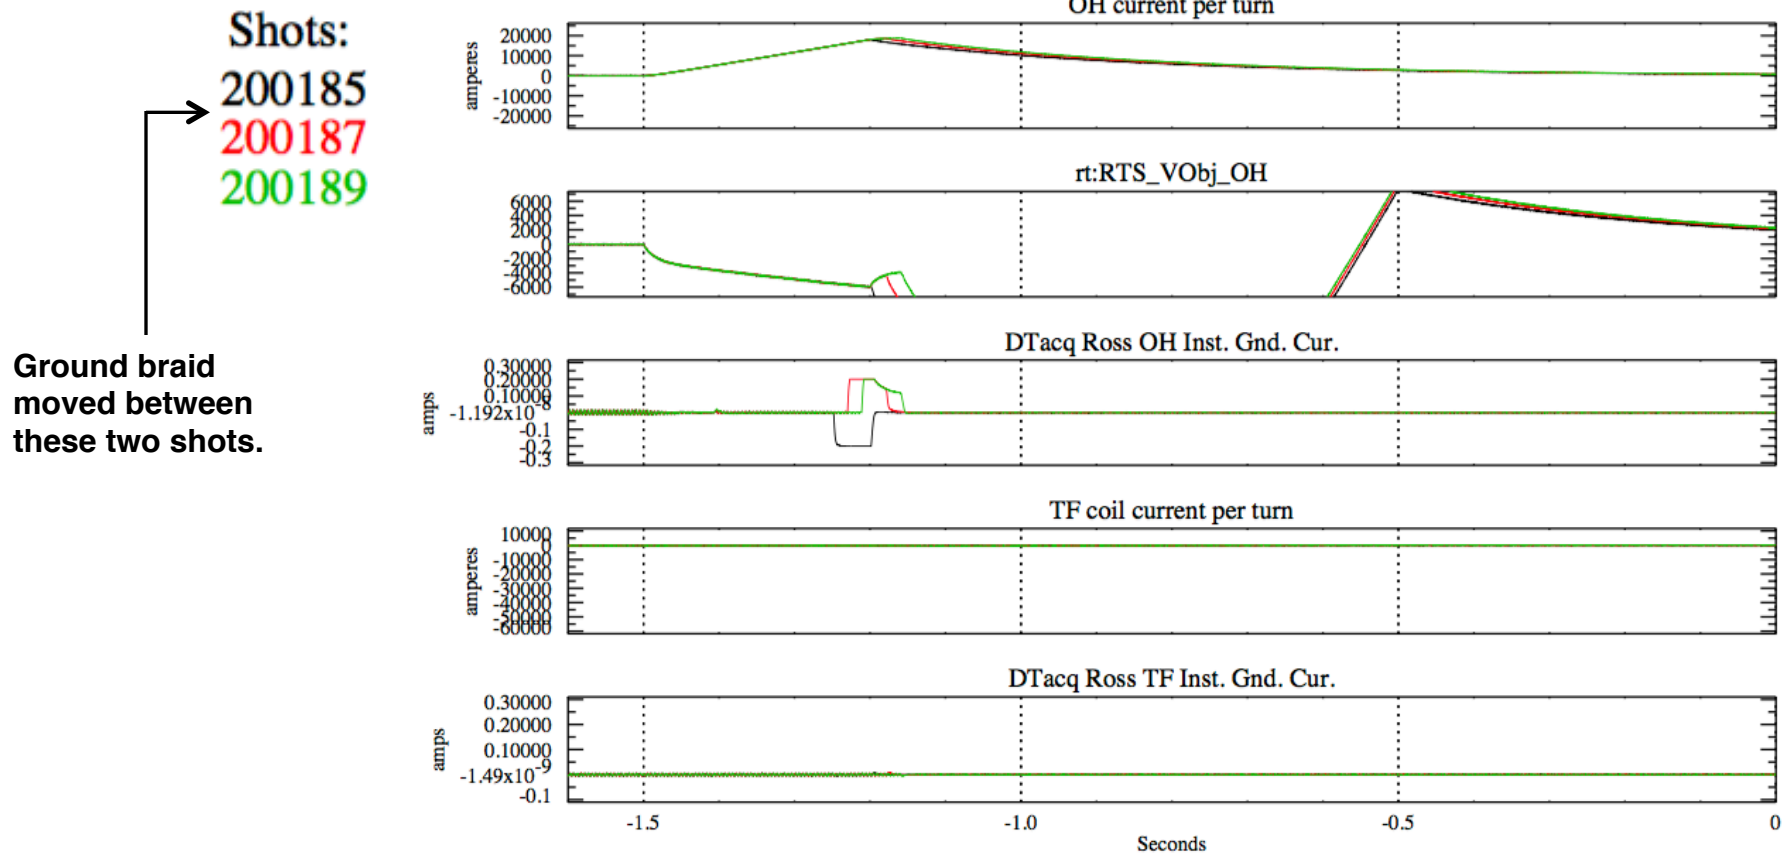
Major Clue Can Be Found in the Ground Currents

- Ground currents changed sign when the OH ground plane braid was moved from Cat. 4 to Cat. 3 reference.
 - So the ground braid was likely part of the issue.

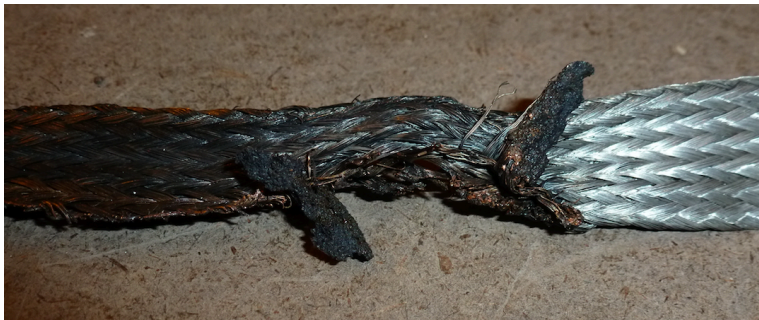
Damage observed at multiple points along the braid

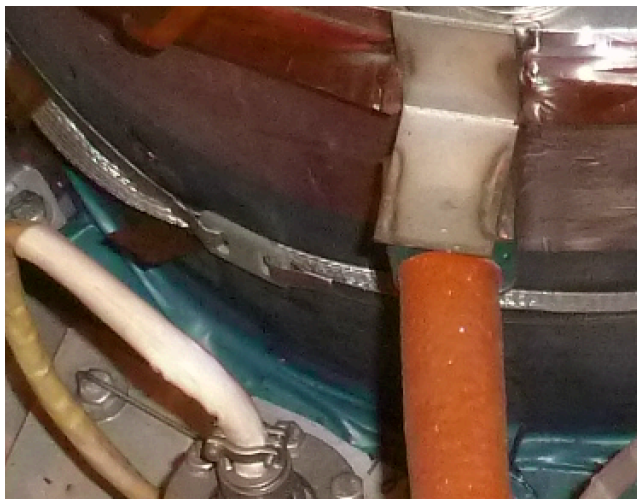
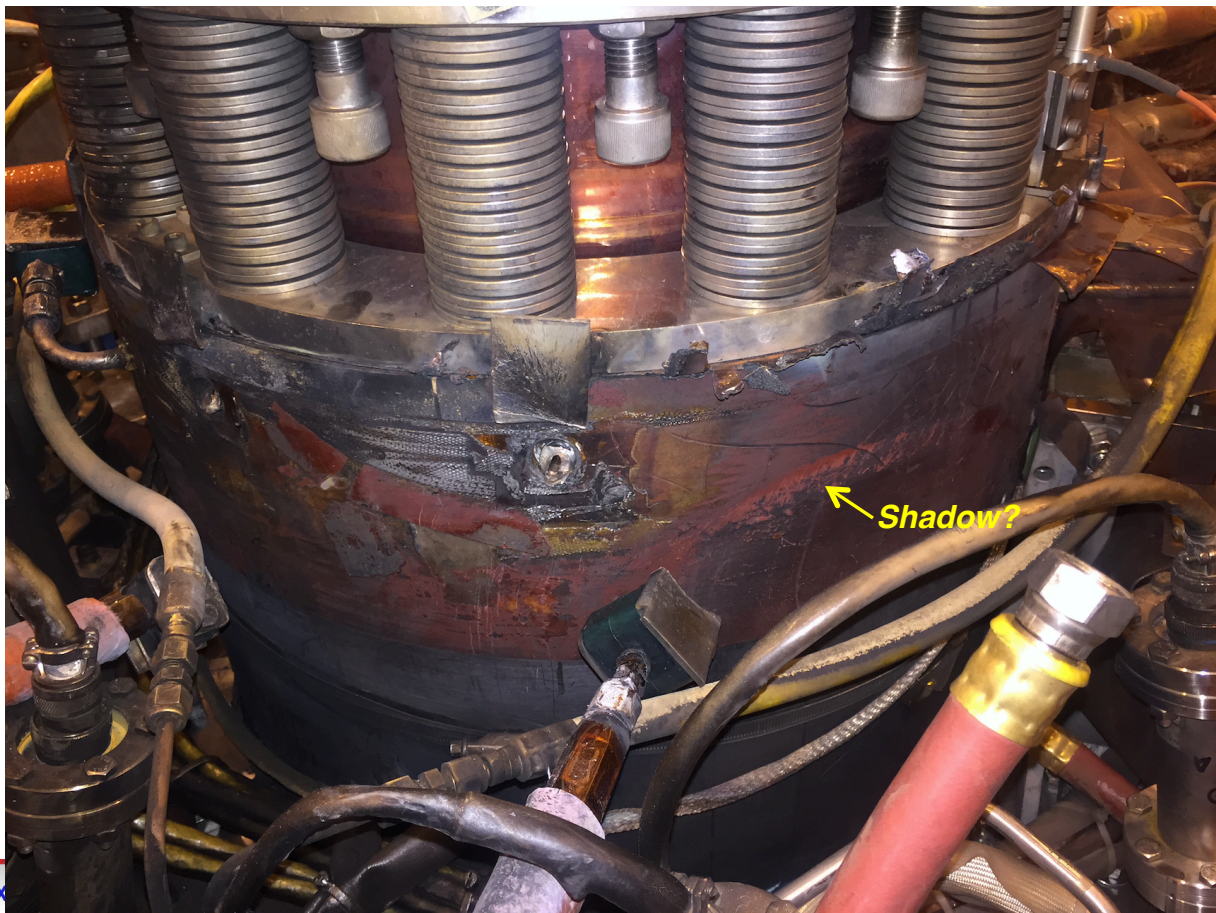
- Ground braid was observed to:
 - be toroidally continuous, and thus subject to eddy currents and launching loads.
 - have come loose from its clamps, and able to slide up and down.
- We believe that:
 - the ground braid was moving up and down, working its way loose.
 - Came in contact with the water fittings, resulting in ground faults on the shots before the fault.
 - Localized damage, consistent with this theory, can be found on the braid.
- The ground braid may have sparked or even bridged the water feed / clamp gap on the final discharge.
 - This likely accounts for the change in fault characteristics.

Resting point of the braid is well below the fault area
JxB lifted it up, into the are of the fault

Braid bridged the gap in the clamp
But was pinned at that location,
~180 degrees from the fault area

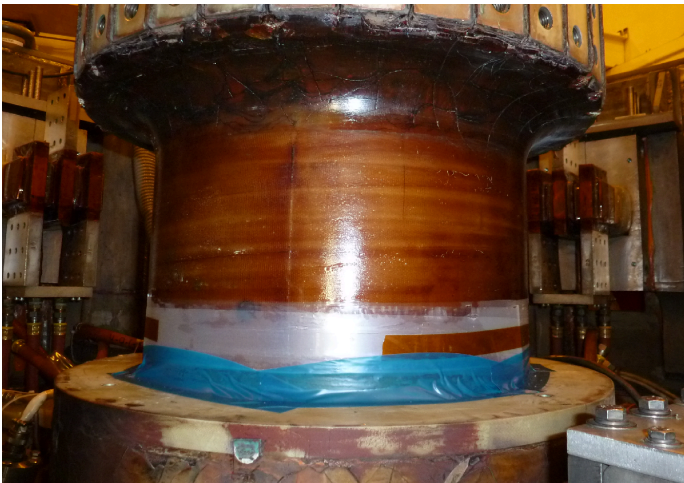
Shiny insulation on the TF coil

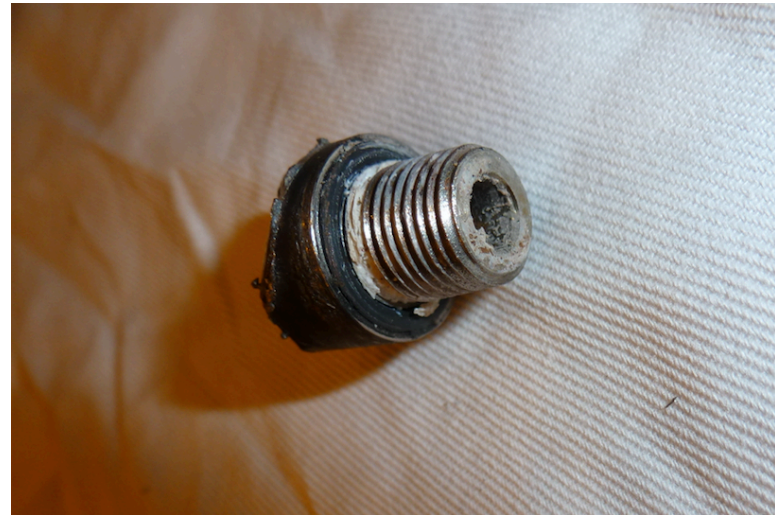
Water Fitting: Melted on one side, just “used” on the other.
