## NSTX-U Team Meeting

Masa Ono

September 15, 2016

# PF-1AU coil forensics

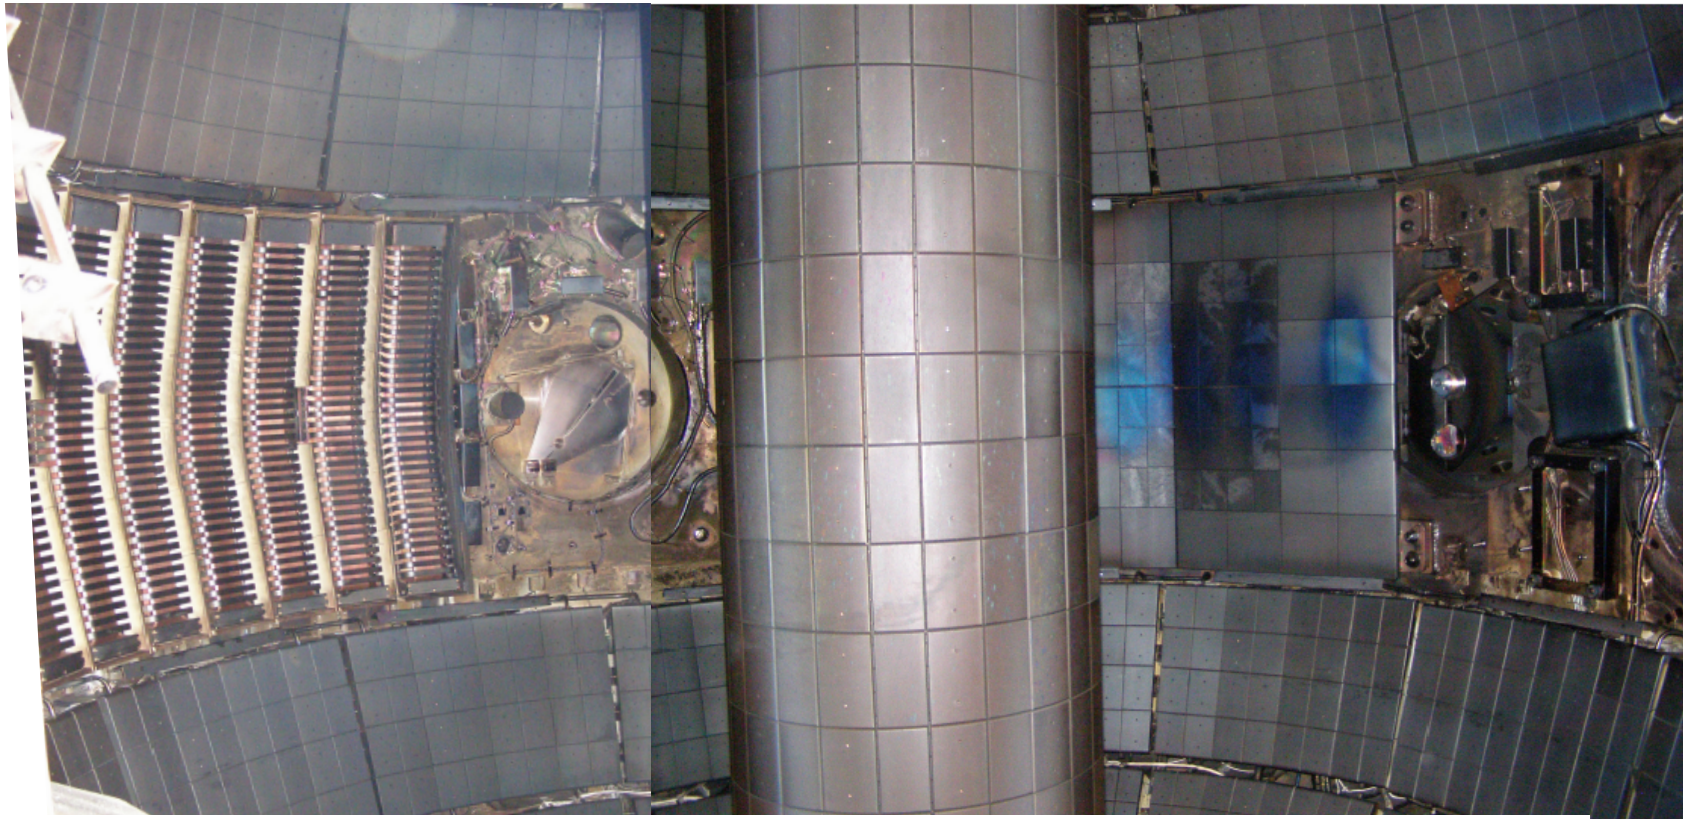
# Initial Look of NSTX-U Vacuum Vessel Interior Taken on September 14 by Mark Cropper

The VV interior appears to be in a good condition

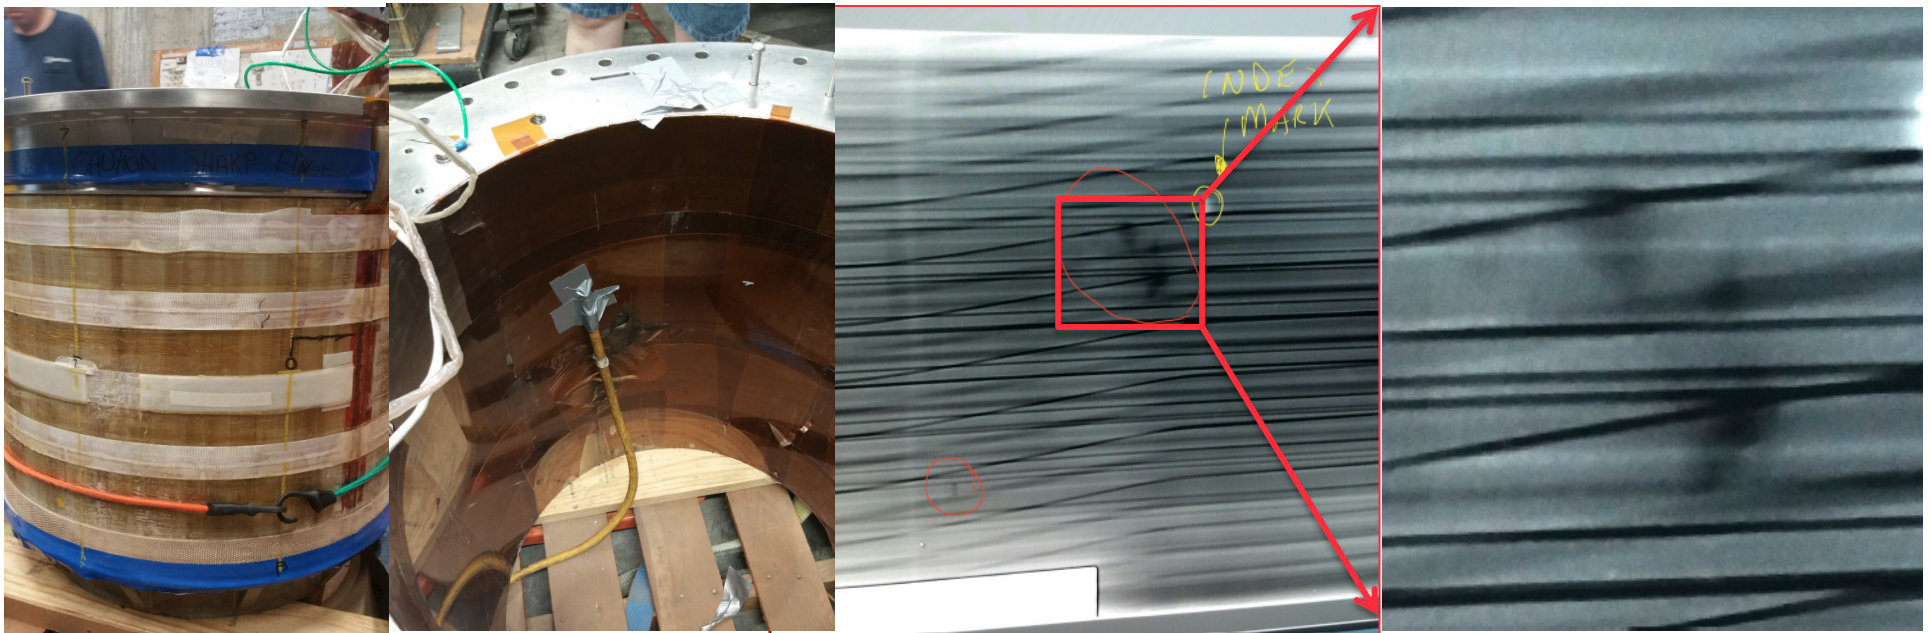
- Preliminary images showed potential copper voids near the “joggle” transition.
- Additional coil radiography for the void area completed last week and the coil is returned to the lab this week for dissection and borescope inspections
- Second peer review of PF1AU forensic analysis planned this week to review the radiography results and review the dissection and borescope inspection plan.

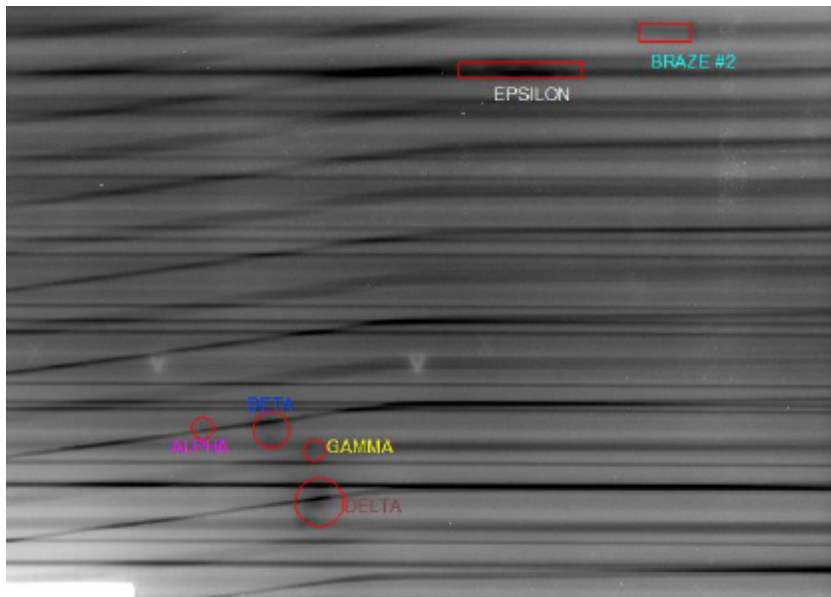
# Additional Radiography Provided Radial Localization Information Performed

The Alpha, Beta, Gamma, and Delta areas are proximal to Layer 2: Rows 8 and 9.

- The Epsilon area is proximal to Layer 2: Row 3
- Braze Joint #1 is proximal to Layer 1: Row 15
- Braze Joint #2 is proximal to Layer 2: Row 3
- Braze Joint #3 is proximal to Layer 3: Row 13
- Braze Joint #4 is proximal to Row 6 (9/1/16 imaging)

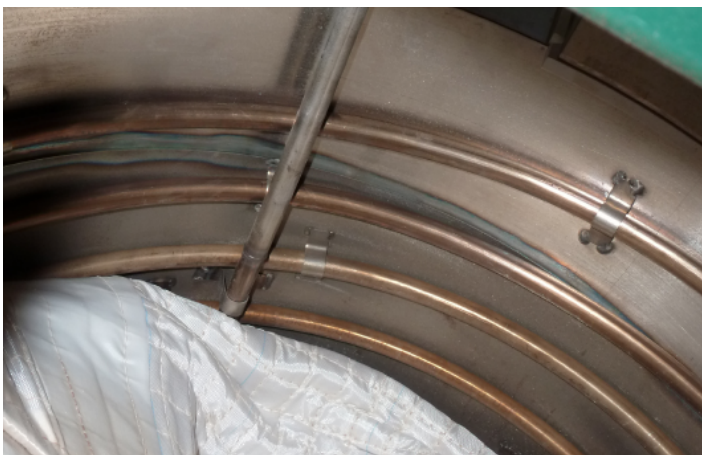
Divertor CS SS cooling tubes in NSTX, look pristine after 10 years

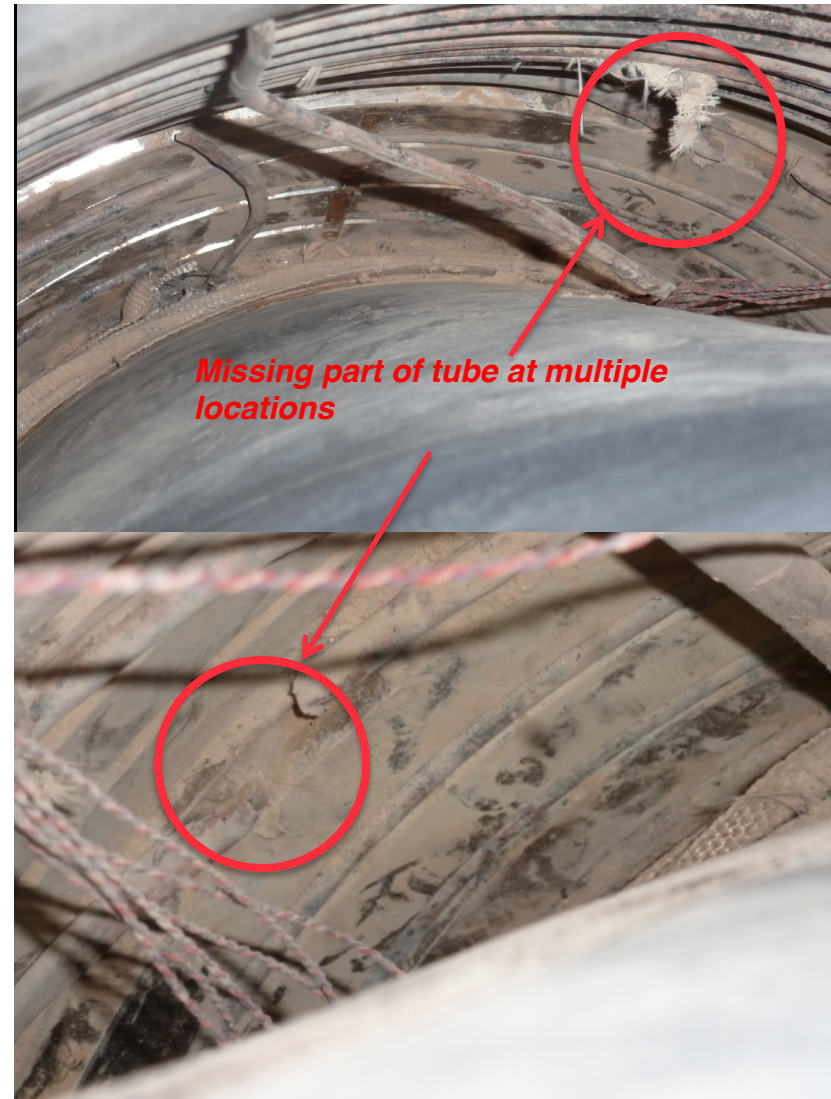
- New PF-1AU redesign and fabrication activities started. Four design improvements identified. Replacing PF-1AL became a logical option.
- With PF-1AU removed, on August 25, severe damage was reported in the copper cooling tube in the upper center-stack divertor wall. Damage was likely to be caused by induced currents by OH. The copper tube must be replaced with ss tube (as in NSTX). This requires Center-Stack removal.

## Induced currents in copper tube likely cause

Severe damage in divertor CS cooling tubes

- Due to up-down symmetry, we expect similar cooling tube damage in the lower divertor area. Lower cooling tube does not hold any air pressure.
- With damaged cooling tubes, the divertor area cannot be cooled between long-pulse higher power NSTX-U operations.
- Copper tubes if left in CS maybe degraded further. They should be replaced with SS tubes at this time.
- Tubes can be only accessed by:
  1. Removing CS from VV.
  2. Pulling CS casing from OH-TF bundle
- The damaged cooling The cooling tubing installation schedule is similar to the new PF-1AL and -U installation schedule so they can be performed in parallel with no significant schedule hit.

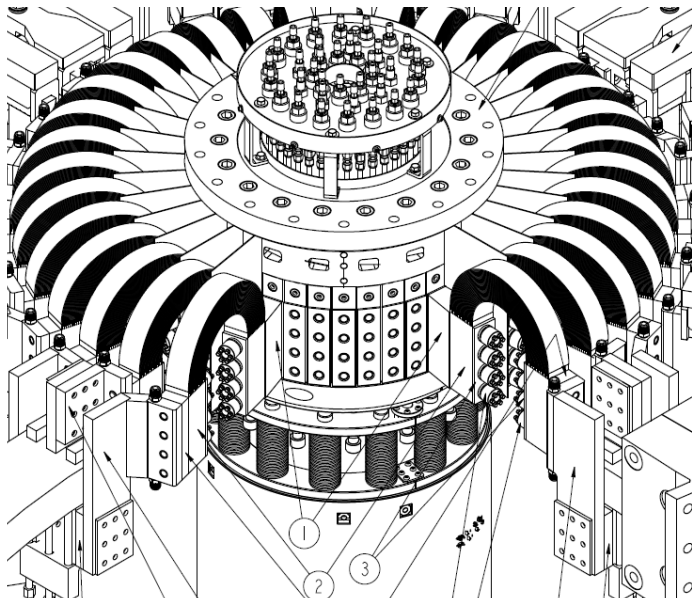
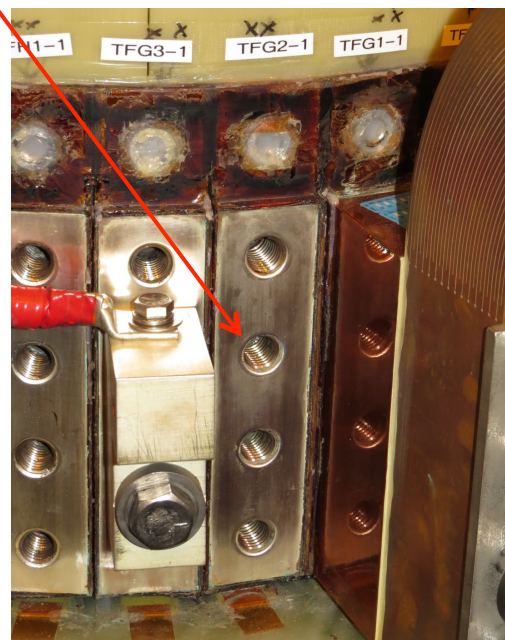
- In FY 2016, NSTX-U operated mostly at  $B_T \sim 6.5$  kG up to  $\sim 2.2$  s flat top for well over 1000 shots.
- The TF joint measurement were performed as the TF joints were disassembled.
- All measured joints are nominal based on design, installation procedure, modeling data, bench measurements, and in-situ measurements.
- Joint surfaces look very good.

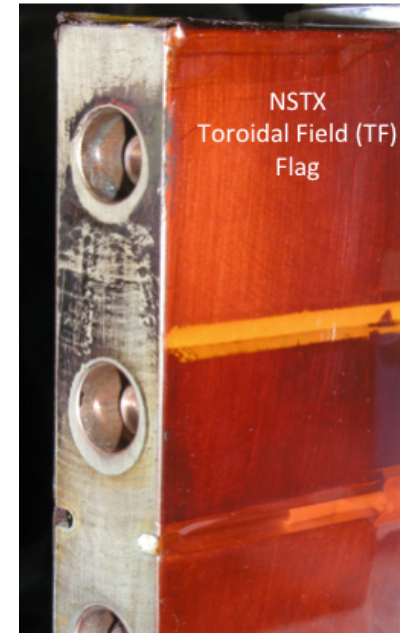
*Joint surfaces degraded in NSTX due to lift-off*
