# Forensic Analysis of Faulted NSTX-U Inner Poloidal Field Coil

**Abstract**—The failure of the NSTX-U PF1A upper coil suspended plasma operations during the project’s first operational campaign after commissioning. Initial nondestructive testing and examination of the failed coil was followed by extensive nondestructive radiography. Destructive testing facilitated visual borescope/videoscope inspection through the cooling path, vacuum testing, and electrical testing of every conductor segment. One conductor cooling path visually evidenced a void through the sidewall of the cooling path in a layer-to-layer region. The identified void in the conductor cooling path was not proximal to a braze or joggle. Electrical testing indicated that the voided conductor segment was a member of a group of 14 conductor segments that evidenced low-resistance connectivity. Four braze joints and two lead segments were subjected to 400-lbf/in<sup>2</sup> hydrostatic pressure testing followed by helium leak testing and evidenced that there were no detectable leaks in the tested cooling path segments. The faulted region was proximal to the center of the coil pack and evidenced historical electrical pitt

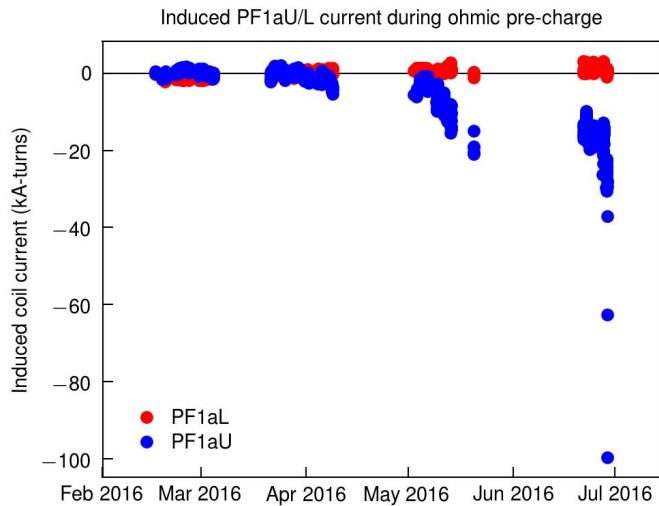
The induced PF1A-U coil currents generated during routine plasma operations can be retrospectively assessed because the ohmic coil (the central solenoid) applies a consistent loop voltage to the PF1A-U coil immediately before each plasma discharge. More specifically, the ohmic coil is ramped to a precharge current of +20 kA before the initiation of the plasma. This ohmic current ramp applies the same  $\sim 2$  V of inductive loop voltage to the PF1A-U coil in every discharge. As such, the PF1A-U flux-loop measurements could be examined over several months of operations to determine if currents were being induced in an electrical fault in the PF1A-U coil. Fig. 3 illustrates the total induced current in PF1A-U as inferred from the poloidal flux-loop measurements. These data are obtained by computing the mutual inductance coupling matrix between the two flux loops and the coil and then inverting the coupling matrix to extract the coil current. The PF1A-U induced current measurements [Fig. 3 (blue)] show a clear degradation that begins toward the end of the March/April run period. This degradation continues through the May and June run periods and then accelerates rapidly on the final run day before operations were halted. Approximately 100-kA turns of current were induced in PF1A-U during the ohmic precharge for the final plasma shot. Similar measurements for the PF1A lower (PF1A-L) coil [Fig. 3 (red)]

Fig. 3. Gradual change in the inductance of PF1A-U over time.

show that PF1A-L did not experience any degradation over the course of the run. On July 22, 2016, PF1A-U operations were suspended.

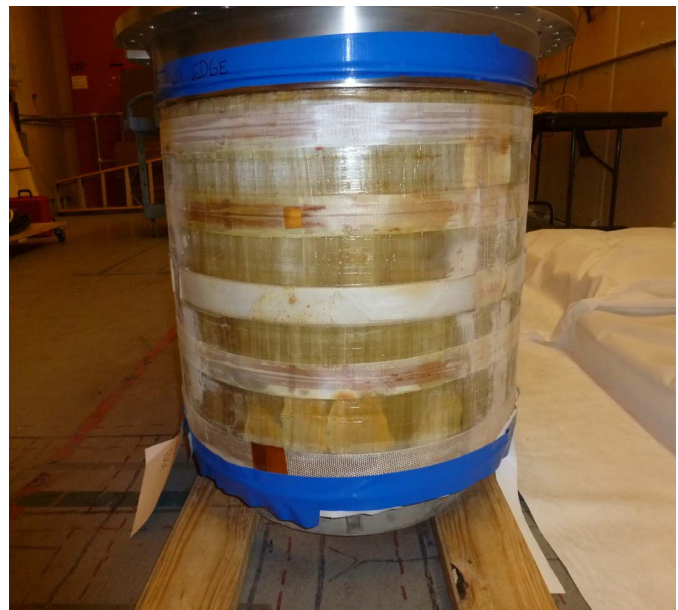
The PF1A-U was visually examined and extensively photographed in the South High Bay. It was noted that portions of the observable surfaces evidenced a powdered deposit indicative of dried sediment. An external visual inspection of the coil conductor leads was unremarkable. A majority of the electromagnet was not visible due to the shields that cover the perimeter of the coil. These shields are welded to the upper and lower flanges of the mandrel. Nevertheless, areas of surface delamination and discoloration were observable in the gaps between the shields.

Fig. 4. PF1A-U exterior with shields removed.

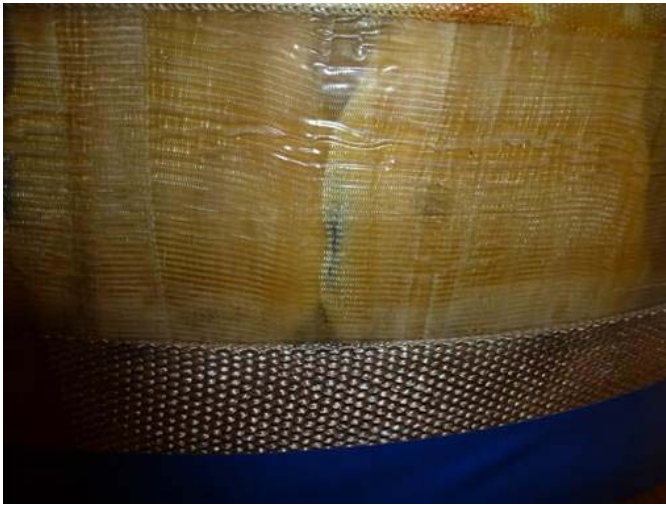
Fig. 5 illustrates a focused view of the outside surface of the PF1A-U coil. Short, dark vertical lines were observed that evidence separations/tears in the ground layer wrap. An internal coolant path leak in the electromagnet may communicate with these separations as potential exit points for coolant. Removal of the shields evidenced numerous ground wrap delamination areas identified by their lighter color and confirmed by lightly tapping the areas with a tool that audibly noted hollows beneath the ground layer.

Fig. 5. PF1A-U ground wrap delamination.

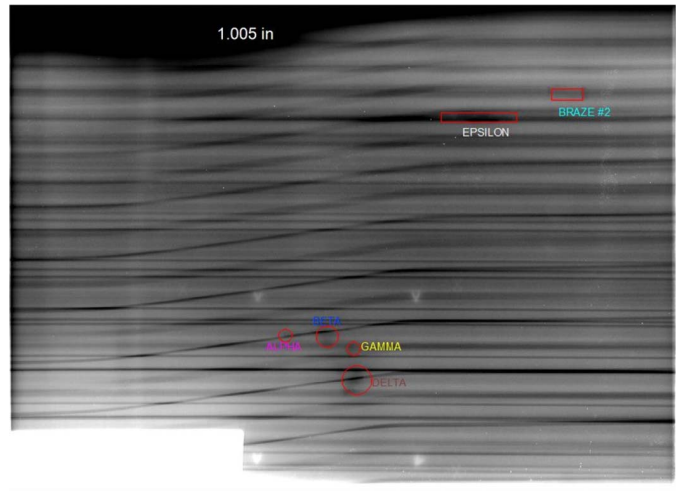
Fig. 7. Approximate references for anomalies identified in region 0\_1A.

triangulation analysis method developed at PPPL for determination of the radial position of the anomalies. Scale paper templates were used to position reference indices and the iridium-192 radioisotope source to create an intentional  $25^\circ$  parallax of the anomalous region. A total of 13 new images were recorded and were indexed in a similar fashion to the previous radiograph images with scale reference and the addition of a parallax notation. The scaled images were digitally imported into an AutoCAD drawing. The anomalous regions angularly proximal to the lead-in/lead-out area were divided into visually perceivable density variations “alpha” through “epsilon” (Fig. 7). In-line braze joint 2 was visible in the imaging and was also included in the triangulation analysis. Circles and rectangles were drawn over the observed density variations to optically determine an approximate center point reference for each area. A triangulation analysis was performed to determine proximate radial positions of the observed anomalies. The analysis indicated that the regions alpha through gamma were proximal to conductor rows 8 and 9 and between conductor layers 2 and 3. The analysis also indicated that braze joint 2 was radially proximal to layer 2. This geometric approximation corresponded to the Everson Tesla, Inc. (ETI) MPO documentation for braze joint 2, validating the radial positional interpolation of regions alpha through epsilon.

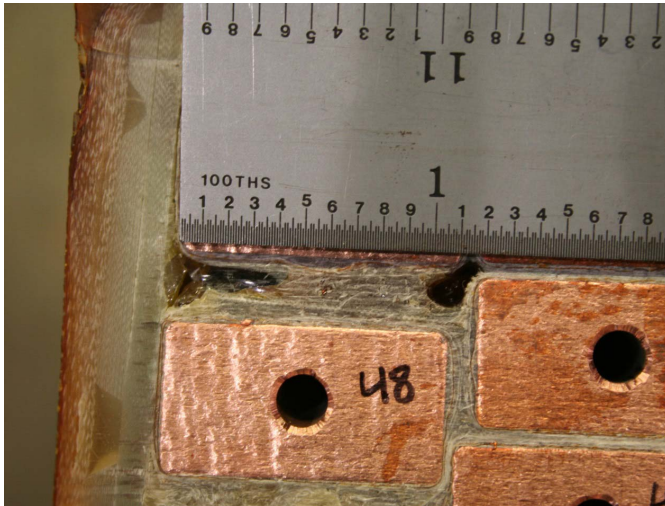
Exterior visual examination of cutting planes A and C, left and right, evidenced insulation anomalies that were also observed during the milling process (Fig. 9). Cutting plane B, left and right, evidenced a separation between conductor layers 2 and 3 from approximately conductor row 3 to conductor row 16. Observed conductor spacing, insulation characteristics, and conductor keystoneing were noted and

Fig. 9. Coil pack section plane C void.

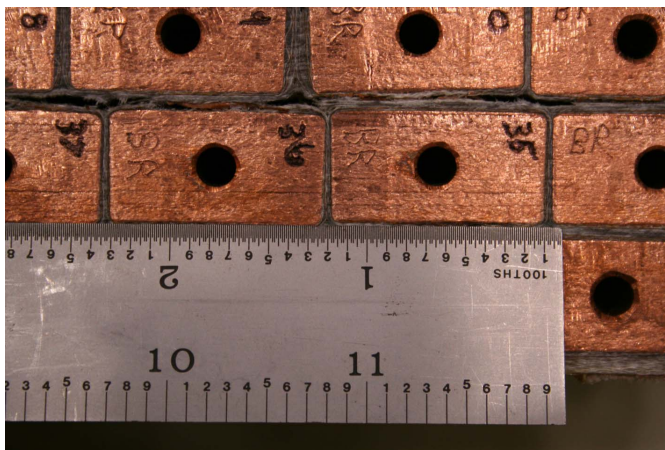
Fig. 10. Coil pack section plane B keystoneing.

photographed (Fig. 10). Examination of the insulation wrap sequence evidenced that each conductor was wrapped with a half-lap co-wound glass/Kapton layer with the glass portion laid up against the conductor surface. A glass-only half-lap layer was observed to be wound over the co-wound glass/Kapton layer. Each layer-to-layer region evidenced an additional flat-laid glass layer.

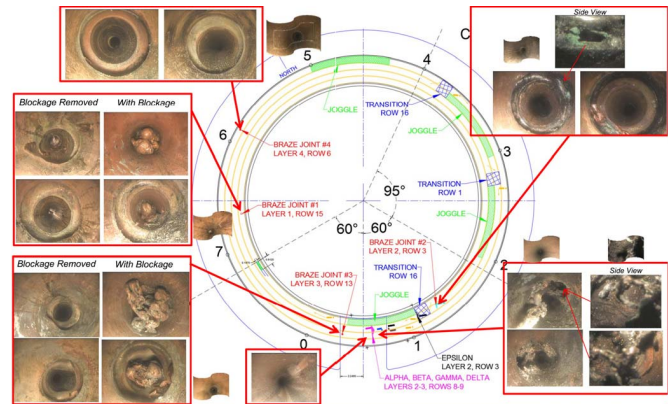
Fig. 11. Borescope findings compilation.

the braze joints and anomaly “delta” (features visible from the cooling paths) radial positions predicted in the radiographic triangulation method were accurate and verified through the cooling path visual examination. A compilation of findings mapped to a plan view of the PF1A-U coil is illustrated in Fig. 11.

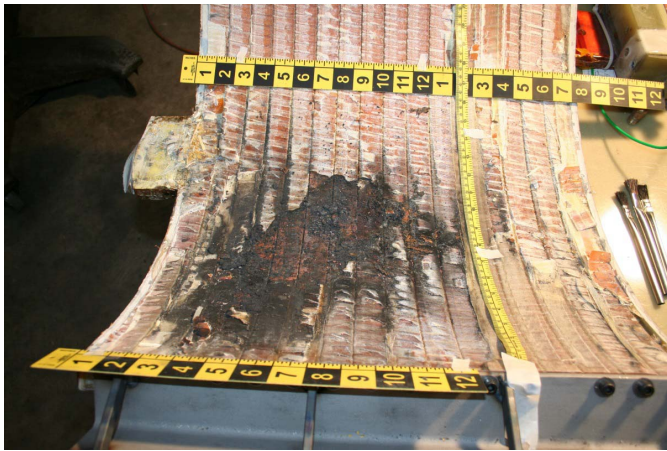
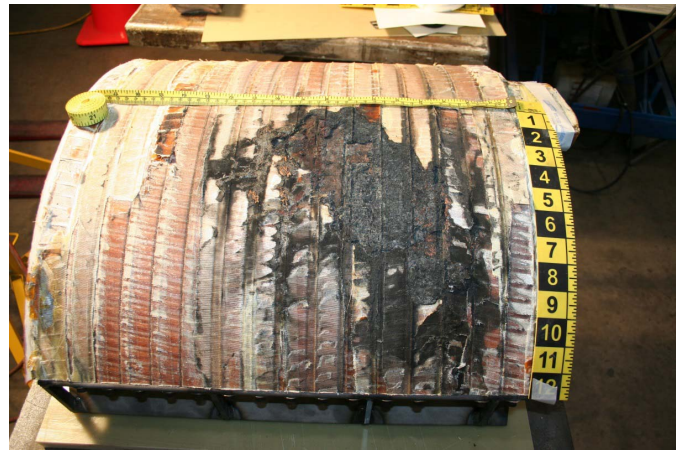
Fig. 12. Layer 3 surface with debris overview.

Fig. 13. Layer 2 surface with debris overview.

An area of damaged electrical insulation was observed that measured approximately 10 in in height and 12 in in length (toroidally) between layers 2 and 3 (Figs. 12 and 13). Areas of unwetted woven glass fibers were observed proximal to the damaged region (Fig. 14).

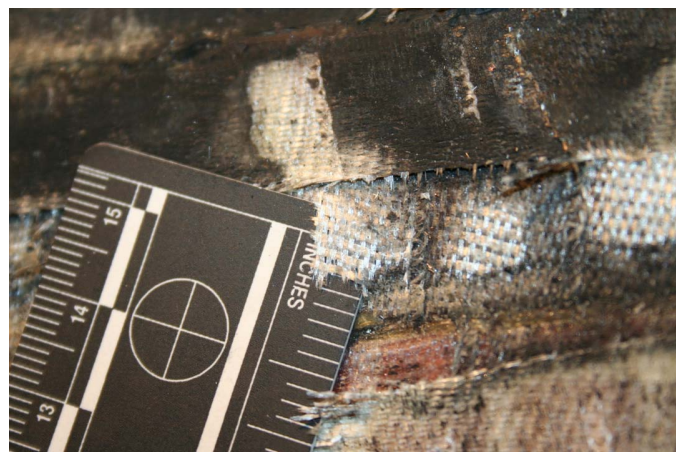
Fig. 14. Unwetted woven glass fibers.

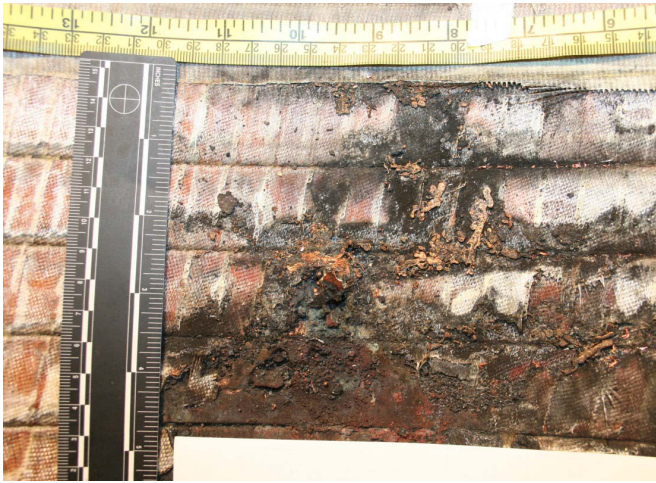
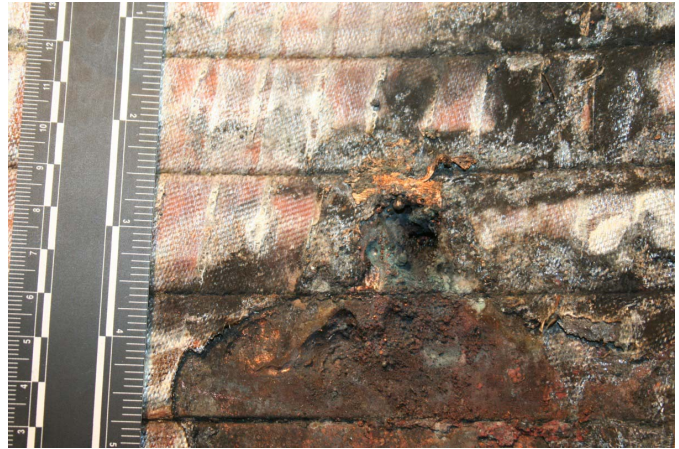
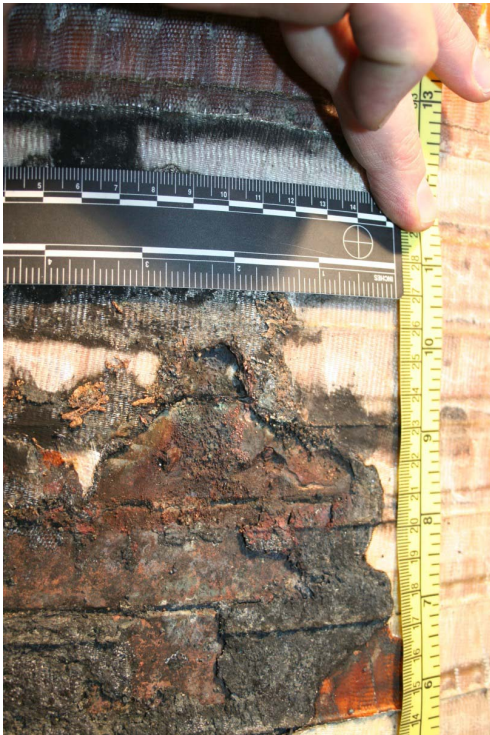
A primary electrical activity area was observed proximal to conductor turns No. 40 and 41, with a void located in the sidewall of conductor No. 41 along the cooling path in layer 3 facing layer 2 (Fig. 15). This void was previously documented as viewed from within the conductor cooling path. The opposing layer 2 area evidenced pitting but no breakthrough to the cooling channels (Fig. 16). The observed pitting was characteristic of electrical activity occurring along the outer surfaces of the conductor(s). The void in the sidewall of conductor No. 41 would therefore have evolved from the conductor surface and extended into the cooling path over time. Solidified molten debris was observed surrounding the void in conductor turn No. 41 and appeared to exhibit an impression of the woven glass fiber insulation. Spherical globules of molten debris, some adhering to the conductor surfaces, some loose, were also observed. Loose debris was removed from the void area, evidencing adhered molten globules as well as areas of oxidation along the exposed conductor surfaces. Cavities were observed in conductor turn No. 40 adjacent to the void in conductor No. 41. Macroscopic examination of the void in conductor turn No. 41 evidenced varying extensive pitting and localized varying oxidation, indicative of repetitive historical electrical activity (Fig. 17).

Fig. 15. Layer 3 void area with debris overview.

Fig. 17. Layer 3 void with loose debris removed overview.

Fig. 16. Layer 2 area opposite layer 3 void with debris.

- 1) The failure of the subject coil was progressive over time and involved conductors between layers 2 and 3.
- 2) The ultimate failure was located within the sidewall of conductor No. 41 along layers 2 and 3. It is probable that the initiating failure originated in the proximal area of the ultimate failure was electrical in nature and propagated from the surface of the conductor into the cooling path.

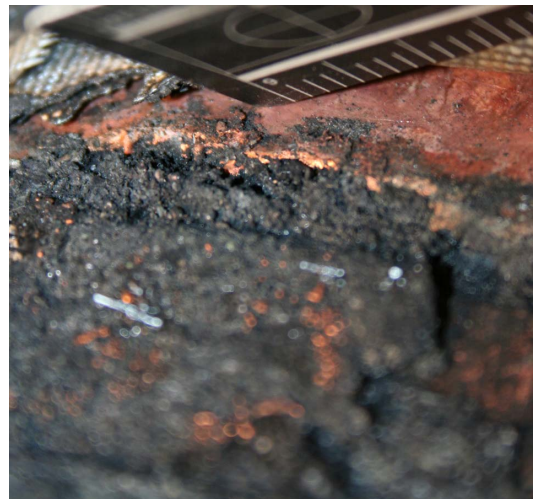
A secondary electrical activity area was located along conductor turns No. 30 and 36 (Fig. 18). The electrical

Fig. 18. Layer 2 conductor No. 30 electrical activity.

activity in this area was not oxidized nor did it evidence significant pitting, indicating that this area of activity occurred near or after the time of the ultimate failure. The authors noted that the subject coil was inductively energized after the ultimate failure for diagnostic purposes, and the authors cannot rule out the possibility that the secondary electrical activity may have occurred during these tests. The secondary electrical activity area was likely initiated by migrating debris and liberated cooling fluid after the ultimate failure of conductor No. 41.

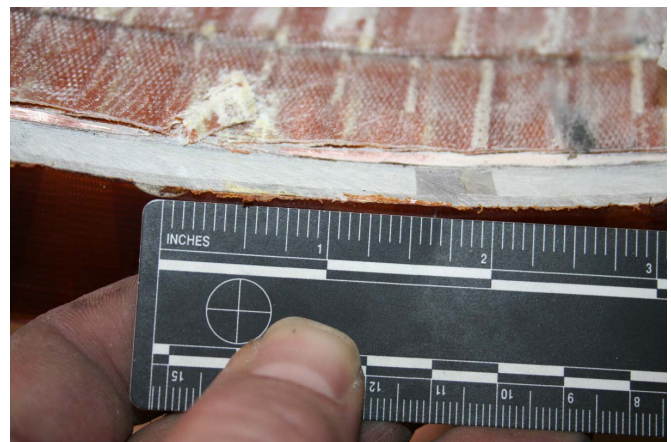
Fig. 19. Resin vent sprue mandrel versus G-10 offset.

observed that the lead-side insulation shim/mandrel sprue openings were offset approximately 1-3/4 in (Fig. 19). The lead-opposite insulation shim/mandrel sprue openings evidenced an offset of approximately 5/8 in. The insulation shim

fabrication drawing indicates that the same shim design was used for both PF1A-U and PF1A-L. However, the PF1A-U and PF1A-L stainless steel mandrels, and their corresponding sprue hole locations, were not identical. A  $7.5^\circ$  toroidal angular difference in sprue hole location was identified according to the mandrel fabrication drawings. This angular difference accounts for an approximate 1.66-in misalignment in the lead-side PF1A-U insulation shim sprue holes versus the stainless steel mandrel sprue holes. However, the design documentation does not account for the lead-opposite sprue hole alignment.

- 6) Misalignment of the insulating shim and mandrel sprues likely impeded resin flow during the VPI process. The lead-side sprue misalignment is attributed to a design variance while the lead-opposite sprue misalignment is likely to have occurred during assembly.

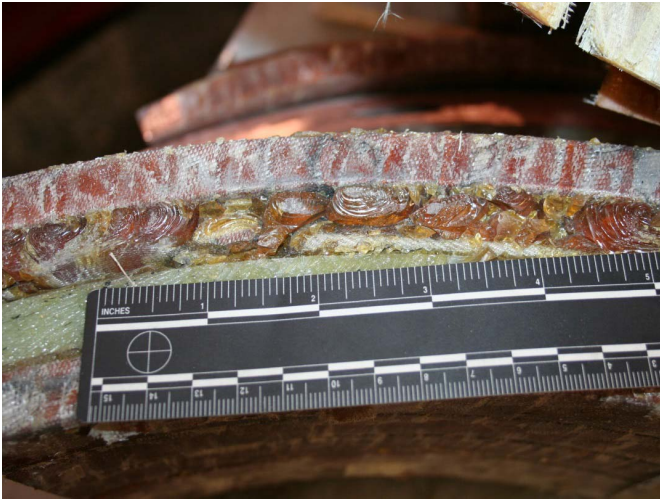
Fig. 20. Resin globules along layer 3 bottom turn.

Samples for metallurgical and chemical analysis were extracted from coil pack section B\_C. The ground wrap insulation system was able to be separated from the three portions of the coil pack by inserting a wedge in between the conductor insulation wrap and the ground wrap. The resin fill density was observed to be inconsistent, forming into globules in resin-rich areas (Fig. 20).
