Status of HHFW antenna inspection for coatings, blobs, dust and particles prior to cleaning

Lithium deposition affects HHFW antenna with coatings and dust projectiles

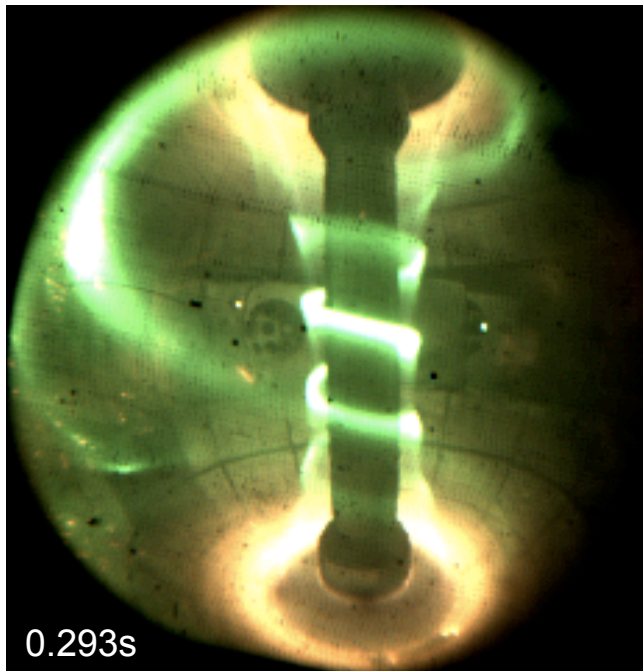
Shot 141988 $B_T = 4.5$ kG, $I_p = 0.9$ MA,
Helium, $P_{RF} = 1.9$ MW

- Lithium projectiles at end of shot
 - Moving outward toward antenna

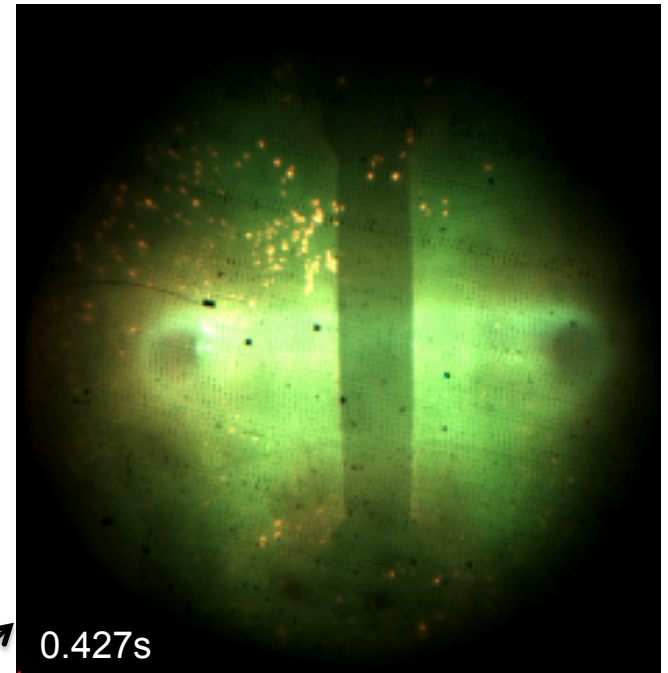
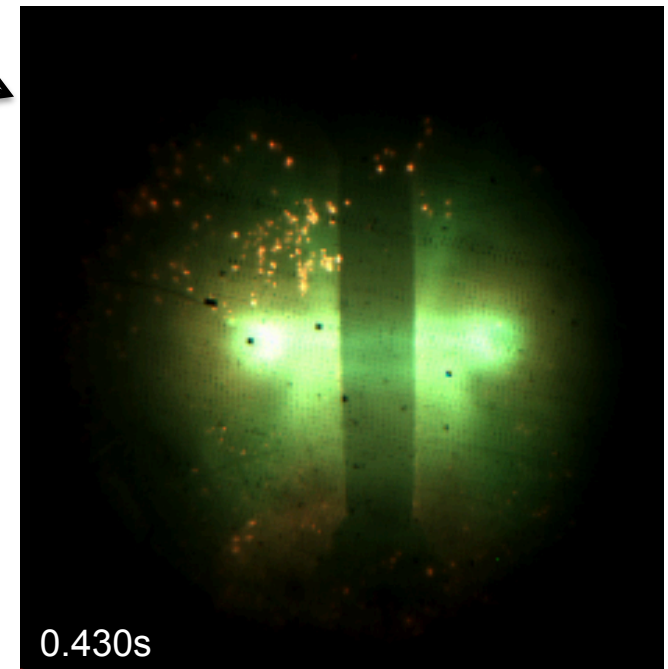
- Lithium from top of antenna moving along magnetic field line

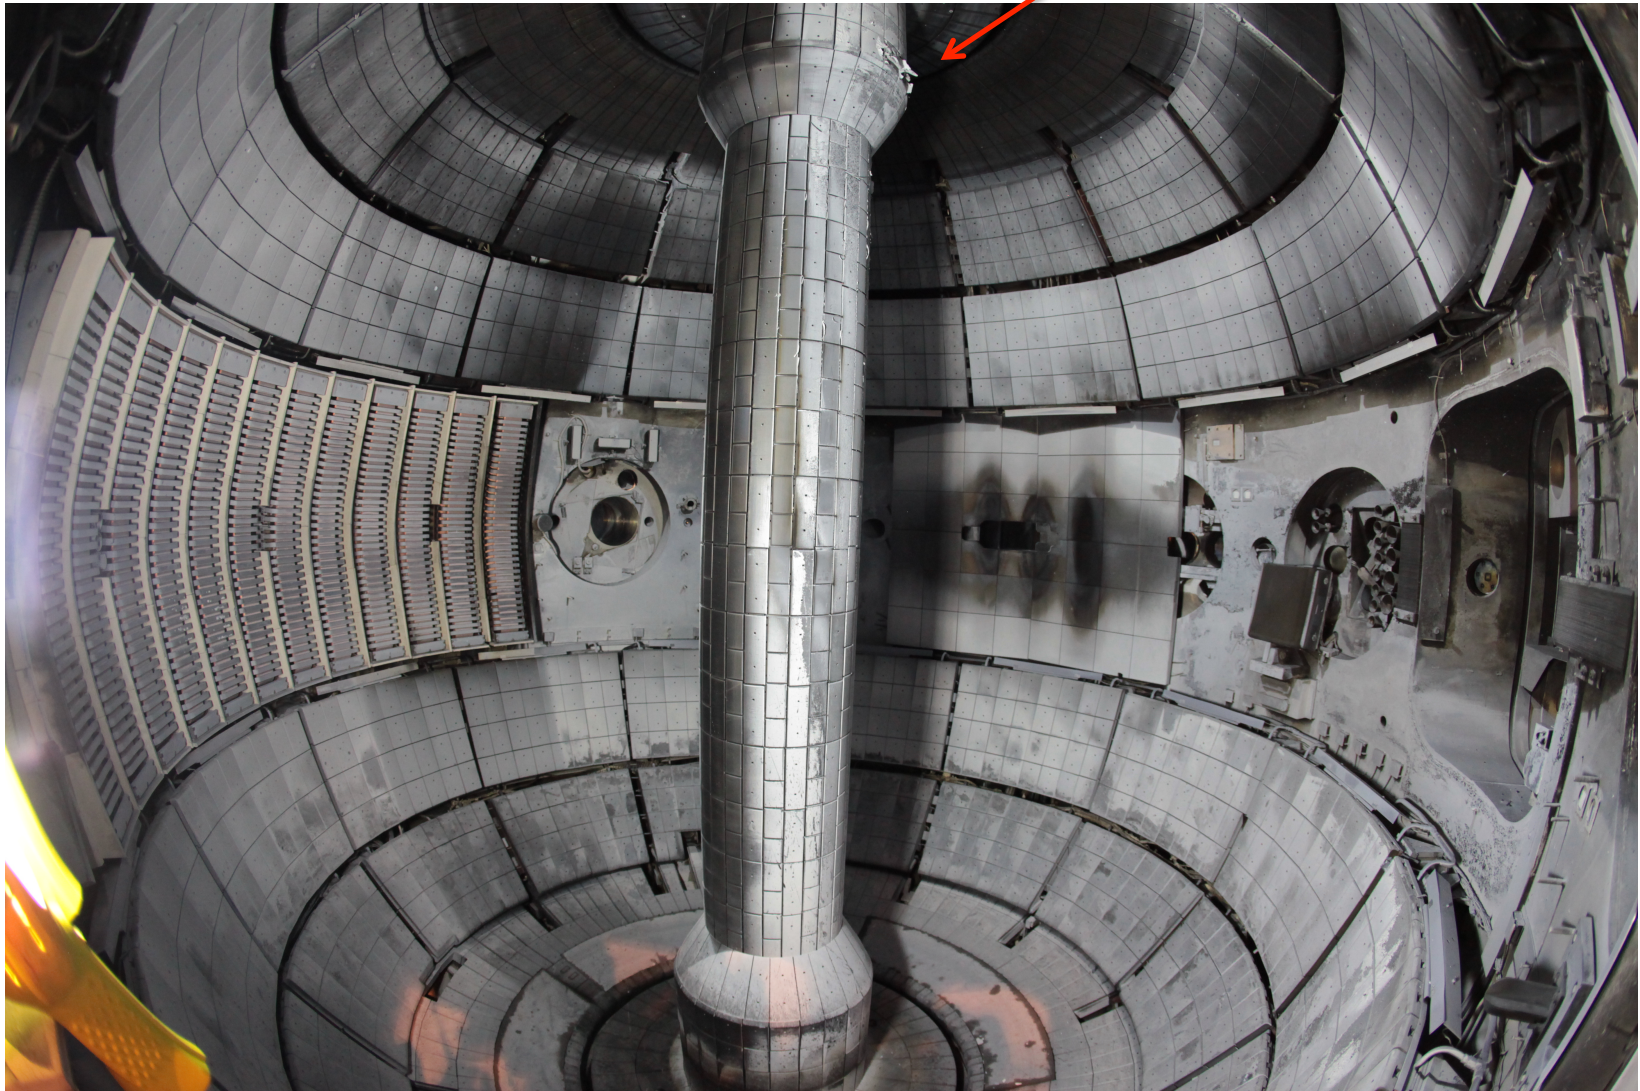
Vessel picture showing lithium coatings and sheeting

Sheeting here

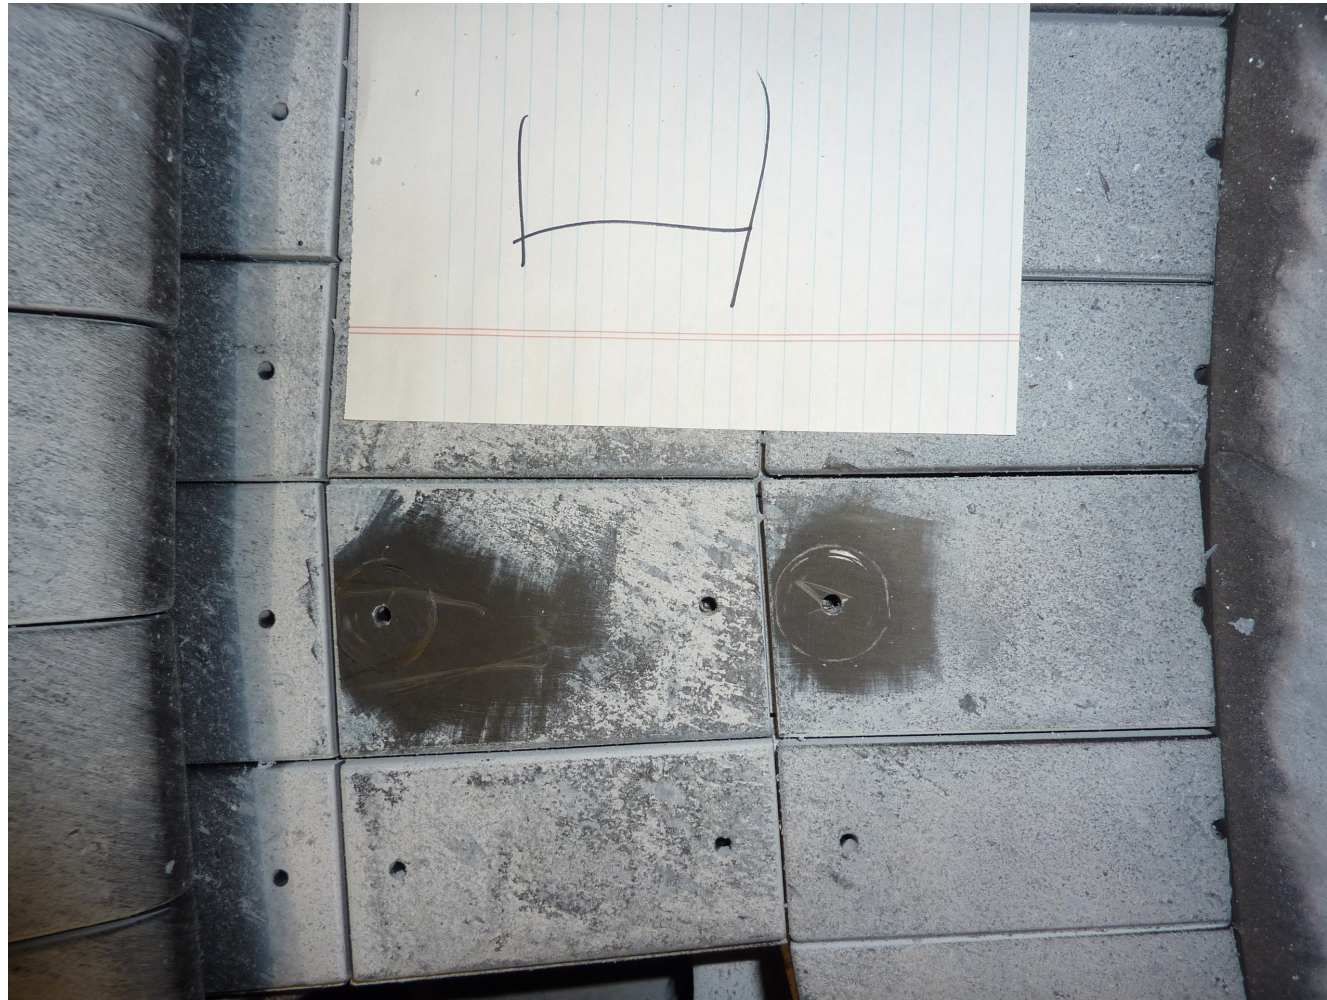
Tile current Rogowski measurements hampered by insulating coating on tiles

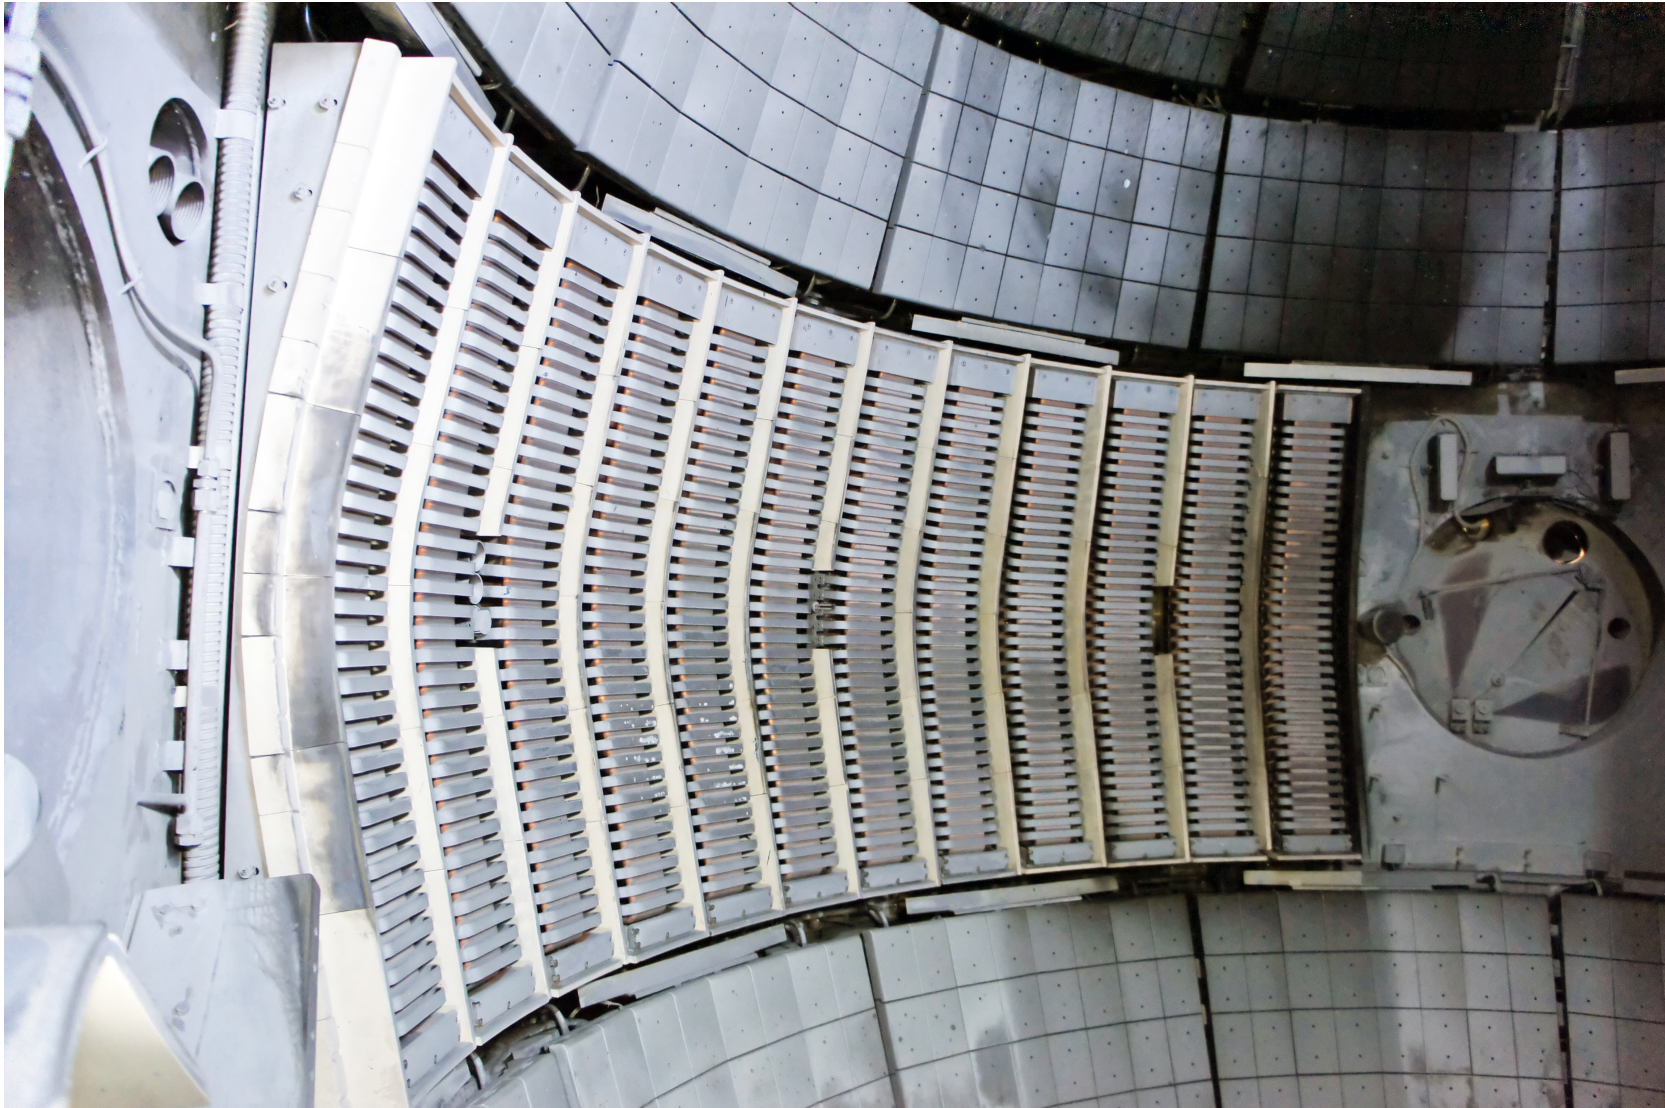
Antenna looks reasonably smooth from a distance

Note the darkened end BN bumpers, especially in ion direction

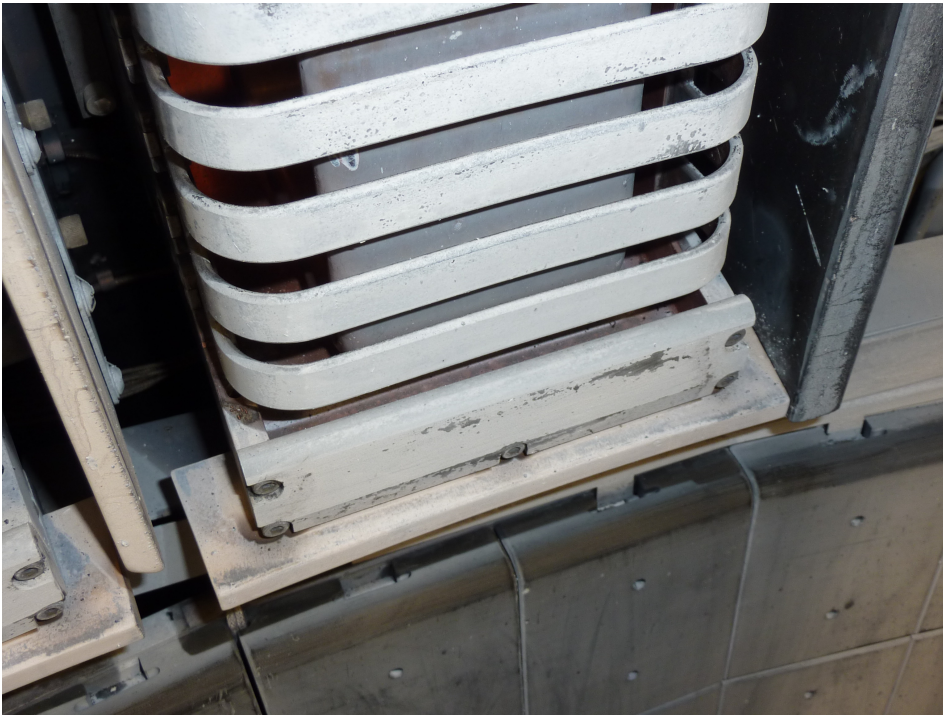
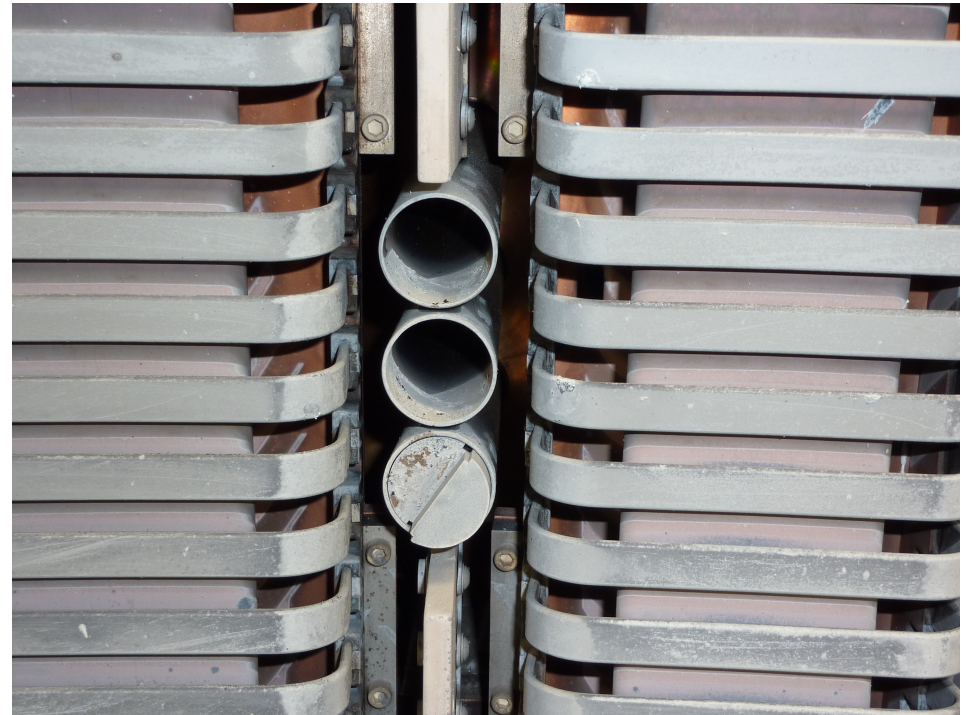
Closeup views show more damage to antenna

- Bottom right corner shows some arcing
- BN bumper is blackened
- Microwave reflectometer horn is coated with film

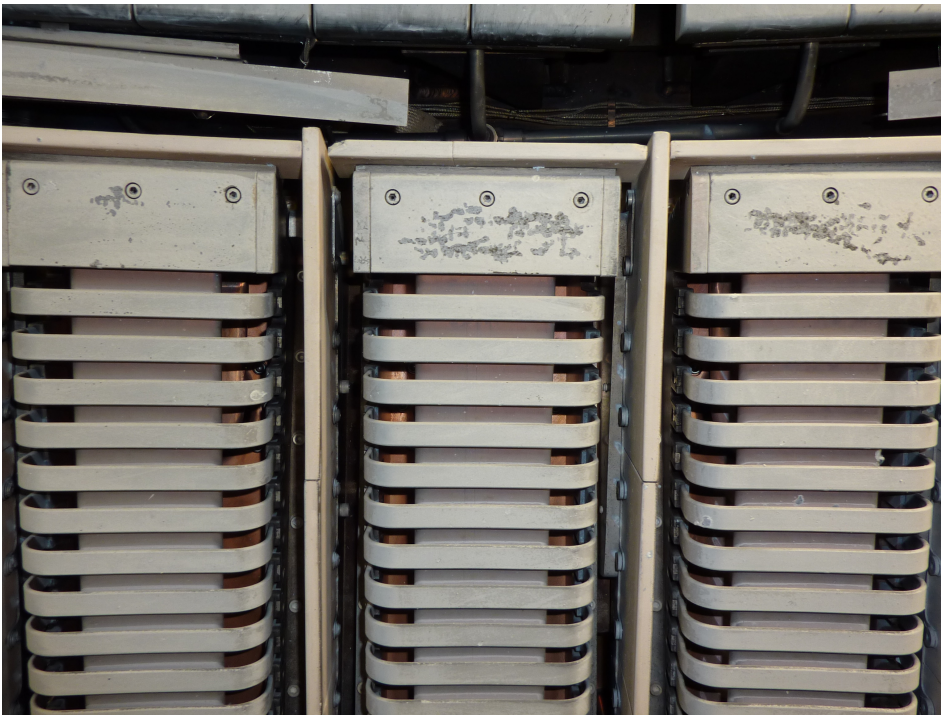
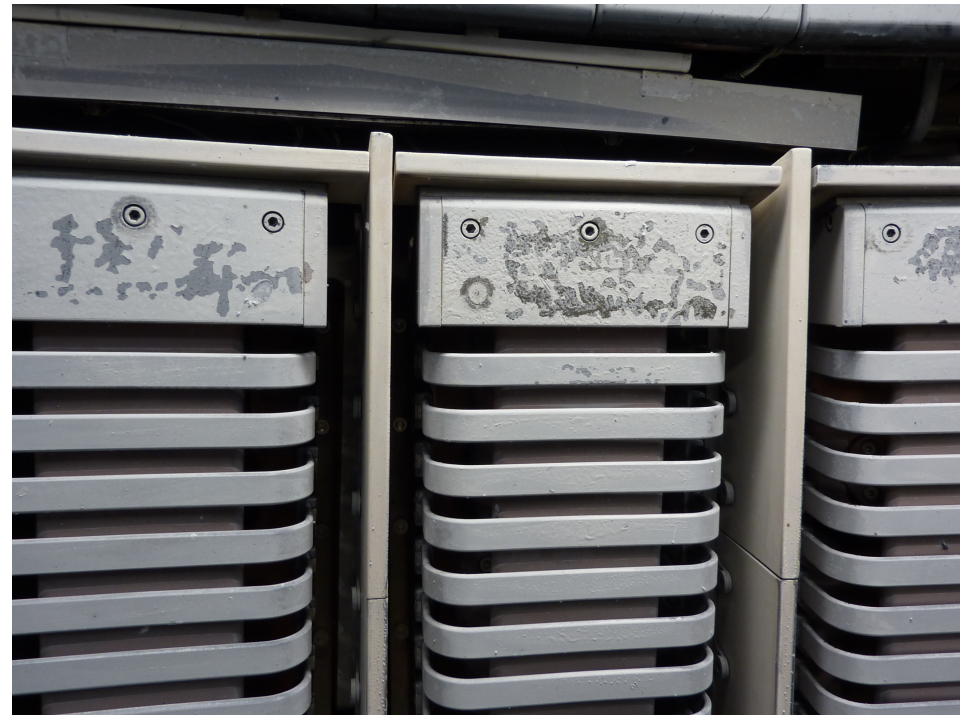
Clear arcing observed at top

- Top left and center Faraday shield top covers show large number of arc tracks

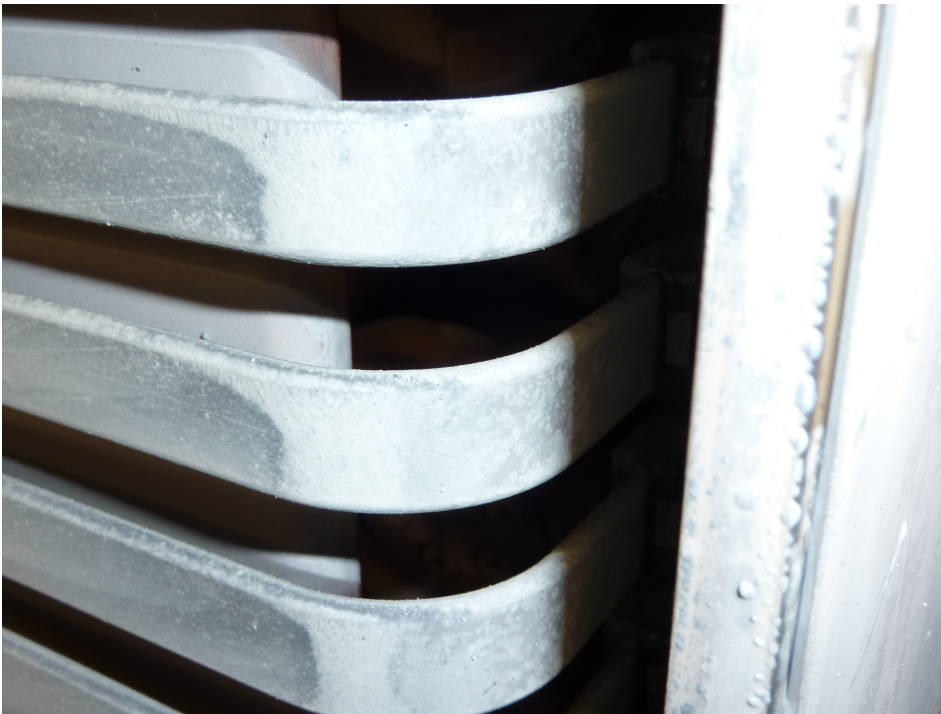
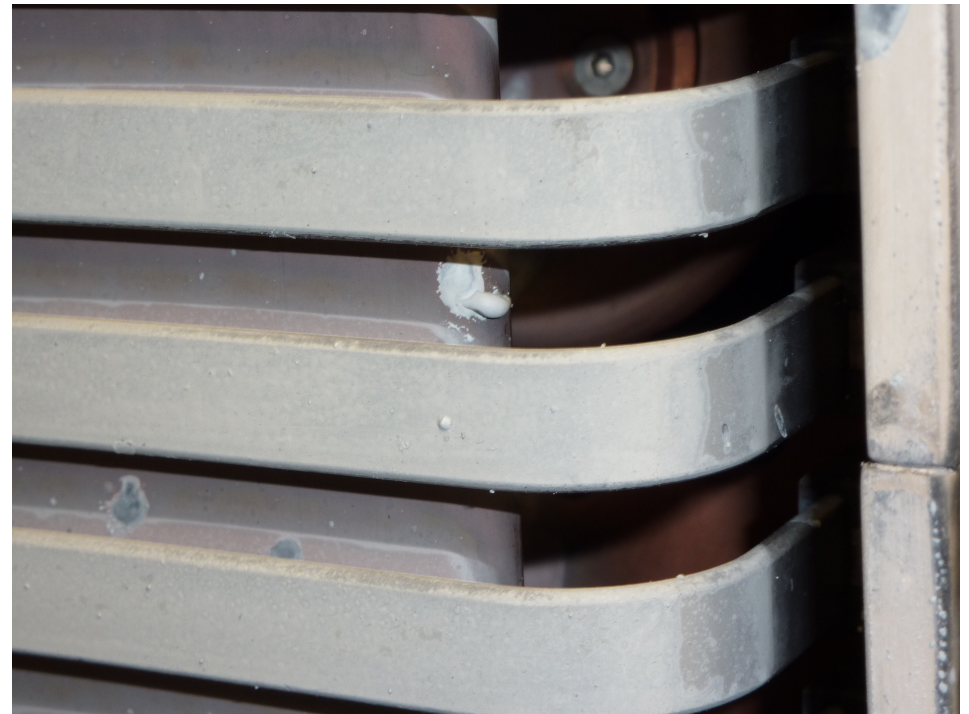
Globs of lithium are seen on structures – BN septa, straps and Faraday shield

- Blob on current strap is especially bad for arcing and such globs could explain the need to vacuum condition extensively
- Blobs on BN septa may be cause of bursts between antenna elements that most of the time did not result in arcs
