# Identifying the Cause of the NSTX TF Coil Bundle Failure\*

L. E. Dudek, J. H. Chrzanowski, P. Heitzenroeder, T. Meighan, S. Ramakrishnan and M. Williams  
Princeton Plasma Physics Laboratory  
Princeton, NJ USA

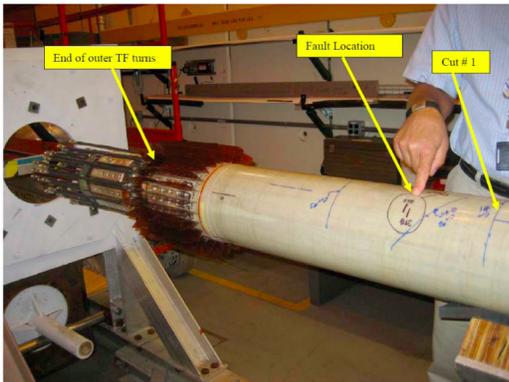
Fig. 1. Coil being marked for cutting

The location of the short along the length of the TF Bundle was determined using resistances between the shorted conductors. The coil was marked at the calculated fault location, 31", from one end and a ~12" section was removed centered on the fault to perform the forensic dissection. The removed section was further cut into 2" thick sections to reveal the location where the

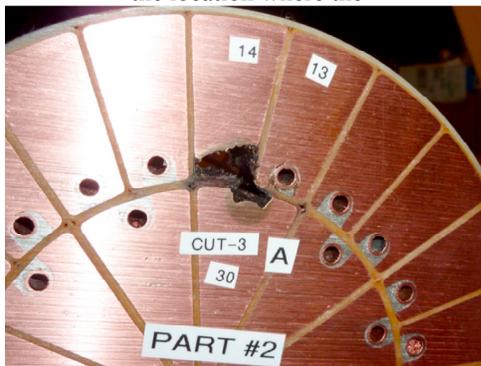
Fig. 2. Coil slice showing the origin of short

short was believed to have originated. Figure 2 shows cut 3 on part 2 which was made at the location of the fault. The remaining two conductor pairs that originally tested low were

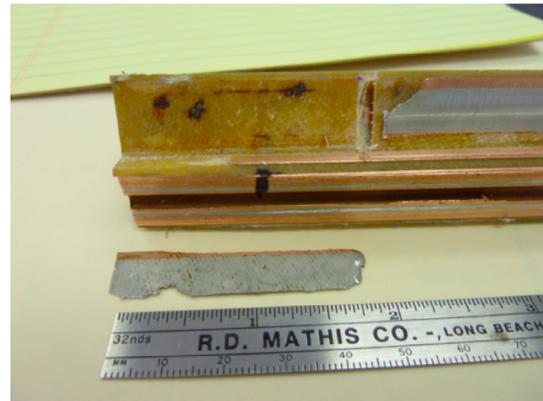
found in a removed section which was further dissected longitudinally to reveal the interface between the insulation and copper at the low resistance point (Fig 3). The insulation facing the solder was seen to have brown colored spots and lines. The discolorations were similar in color to the solder flux used to install the cooling tubes. These spots were isolated using an ohmmeter with 10 Mohm range to test for the lower resistance locations. Many of the discolored lines were along the edges of the solder as if something had wicked out of the copper/solder interface.

Fig. 3. Dark colored stains appeared to be zinc chloride

To eliminate the Zinc Chloride from the process an Organic Flux was used to solder the tubes into the conductors. The solder and flux was prepared in advance as a paste that was preplaced below and around the tube in the groove. In place of a torch brazing process the conductor was heated on a resistively heated “hot plate” to the solder temperature and a torch was only used to touch up the solder [2]. The conductor was held at temperature long enough to ensure the flux was consumed in the process. In addition a more thorough cleaning process was used after the soldering to remove any remaining flux and then baked at 170C to ensure that the last remaining traces were bake out [3].

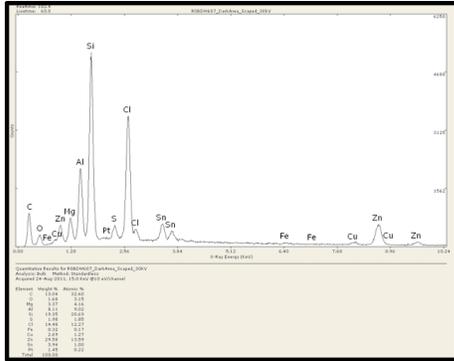
The Scanning Electron Microscope (SEM) and Auger analysis of the colored stain at the insulation / copper interface were performed to determine the elemental composition. These tests were compared to clean insulation samples to isolate the composition of the colored stains. These tests revealed that there were high levels of Zn and Cl in the colored stains which are the main constituents of the flux used to solder the cooling tube.

Fig. 4. EDS Tests found high levels of Zinc and Chlorine

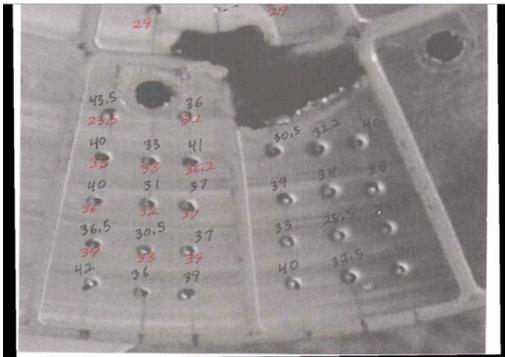
The Rockwell B measurements can be seen on the sample in Figure 5. They were very similar to those measured on an unused section of copper from the same lot and an undamaged section from the coil indicating fatigue did not contribute to the failure.

Fig. 5. Rockwell tests were performed on conductors to rule out fatigue
