13-010111-CLN-01

TO: DISTRIBUTION
FROM: C NEUMEYER
SUBJECT: MEETING ON OH GROUND FAULT FINDINGS AND OPTIONS

OH Coil Ground Fault

Summary of Findings

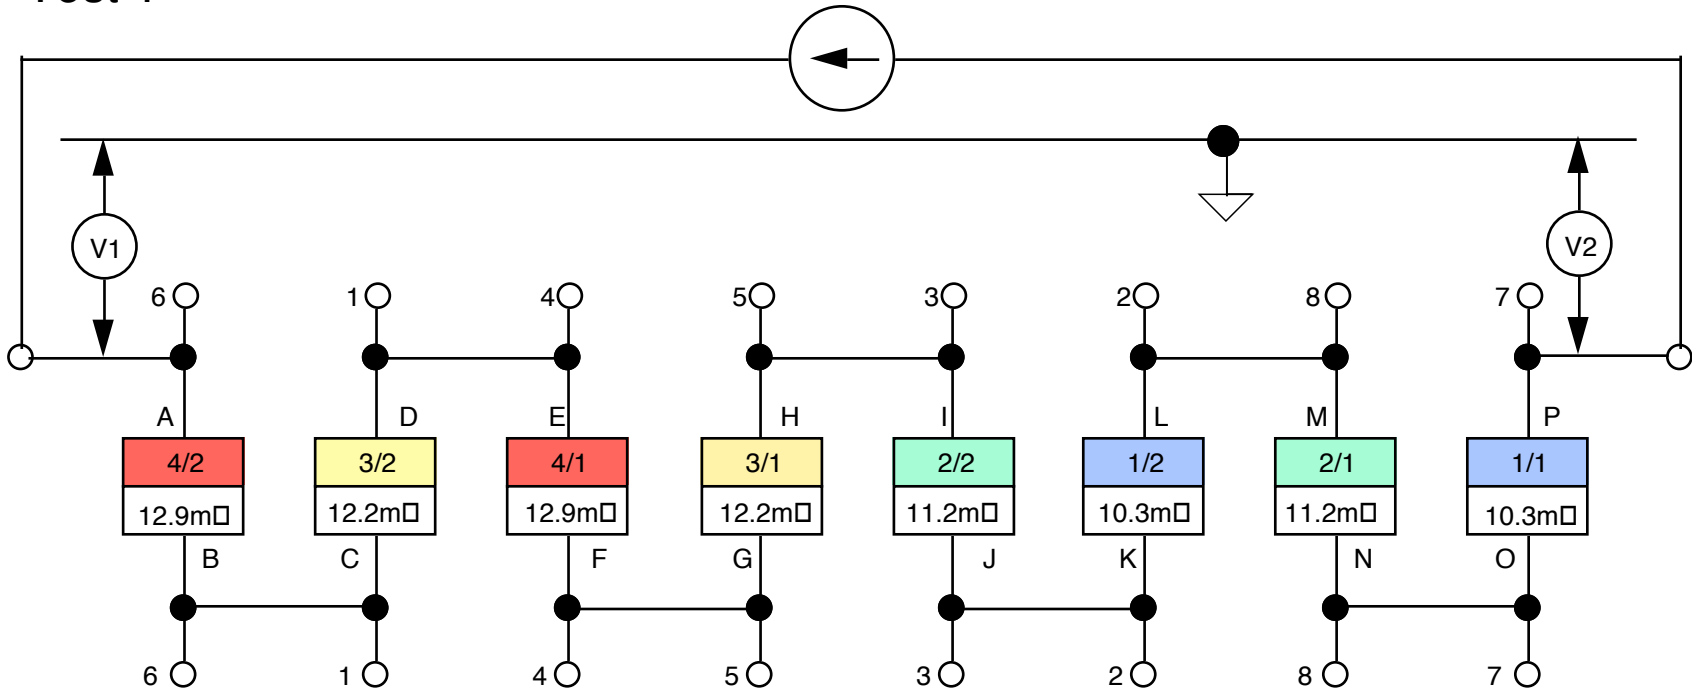
Test 1

$$\frac{(V1 - \overline{V1})}{(V1 - V2) - (\overline{V1} - \overline{V2})} = \frac{R1}{(R1 + R2)} = 4.66\% \text{ (1st test), } 4.0\% \text{ (2nd test)} \quad \text{Galvanic voltage @ } I=0 \quad \square 280\text{mV prior to tests}$$

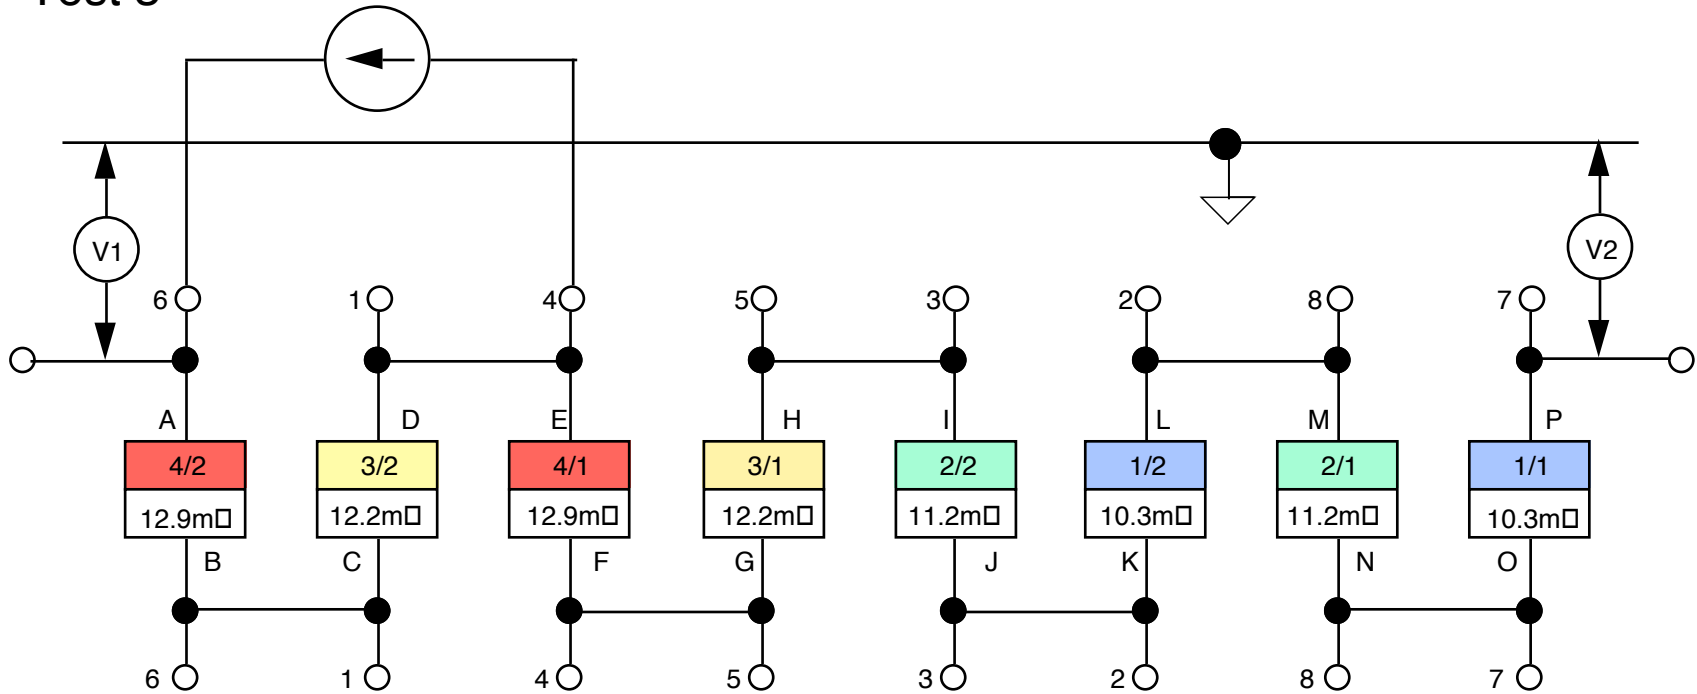
Test 3

$$\frac{(V1 - \overline{V1})}{(V1 - V2) - (\overline{V1} - \overline{V2})} = \frac{R1}{(R1 + R2)} = 11.74\% \text{ (1st test), } 13.1\% \text{ (2nd test)} \quad \text{Galvanic voltage @ } I=0 \quad \square \quad 200\text{mV prior to test}$$

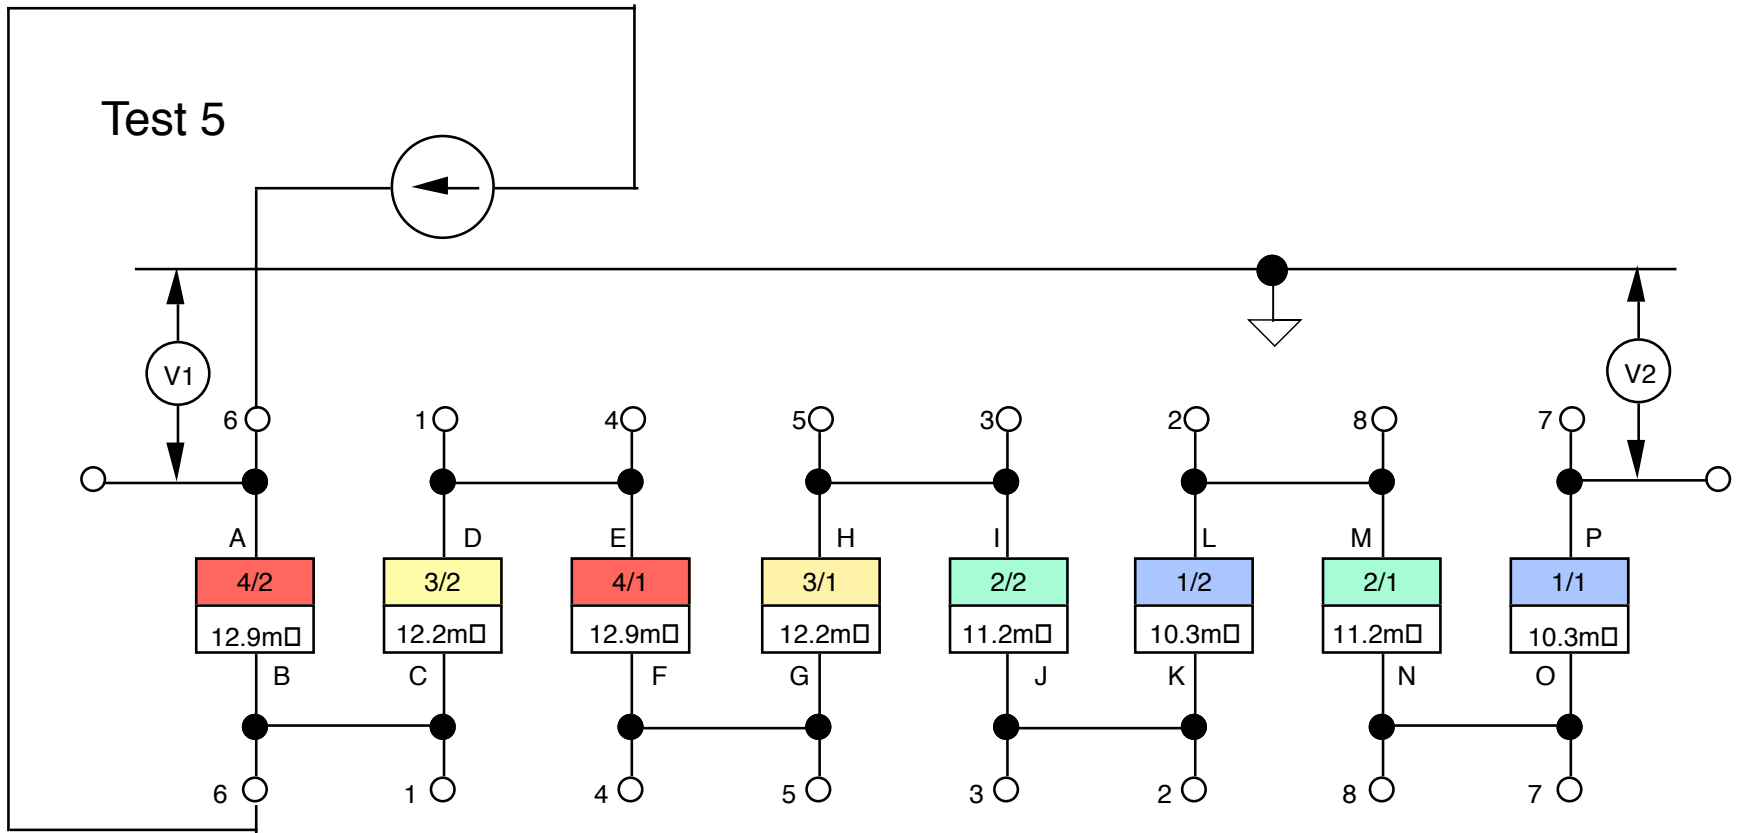
$$\frac{(V1 - \overline{V1})}{(V1 - V2) - (\overline{V1} - \overline{V2})} = \frac{R1}{(R1 + R2)} = 29\%$$

Galvanic voltage @ I=0 □ 200 mV prior to test (jumpy)

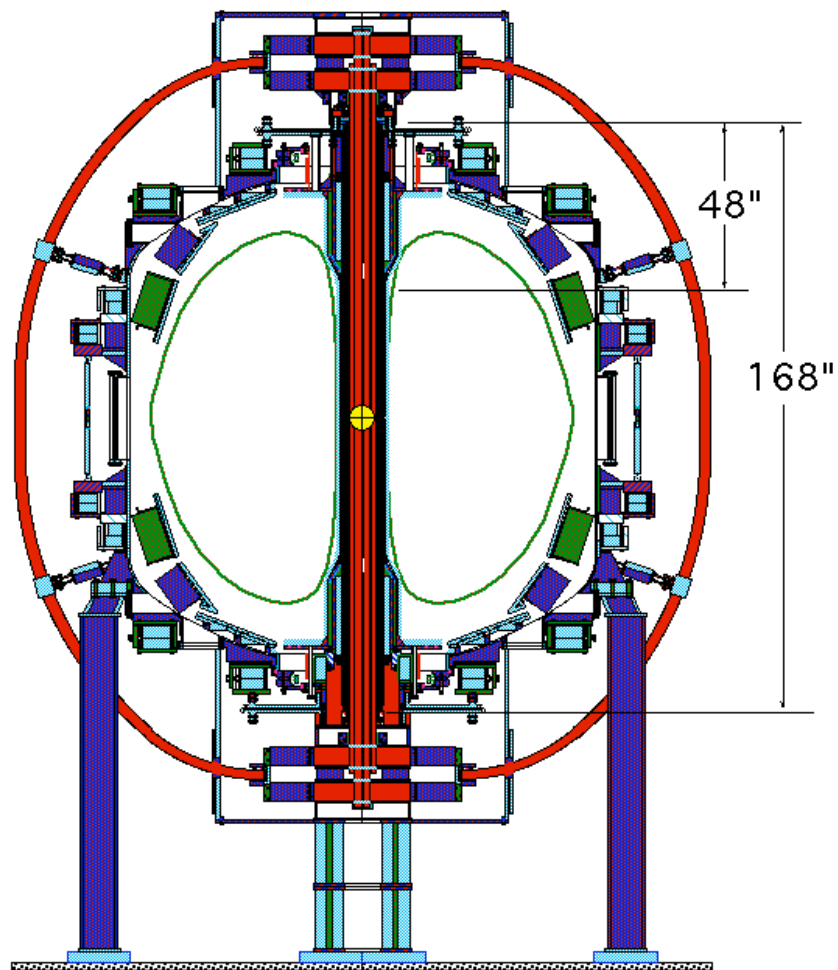
- Ground Fault Location 48" down from Top of OH Coil

- Evidence points to:
 - fault through OH groundwall on outer layer approx. 30% down from the top, below the PF1A area
 - evidence seems solid but only if the fault is limited to a single location
 - turn-turn fault is ruled out because adjacent conductors in layer 4 do not exhibit any influence on null location (due to the two-in-hand winding they are electrically far away)

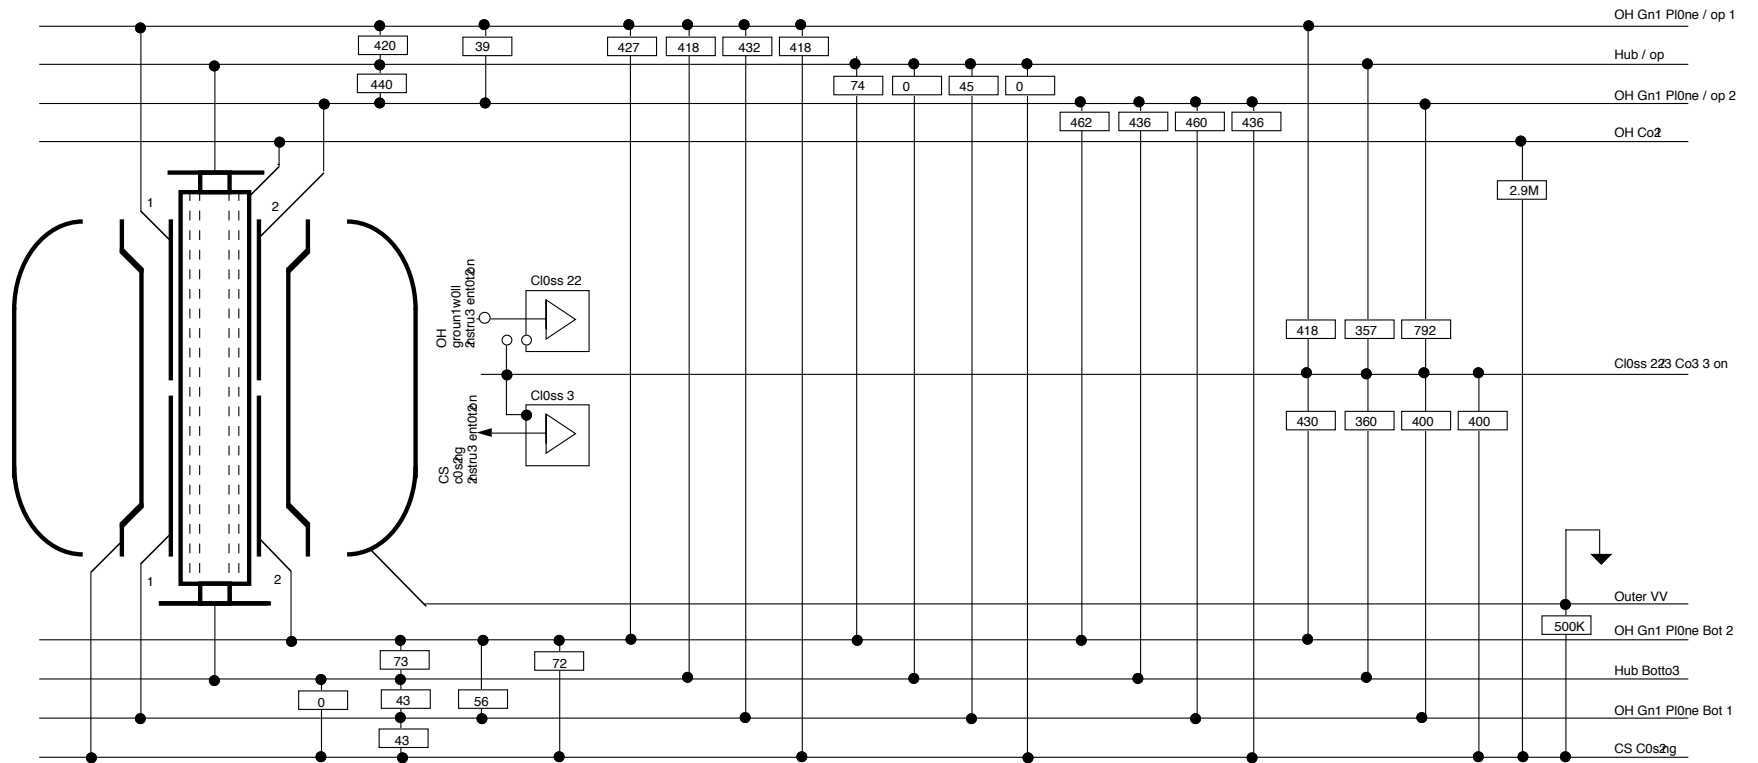
- Injection of DC using floating auto battery and special ultra-low leakage voltage measuring devices now indicates fault within layer 4 (outer layer)
- Measurement of resistance between all equipotential surfaces involved (ground plane sectors, hub assembly, CS casing, etc.) indicates that these elements are not properly isolated from one another.

- Resistances Measured Between All Elements

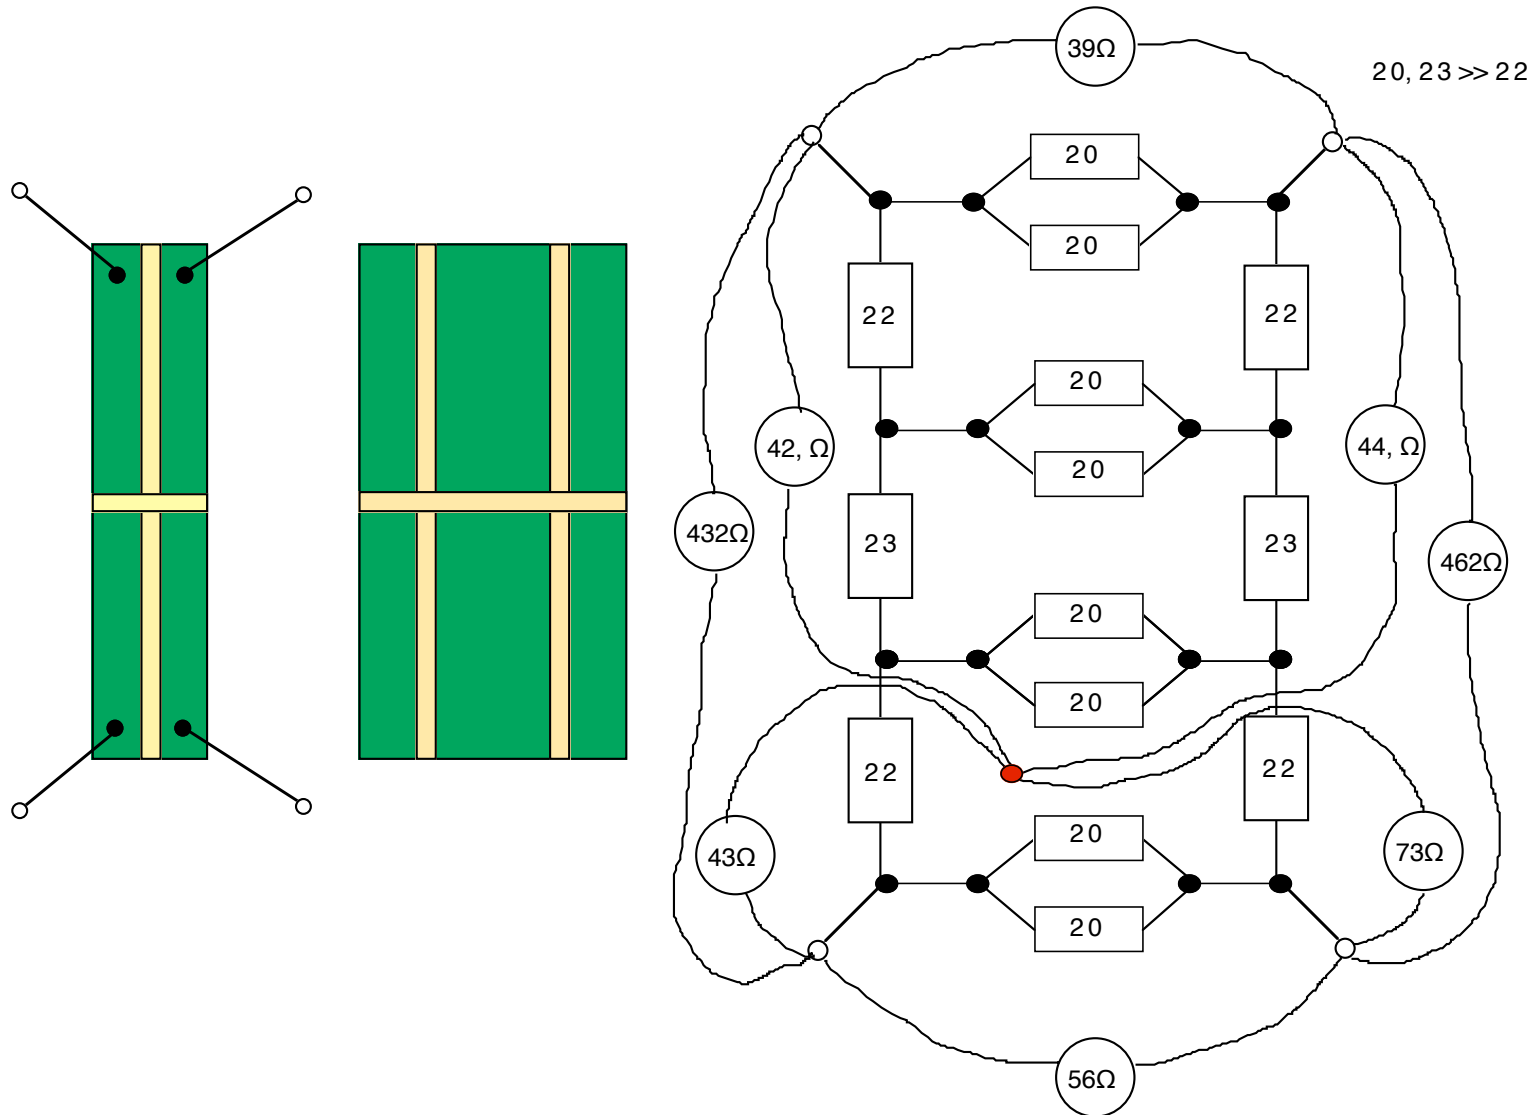
- Anomalous Connection Exists between Ground Plane Segments and Hub/CS Casing Near Bottom of OH Coil

- there appears to be a spurious connection from the lower OH ground plane to the hub assembly, which carries the ground fault leakage current (otherwise the lifting of the ground plane ground wire(s) would isolate the fault)
- there appears to be a spurious connection from the hub assembly to the CS casing (otherwise the lifting of the hub assembly ground wires would isolate the fault)

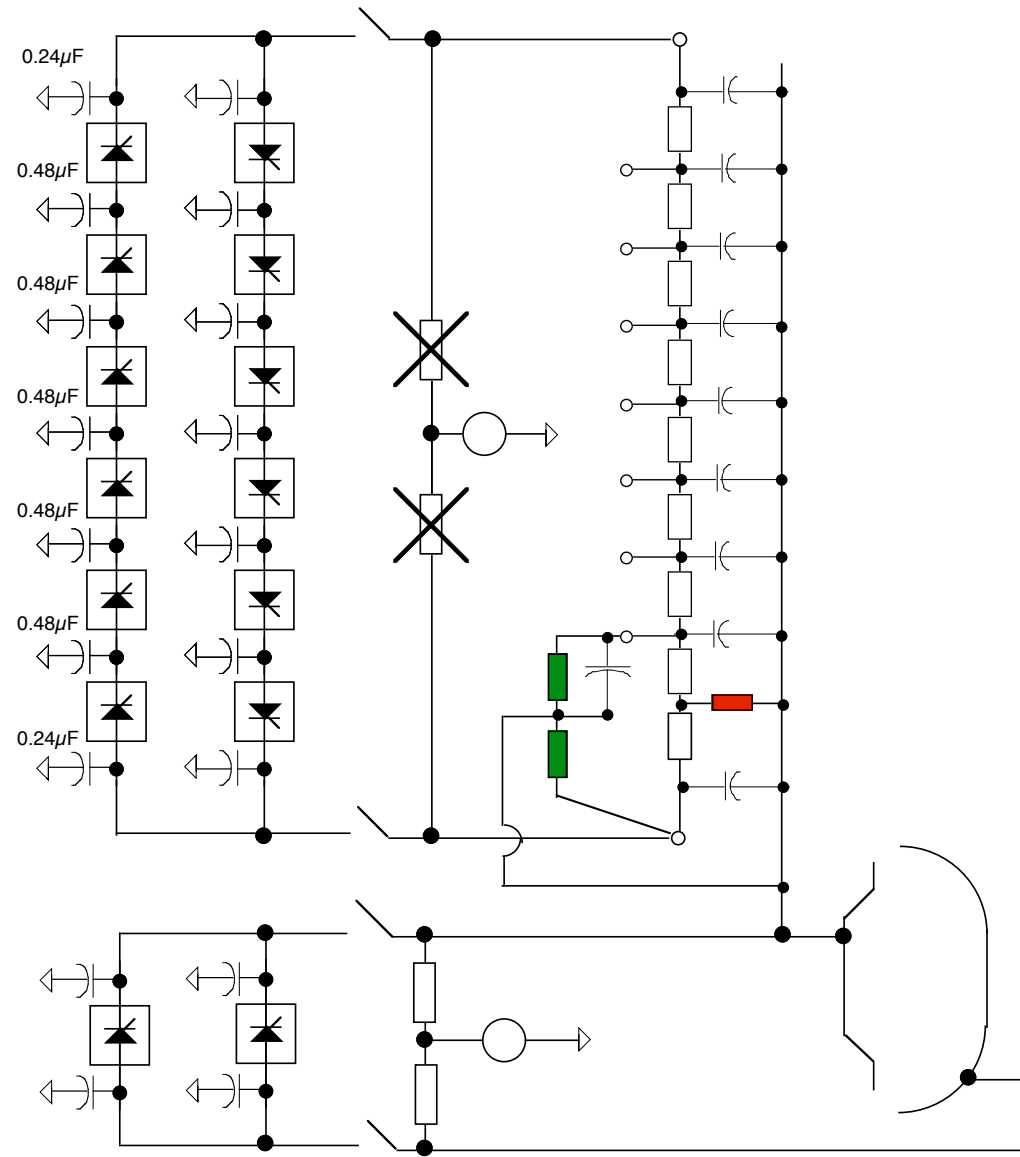
- Can we continue to run?
 - a scheme could be adapted to aim a null voltage at the perceived fault location w.r.t. the CS casing using a combination of resistors and capacitors

- this will be imperfect for a variety of reasons, there will be finite energy dissipation in the fault each pulse
- resistors alone are not sufficient, capacitors are needed
- if OH and CHI operations are mutually exclusive, then one set of R's and C's will work
- if OH is to be run with CHI then a second set of R's and C's will be needed
- if the fault propagates, either due to energy dissipation or other mechanism then a turn-turn fault could easily develop which would embrace a large fraction of the coil (due to the two-in-hand winding adjacent turns are electrically far away)
