13-980106-CLN-01

TO: DISTRIBUTION
FROM: C NEUMEYER
SUBJECT: REWORK OF TF BUNDLE OUTER LAYER TURN TO TURN INTERFACE REGION

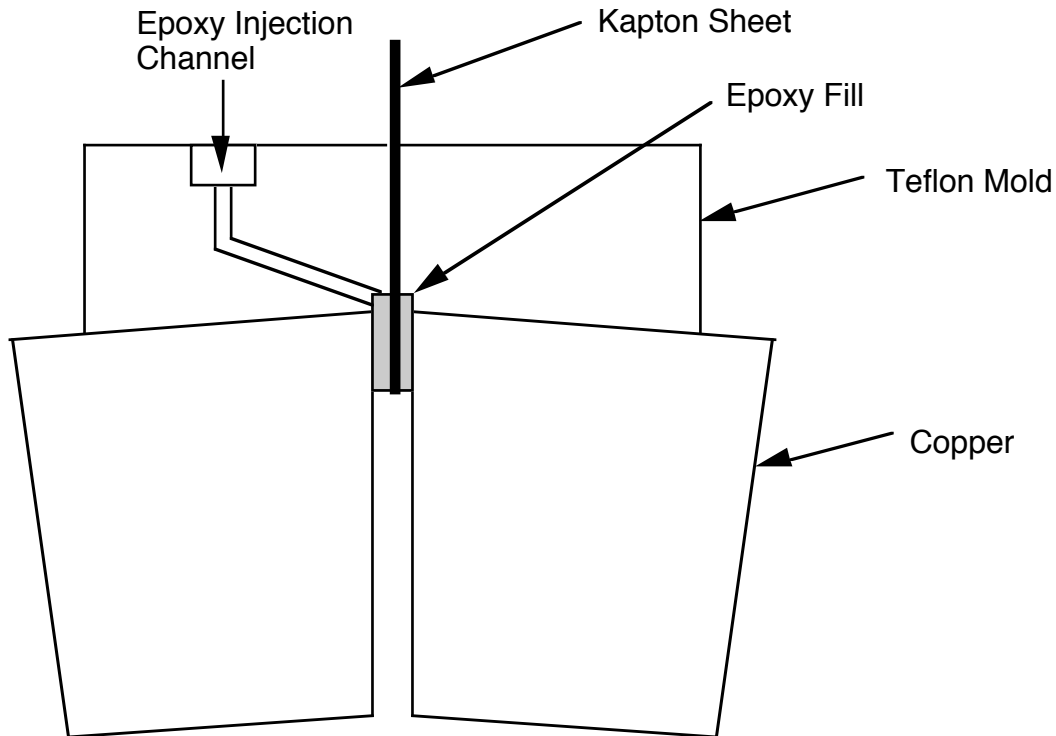
After thinking further about the condition of the kapton fins between the contact faces of the turns on the outer layer of the inner leg bundle, I am leaning now towards the idea of having Everson use the "excavation" method to restore all of the fins to the original design scheme.

1) The excavation technique, with which the insulation/epoxy between turns in the contact region would be milled out to a depth of 1/8 to 1/4", resin would be injected into the milled slot, and a new kapton fin inserted.

- 1) Prior to assembling the quadrants, while they are still separate, all contact surfaces are cleaned up (epoxy removed and surface finish restored), defective kapton fins cut back to level of contact faces, and keenserts cleaned out.

- 2) A machining fixture is devised which mounts on to the contact surfaces/keenserted bolt holes neighboring the defective kapton fin. The fixture guides a "Dremel" type cutter (either a horizontal axis saw blade or vertical axis cutter) precisely along the turn to turn space over the length of the contact face region, such that a slot of 1/8 to 1/4" in depth was milled out in the gap (turn to turn gap 0.064", approx 1/16") between the turns. The fixture would include an attachment to vacuum away the dust from the cutting process.

- 3) Teflon blocks are devised which mount on to the contact surfaces/keenserted bolt holes neighboring the defective kapton fin which has been milled out. These blocks are designed such a new kapton fin can be inserted/sealed between them, and such that a channel is provided for injection of epoxy into the milled region.

- 4) Epoxy resin is injected, and then the teflon blocks are removed.

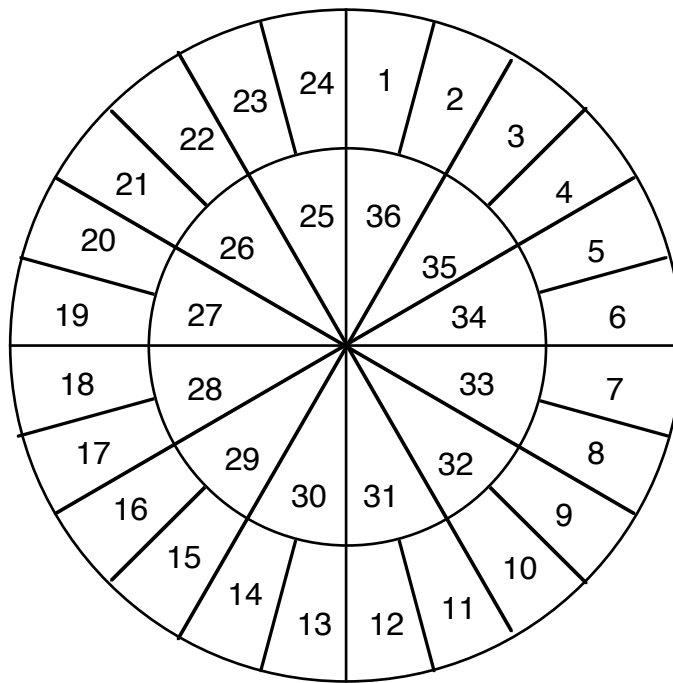
As a matter of additional information, the following shows the winding pattern of the inner leg bundle. As can be seen the voltage between adjacent turns on the outer layer is simply the voltage per turn ($1012.85/36 = 28$ volts) except for the location where turns 1 and 24 face each other ($24 * 28 = 672$ volts). Clearly it is important to position the more robust quadrant to quadrant gap at this location in the winding pattern.

One could argue that at $28/64 \approx 0.5$ volt/mil in the turn to turn gap there is simply no concern and no need for the kapton fins. However, I feel that in order to maintain the integrity of this gap in service with dirt/contamination/motion of parts, the fin remains an important element that we should not sacrifice.
