NSTX TF JOINT RE-DESIGN

C. Neumeyer

20th IEEE/NPSS Symposium on Fusion Engineering

October 14-17, 2003

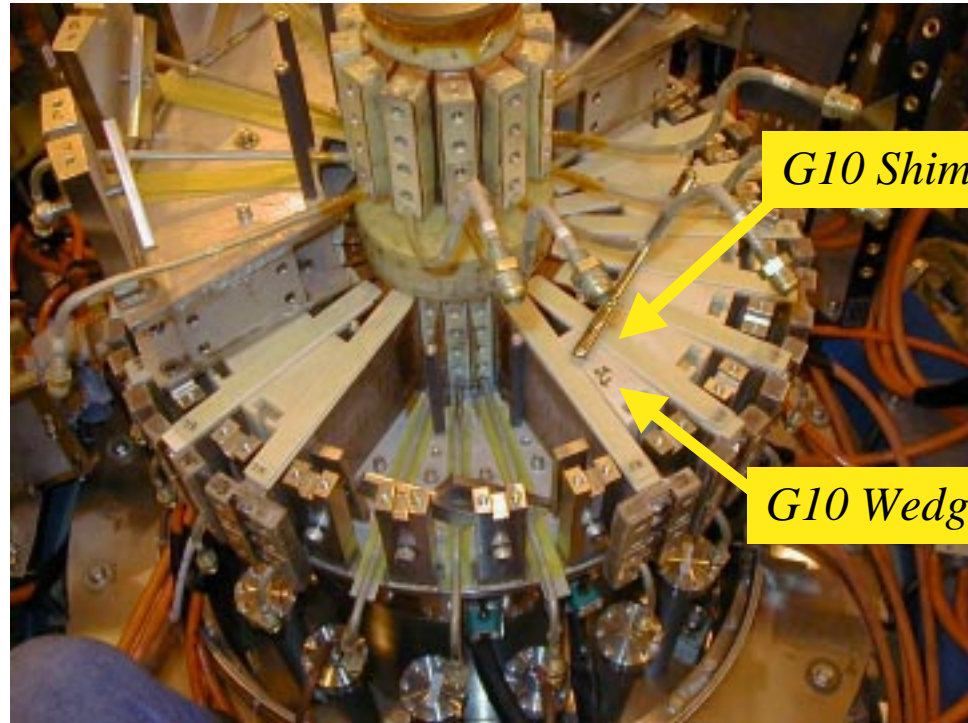
Inadequate Communication of Loads from Flags to Hub

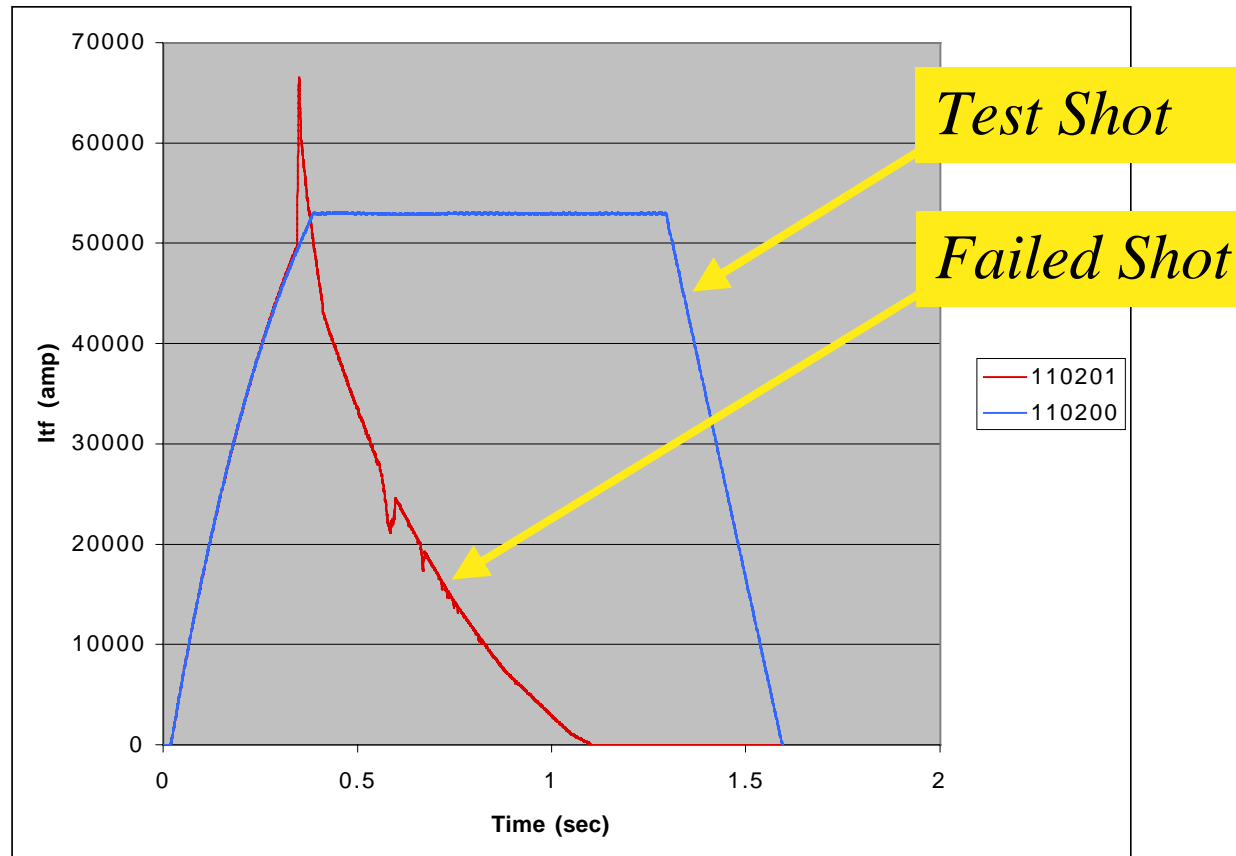
February 14, 2003: Following our morning “test shots”, the first plasma attempt of the day resulted in a loud bang (heard on the control room audio monitors) accompanied by a plume of smoke (visible on the control room video monitors).

Initial inspection revealed that one of the TF “flags” on the bottom end of the machine was displaced radially by about 1 inch

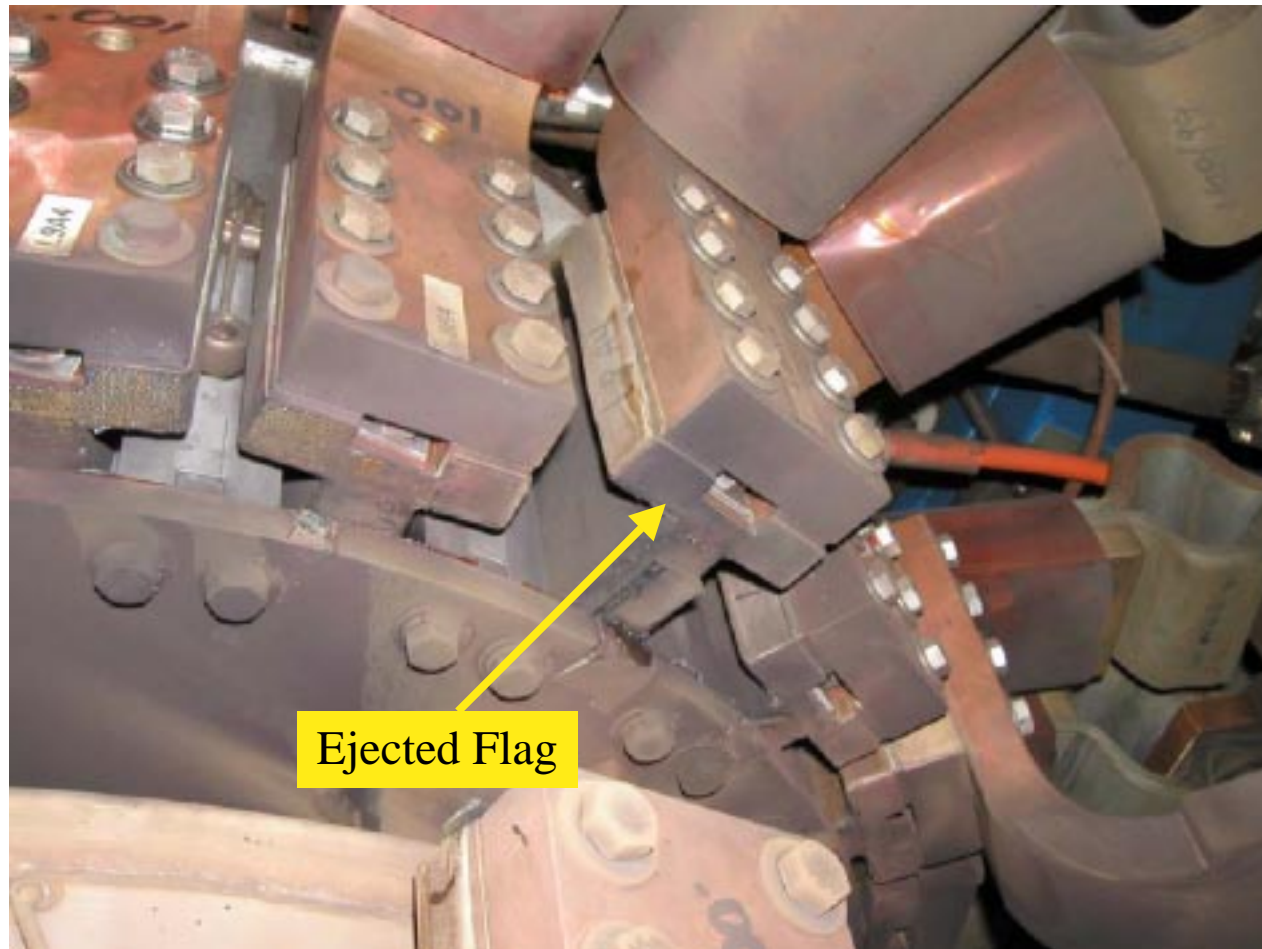
Subsequent inspection revealed the extent of the damage

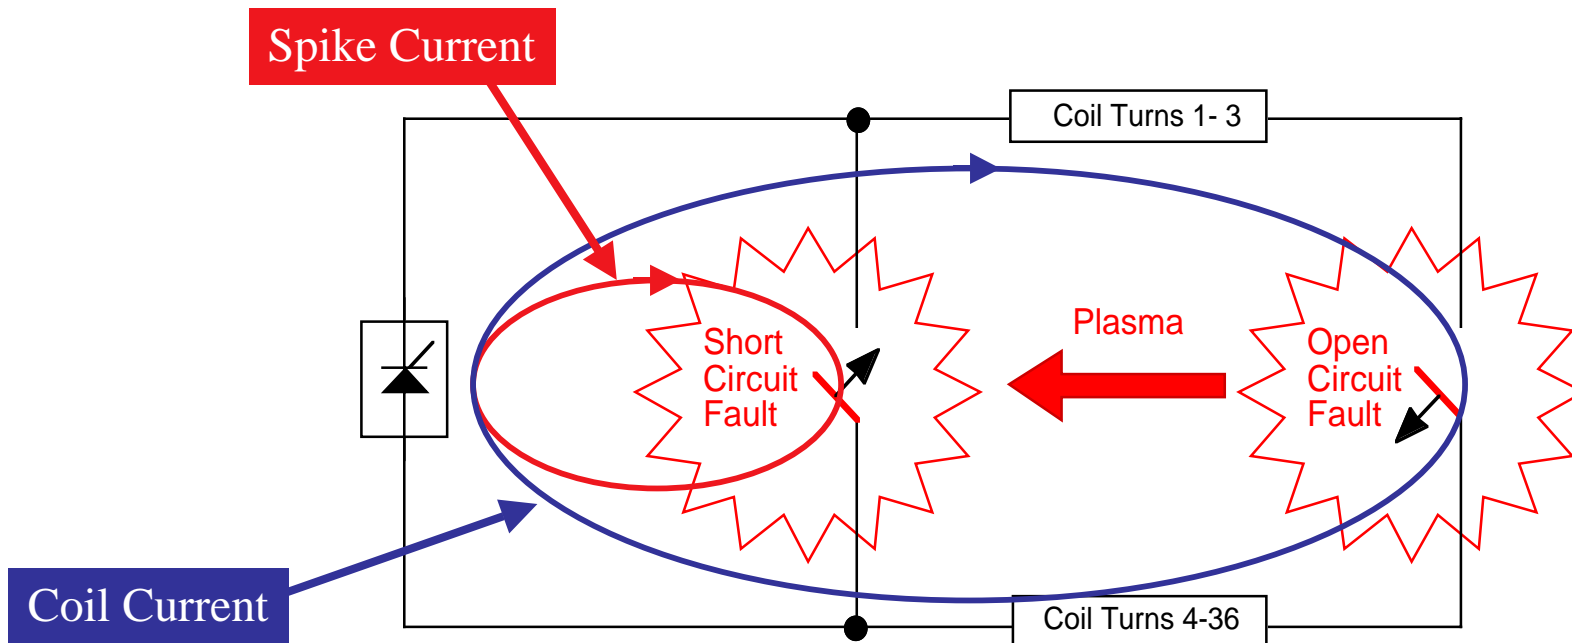
FAULT SCENARIO

- An open circuit fault at flag joint
- Short circuit fault across coil terminals
- Spike of fault current from the power supply through short circuit
- Power supply tripped, current spike decay
- L/R decay of the coil current
- The energy dissipated in the arc was of order 1.4MJ.

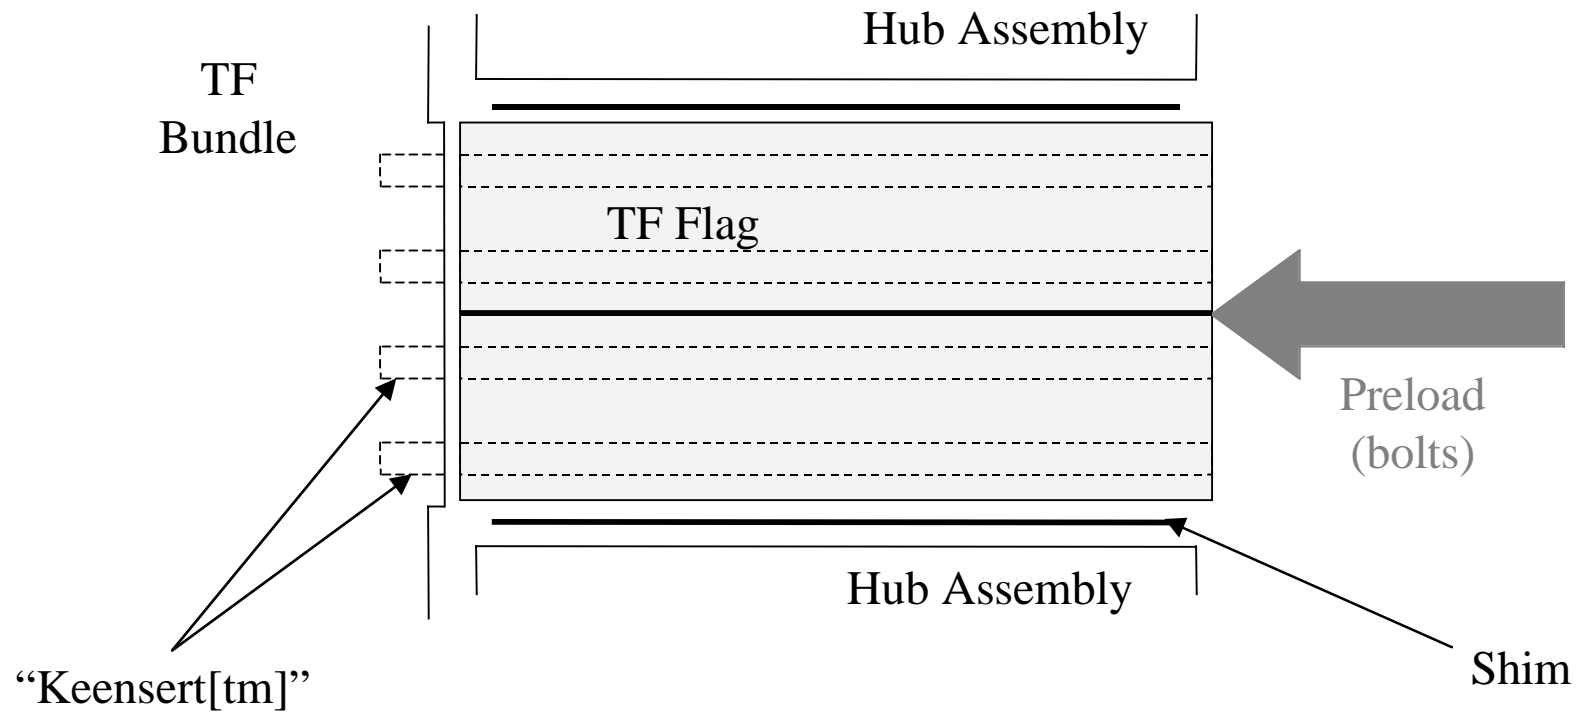
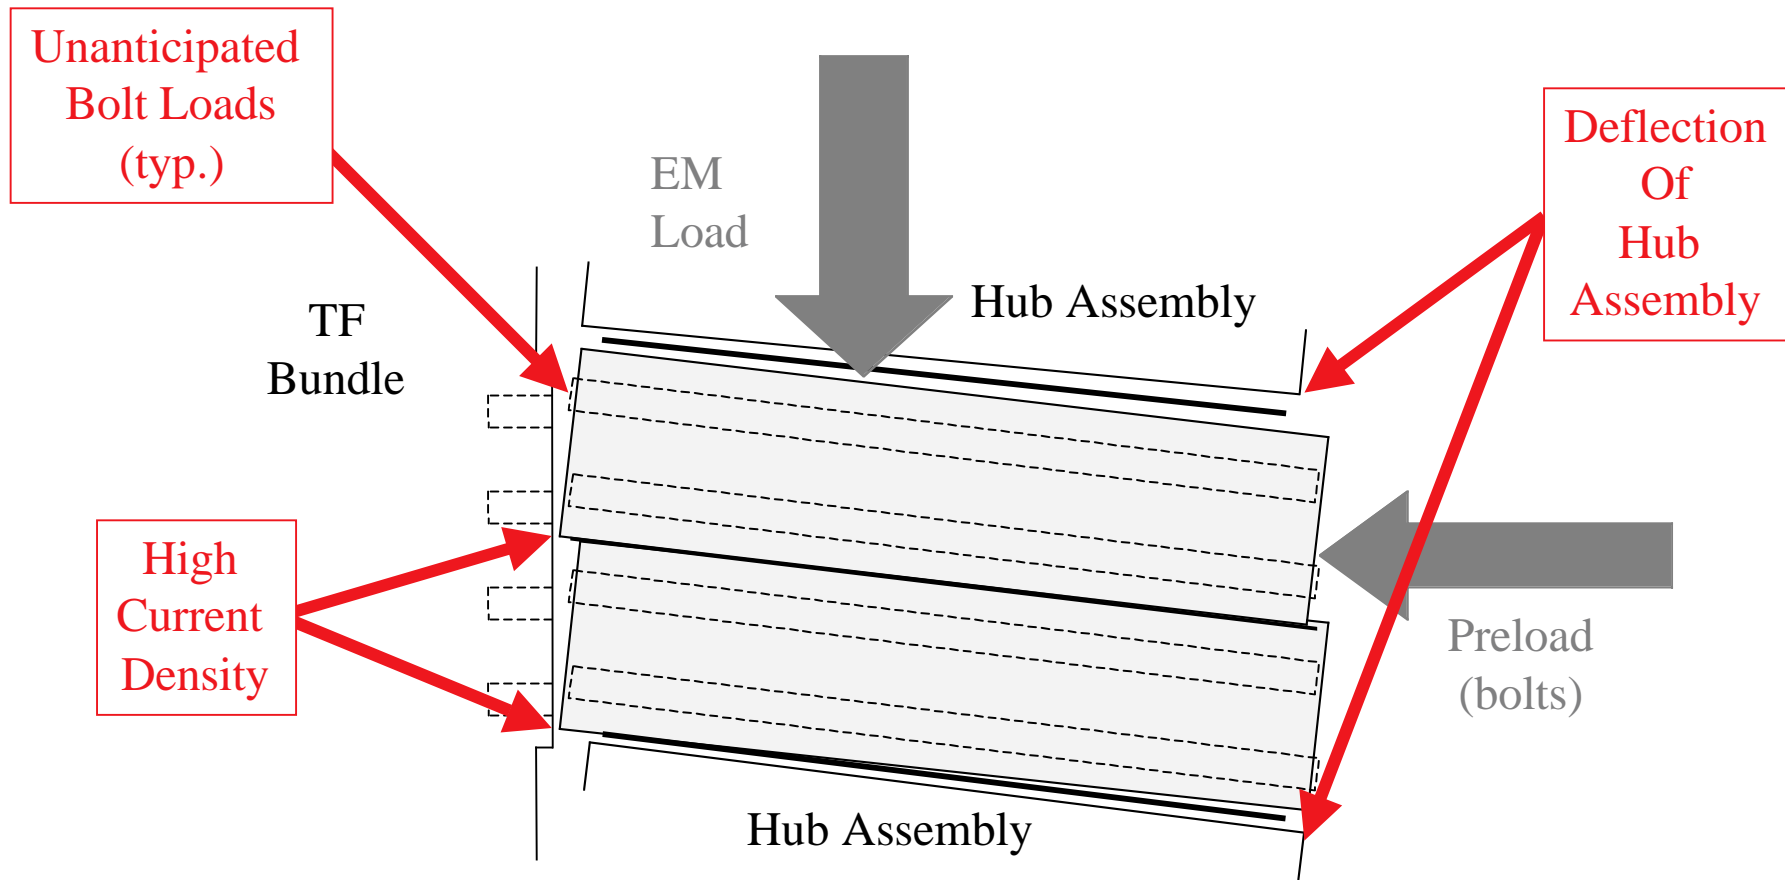
FAILURE OF JOINT

Lack of Hub Stiffness and Shortcomings of Shimming Scheme Led to Cyclic Overload of Fasteners and Eventual Failure

All defects contributing to original failure have been addressed
