# ***NSTX TF Bundle Failure***

Mike Williams  
September 13, 2011

# *The NSTX Toroidal Field (TF) Bundle failed on July 20, 2011:*

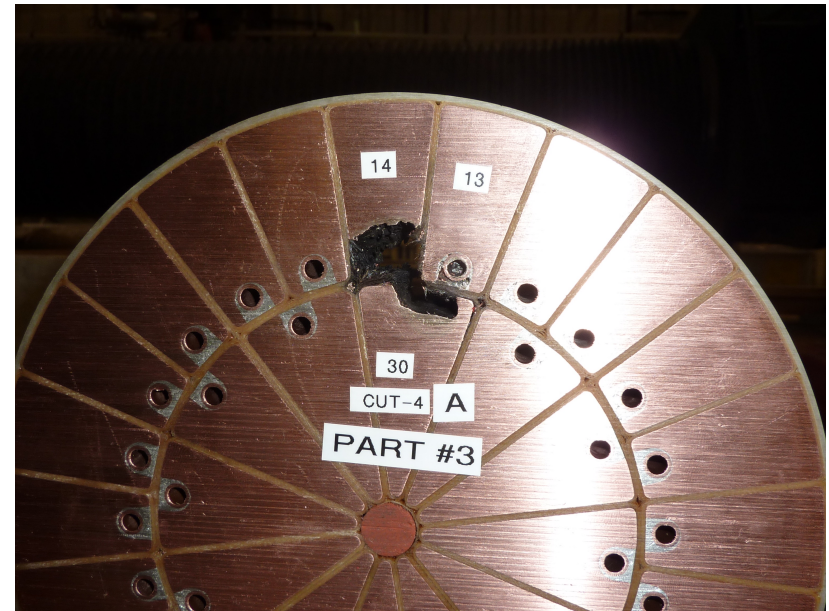
- Non-repairable internal arc damage
  - It would take about a year to build a replacement, install and resume plasma operation (replacement copper on-hand)
- PPPL and NSTX Team subsequently concluded that the best path forward is to begin the Upgrade outage immediately (previously scheduled for April 2012)
  - A successful Upgrade FDR was completed in June 2011
  - We are ready to begin the Upgrade outage
  - But, in light of the failure, we need to evaluate any risks in the Upgrade bundle design before moving forward

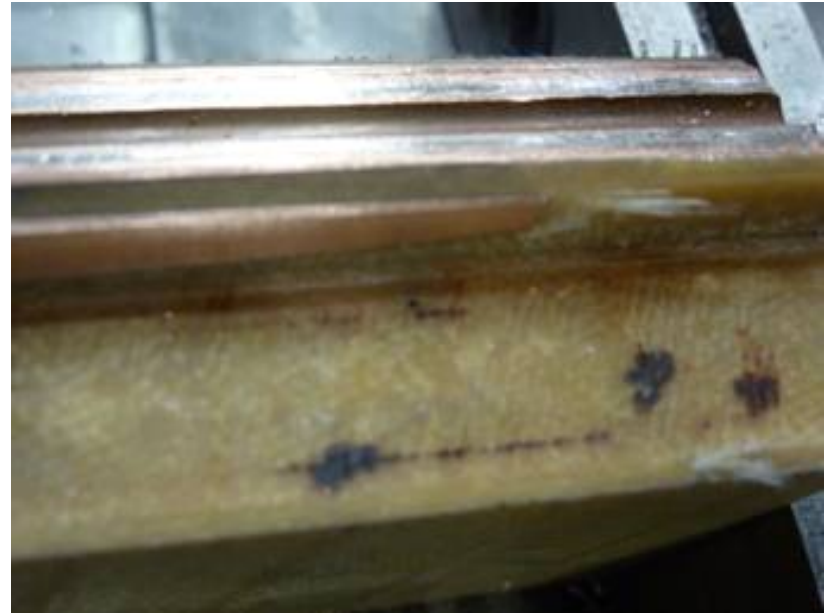
- Failure of conductors was noted to be 1 of 3 pairs that were sub-optimal during acceptance tests
  - 100-3000 M-ohm versus 30,000-50,000 M-ohm during 3 kV quadrant tests
- Forensics yielded convincing evidence with regard to both remaining sub-optimal pairs
  - Found 1-10 M-ohm conductive path in a distinct location measured with an ohmmeter
  - Discoloration of epoxy/glass insulation system
  - Localized resin-poor area

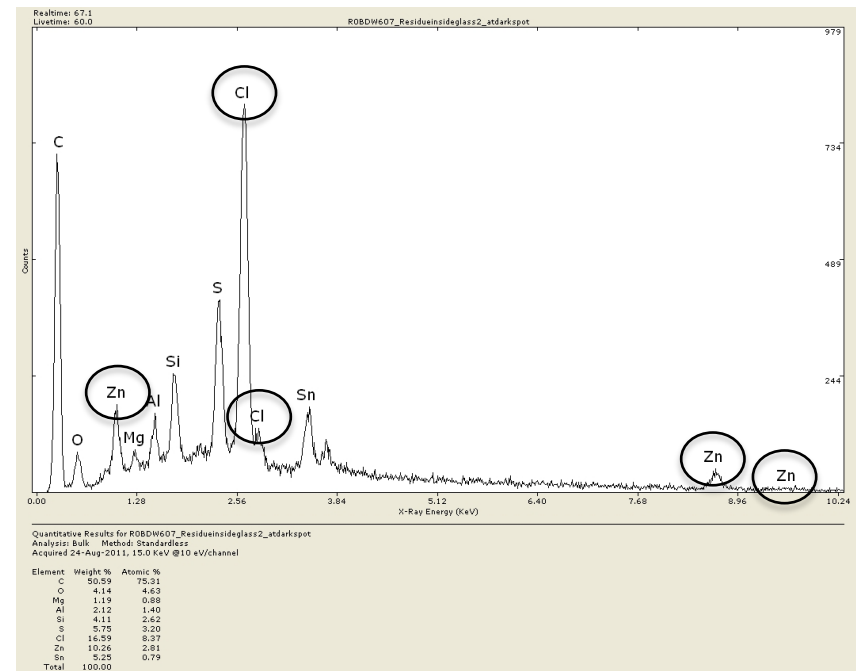
- Metallurgical analysis of copper and tubing found nothing unusual or indicative of excessive stress or fatigue
- Analysis of the insulation verified the elevated presence of zinc and chlorine, two components of the flux used to solder the cooling tube in the copper conductor
- Literature search showed problems with zinc-chloride in insulation systems

- Residual solder flux displaced and contaminated insulation in localized regions during the elevated-temperature curing (baking) of bundle quadrants
- Acceptance testing (3 kV Megger) of bundle quadrants “tracked” in 3 discrete locations
  - All conductors met acceptance criteria
  - Subsequent testing was performed at decreased voltage levels
  - Normal operations were at still further decreased voltage stress
- Subsequent operation on NSTX further degraded these localized insulation defects
  - Seven years and more than 20,000 pulses
  - Repeated electrical conduction and/or continued chemical degradation due to zinc-chloride
- Finally, one of the insulation defects degraded enough to cause an arc between conductors
  - This was in the highest voltage stress region
