# PF-1aU Summary

Stefan Gerhardt

NSTX-U Team Meeting  
PPPL, MBG Auditorium  
7/29/2016

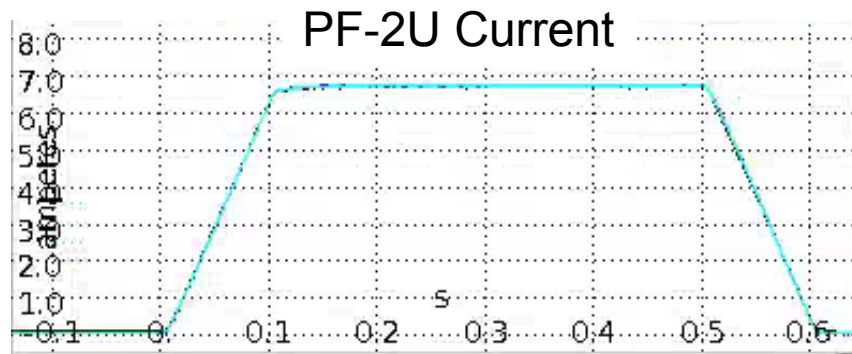
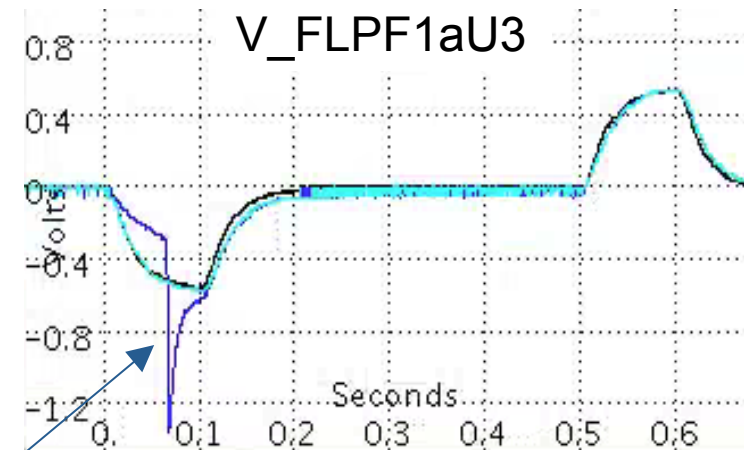
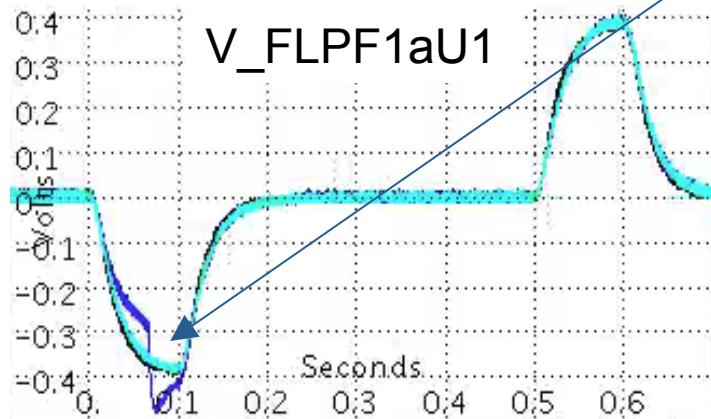
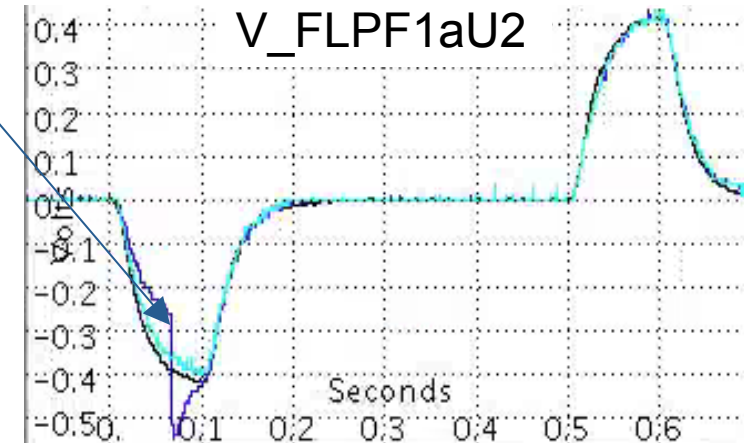
# First Shot of 7/20/2016 Was a PF-2U Shot; Showed a Large Voltage “Glitch”

202124 – reference from December  
205321 – 1<sup>st</sup> 50% PF2U  
205323 – next 50% PF2U

Glitch on  
203521

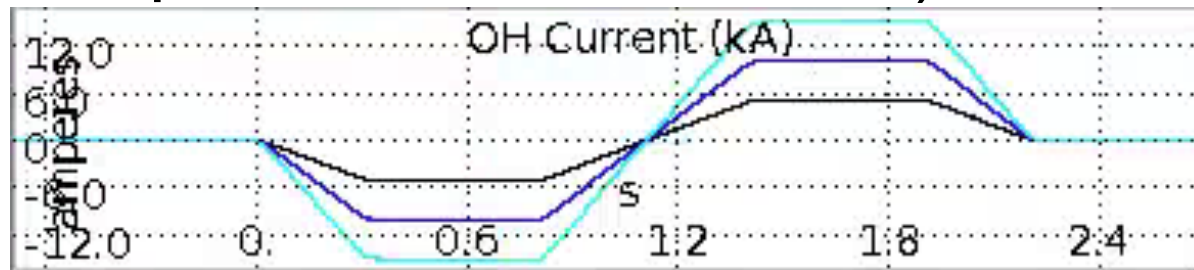
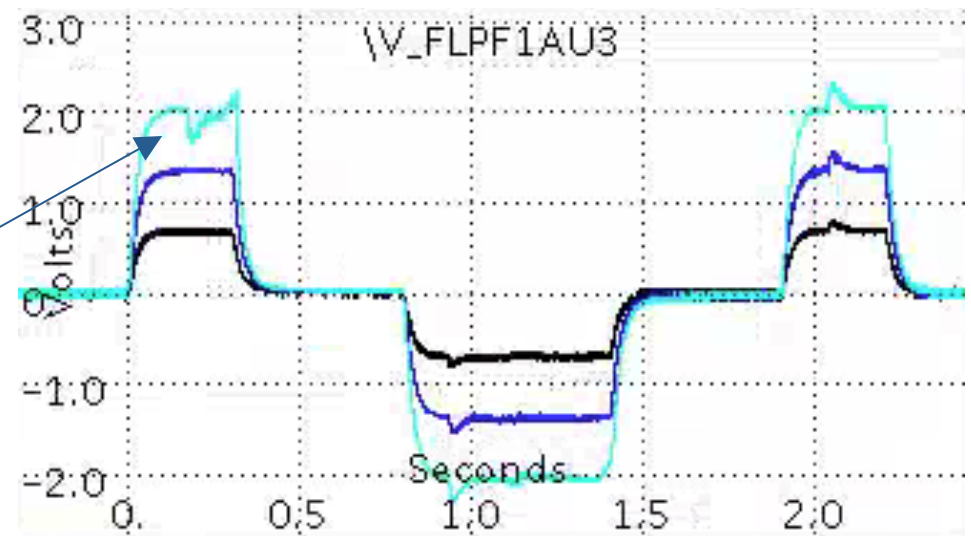
# Similar Glitch Observed on an OH Shot

**205326: 25% OH**  
**205327: 50% OH**  
**205328: 75% OH**

Voltage on a loop wrapped around the 1aU coil

Glitch on 203528

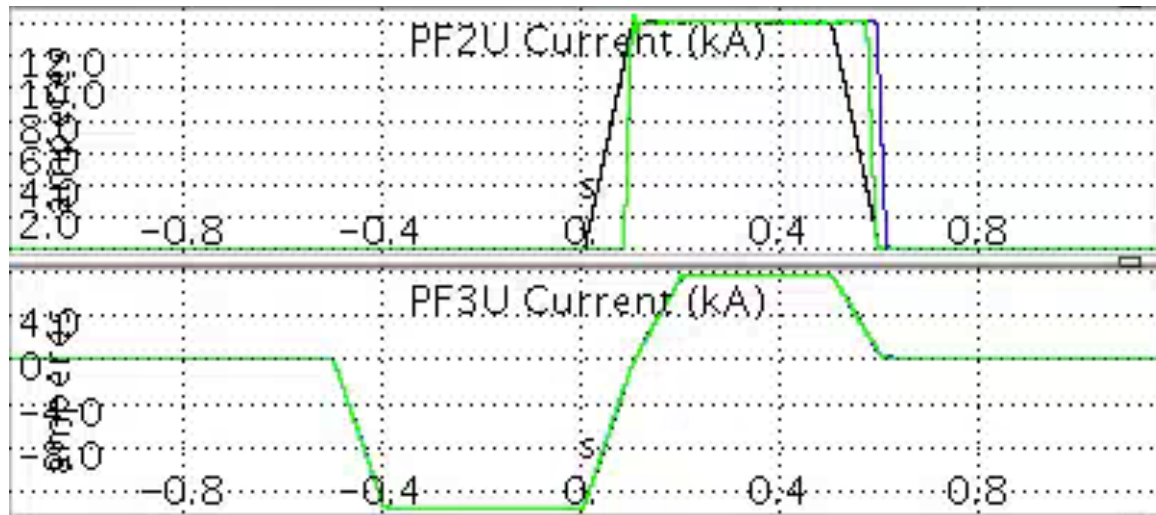
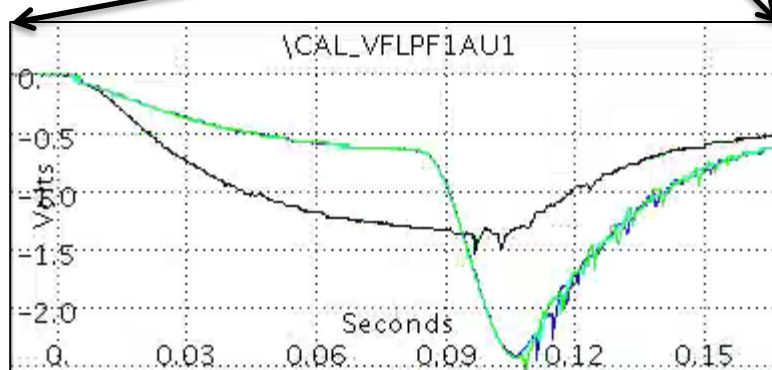
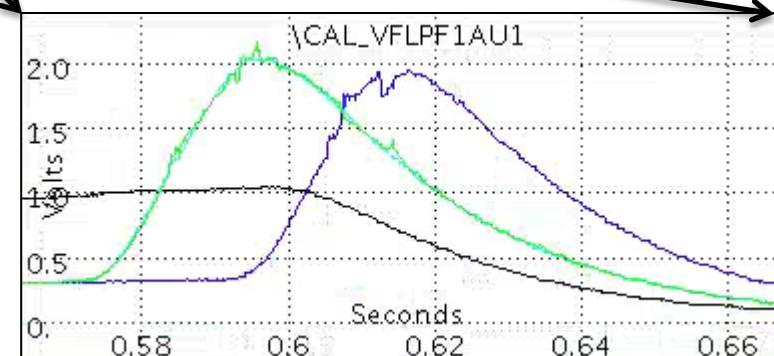
# Operations on Subsequent Days Found Smaller Voltage Transients

Voltage Loop on -1aU Coil...Small Transients Observed

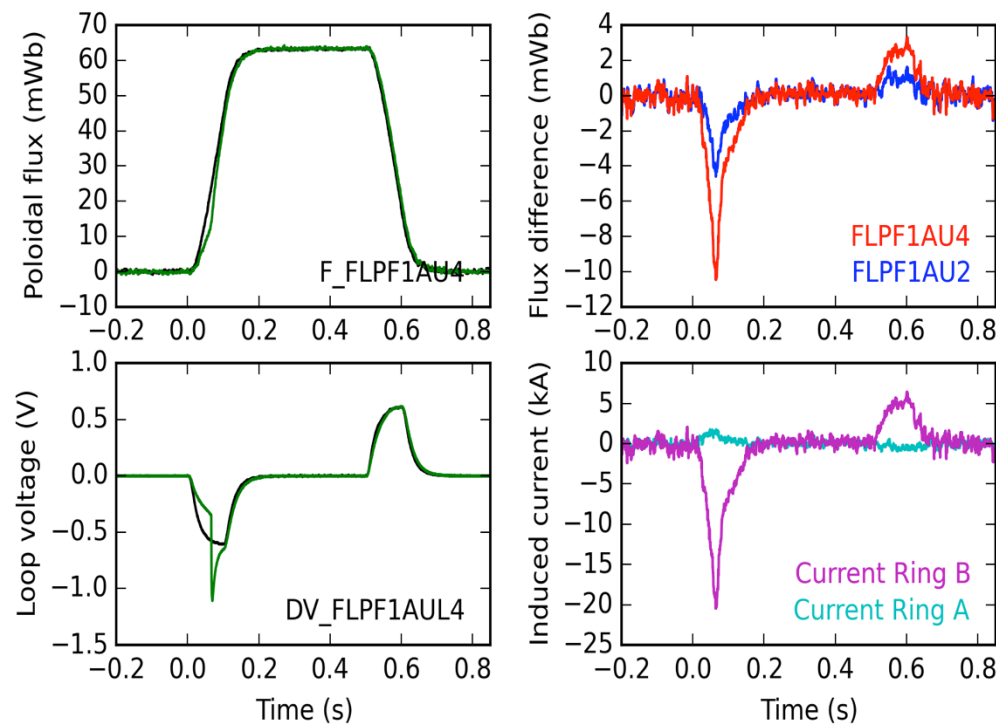
Shot 205321, Shot 202124 (reference)

# Estimate ~20 kA-Turns Induced During the First PF2U Recommissioning Shot

- Large voltage transient suggests initially shorted turn(s) open up
- Total induced current in transient is ~20 kA-turns (at the top of the coil)
- In second hump of induced voltage, a steady difference is still visible
- The second hump has ~5 kA-turns of induced current

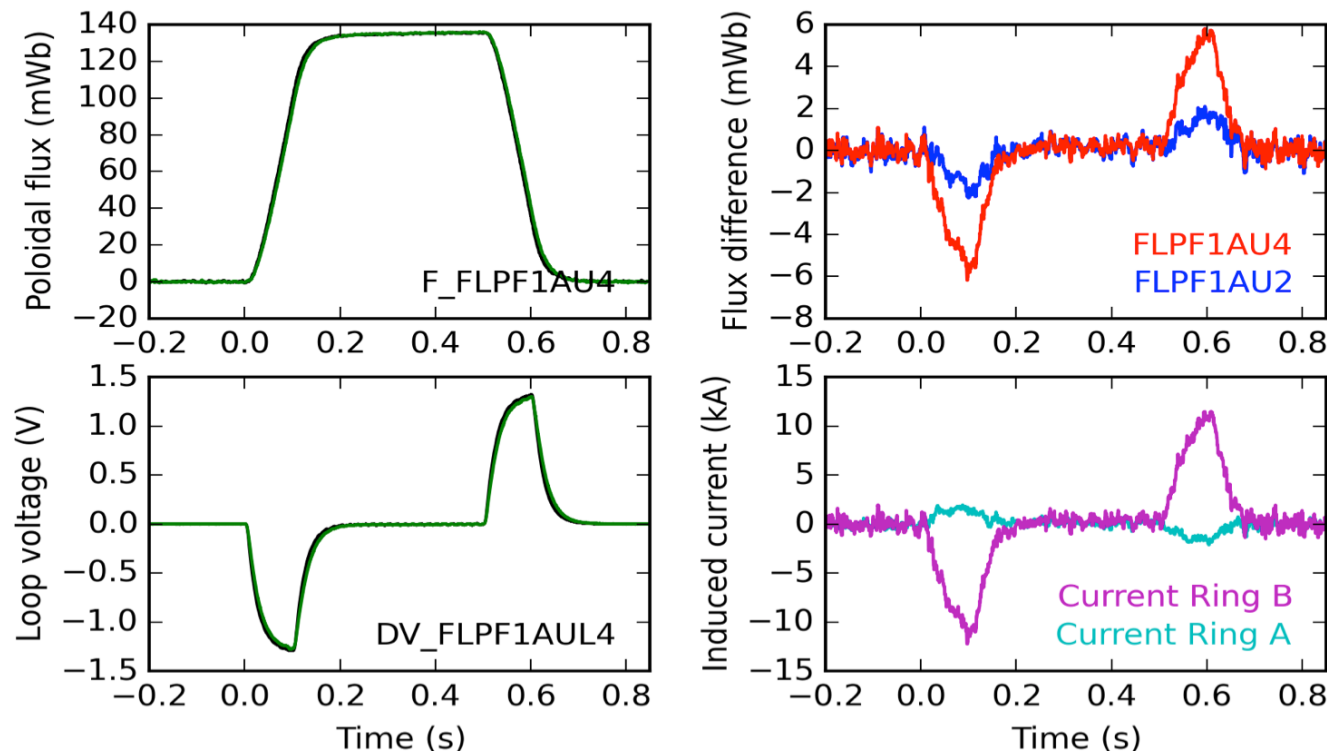
Shot 205324, Shot 202125 (reference)

# Subsequent Shots Showed Circulating Induced Currents in PF-1aU

- Shot 205324 is a 100% PF2U shot
- The previous 5 kA-turn behavior is a consistent 10 kA-turn signature...at 1 volt loop voltage
- The melting potential implied by these currents during plasma scenarios drove us to halt operations on 7/25/16 in consultation with FES.

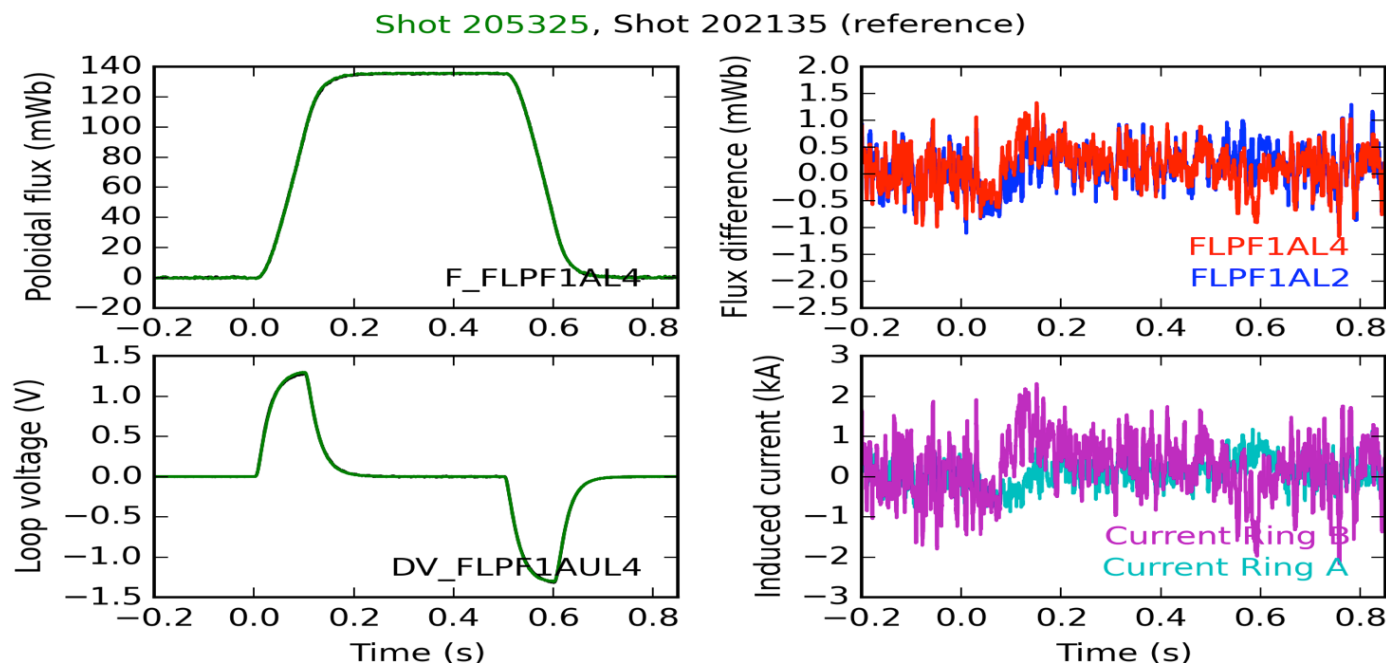
# Similar Analysis on the PF-1aL Shows No Errant Circulating Currents

- Shot 205325 is a 100% PF2L shot
- Negligible circulating current is measured
- The error bars are  $\pm 2$  kA at this larger PF2L current

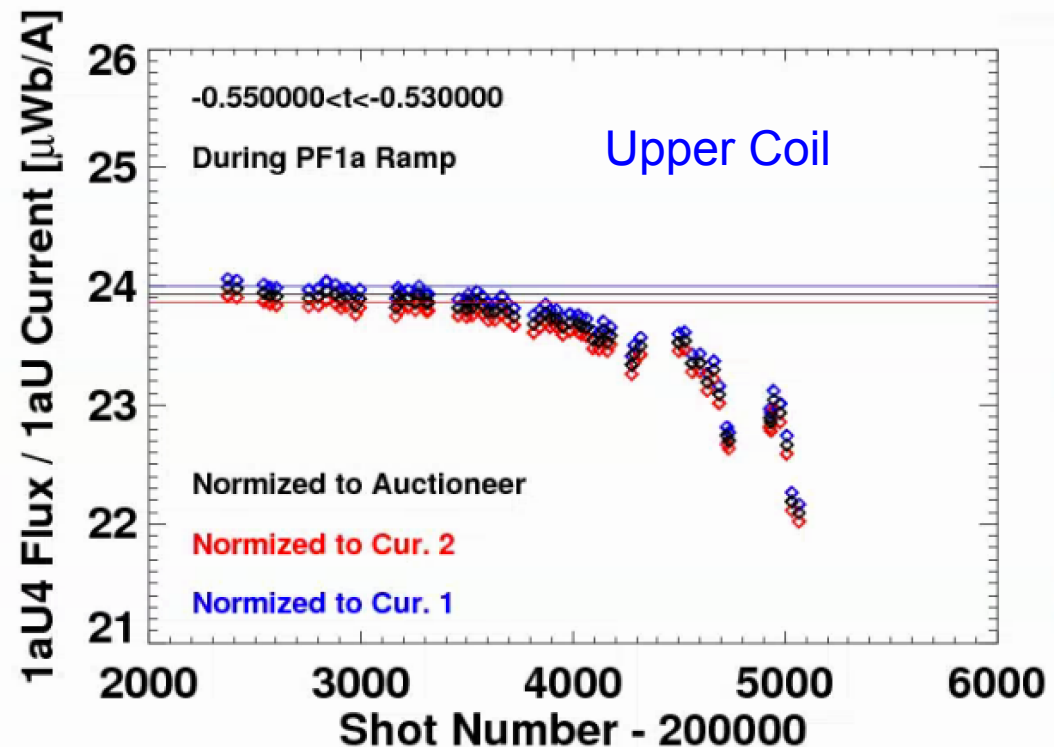
# Analysis of 100% Test Shots Found a Slow Degradation of the -1aU Coil

Less poloidal flux for  
the same power supply  
current

*-> Inductance of the  
coil slowly changing in  
time*

Rapid degradation  
leading into the final  
set of shots

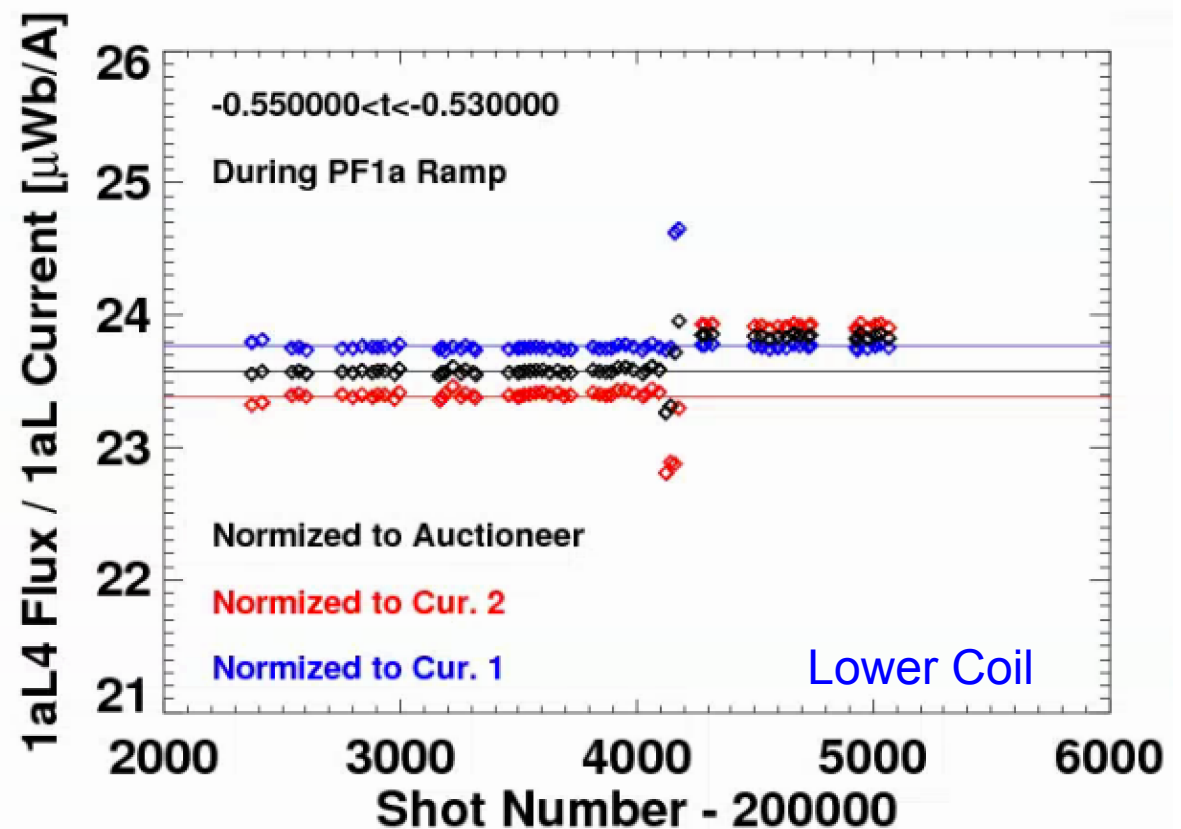
# After Some Confusion, Lower 1a Coil Was Found to NOT have the Same Bad Inductance Trend

Change in the Cur2 calibration on April 5<sup>th</sup>

The actual current in the coil during the test shot changed by a few %

Flux normalized to Cur1 has a flat trend

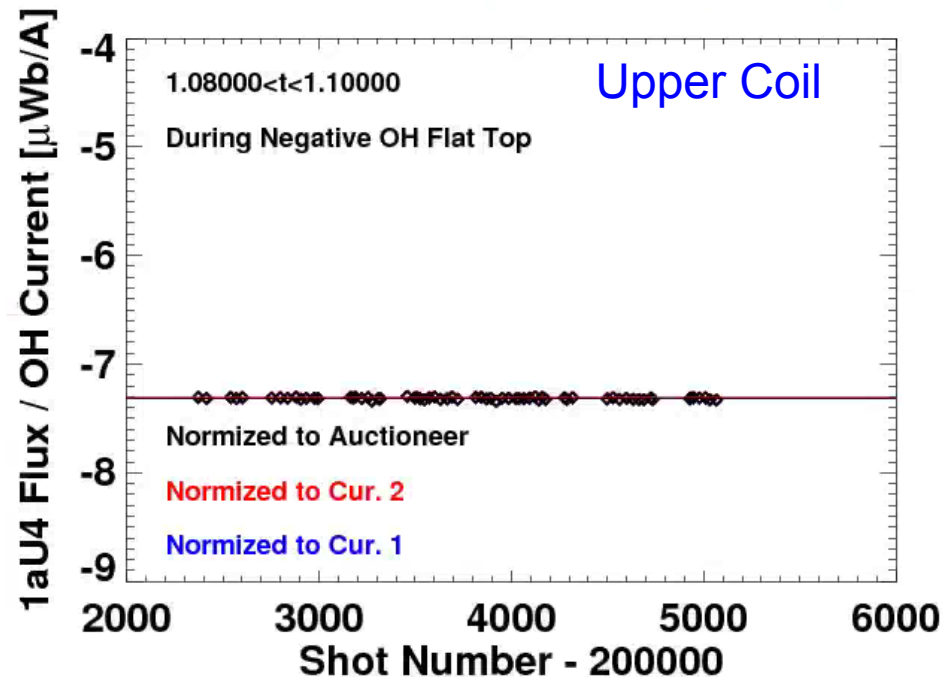
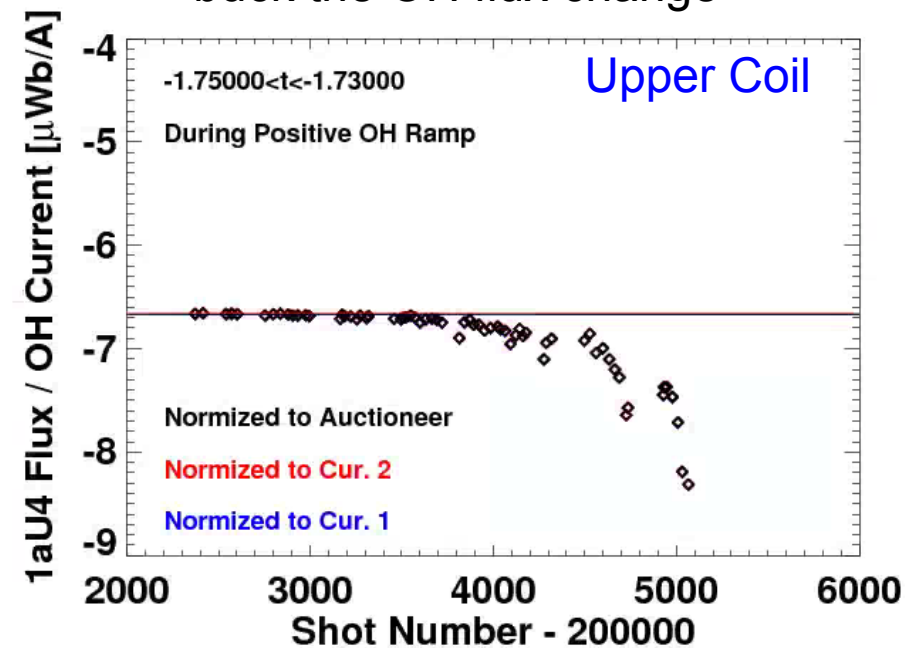
# Similar Trends Observed on PF-1aU from OH-Dominant Part of Test Shots

Large trend when the OH is swinging  
Flux relative to the midplane is reduced  
later in the run

No trend when the OH is flat-topped

Consistent with induced currents trying to  
buck the OH flux change

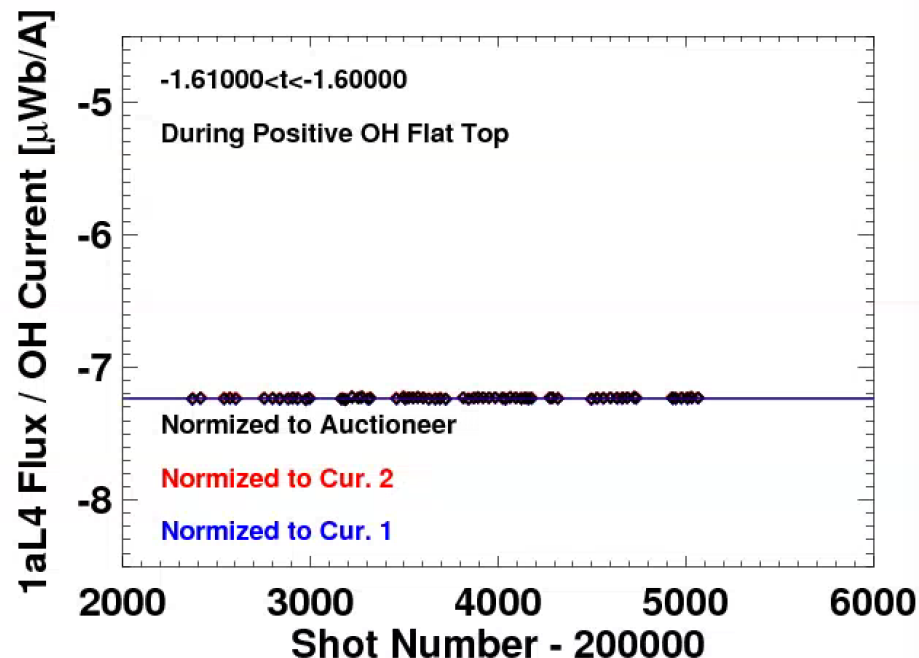
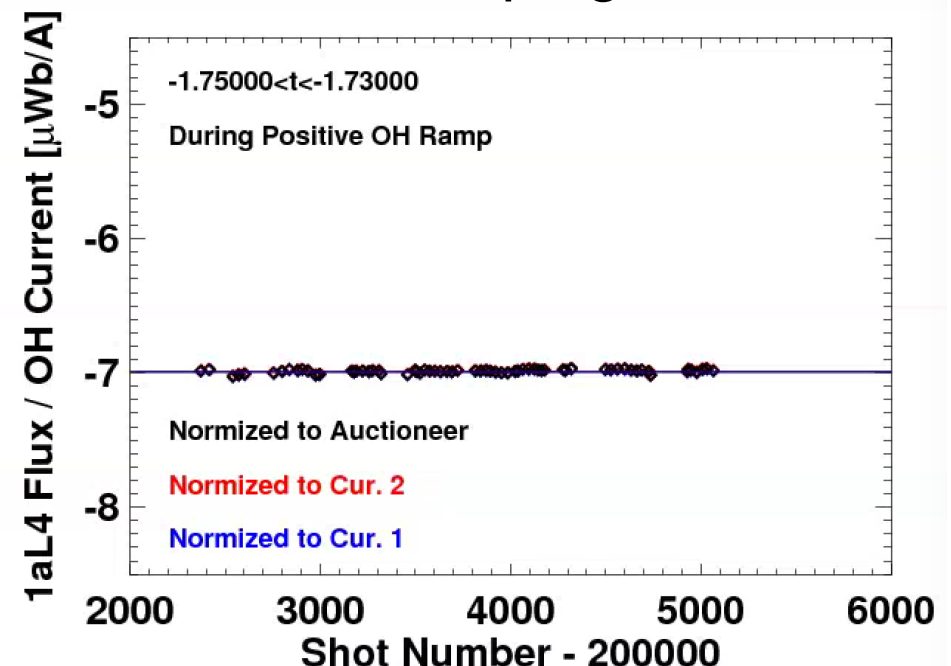
# PF-1aL Shows No Concerning Trends When Considering OH Coupling

No trend when the OH is  
flat-topped

No trend when the OH is  
ramping

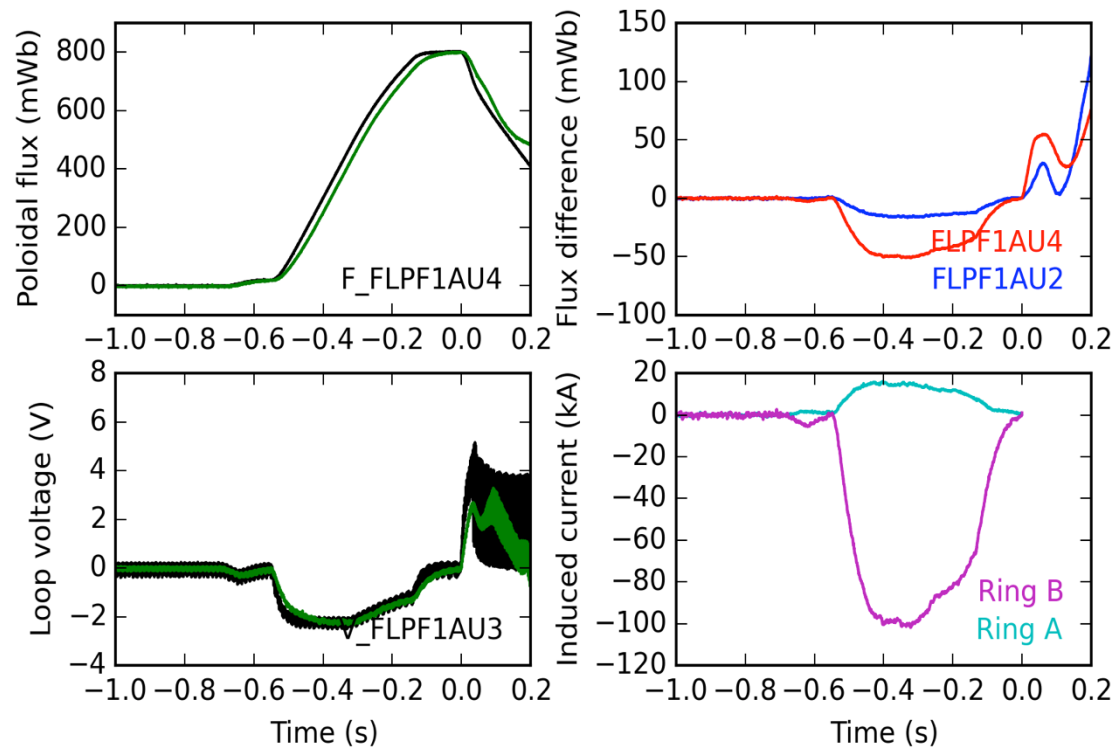
Shot 205088, Shot 203282 (reference)

# OH Pre-Charge Used on Every Shot Provides Another Opportunity for Trending

- Shot 205088 is the last plasma shot of the run
- Approximately 100 kA-turns of current induced in PF1aU
- Minimal induced current in PF1aL

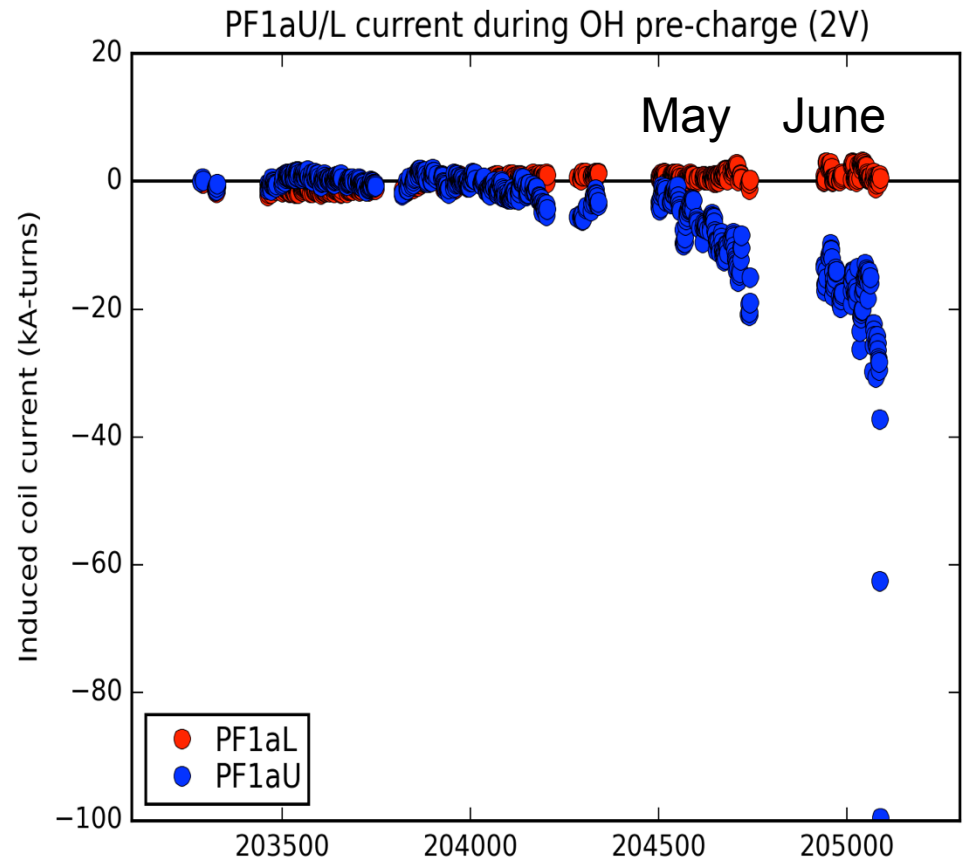
# Database Analysis During OH Ramp Confirms Degradation of -1aU, Consistency of -1aL

- PF1aL trend is flat zero through to the end of the run
- PF1aU first starts to conduct current at the end of the March/April run period
- Consistent degradation during the May run period
- Coil *does not* continue to degrade during May/June maintenance period
- Very fast degradation on the final run day in June
