National Spherical Torus eXperiment Upgrade

Project Status

TB Bundle - Recent Activities

Overview - 2/2: Recent

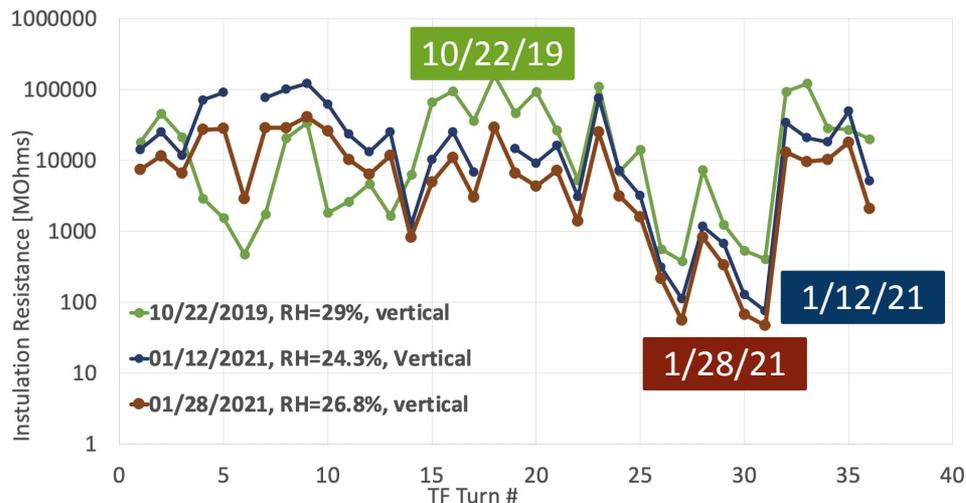
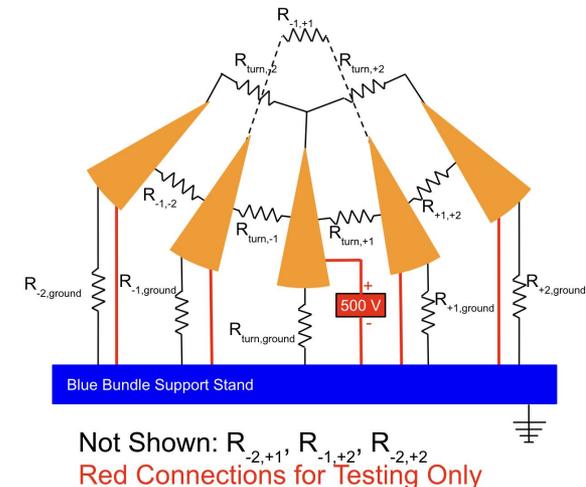
Reduction of Turn IR Observed in January 2021

- Preparing to do some work, and did a set of IR tests on 1/12/2021, observed reduced IR relative to 10/22/19.
- Bundle in vertical position; did some modest cleaning and repeated tests on 1/27/21
 - Further IR reduction observed
- Viewed as likely a matter of surface contamination → disassembly and cleaning

10/22/2019	1/12/2021	1/27/2021
turn	Resistance (MΩ)	Resistance (MΩ)	Resistance (MΩ)
26	560	314	235
27	379	111	76
28	7290	1170	1100
29	1250	668	439
30	536	127	91
31	410	76	54

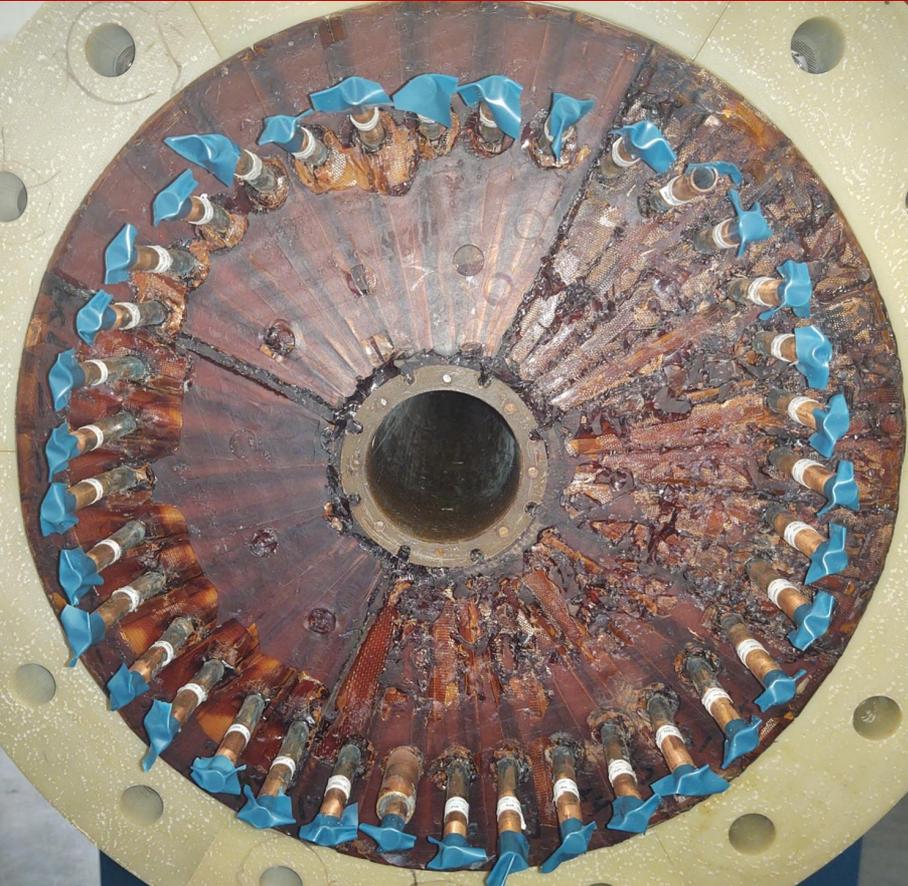
After Cleaning (10/15/21)

Example of Cleaning - Bundle Top 2021 vs 2021

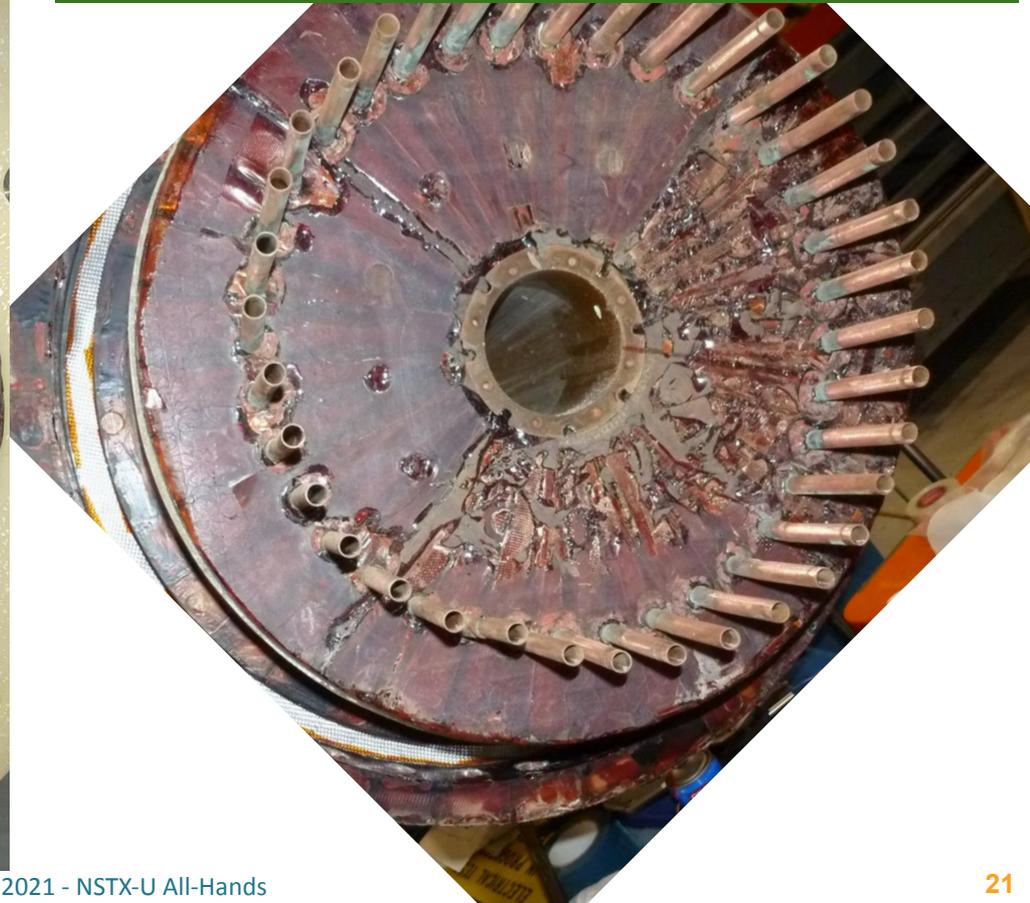
2014 - During Final Assembly - Good Electrical Characteristics at this time

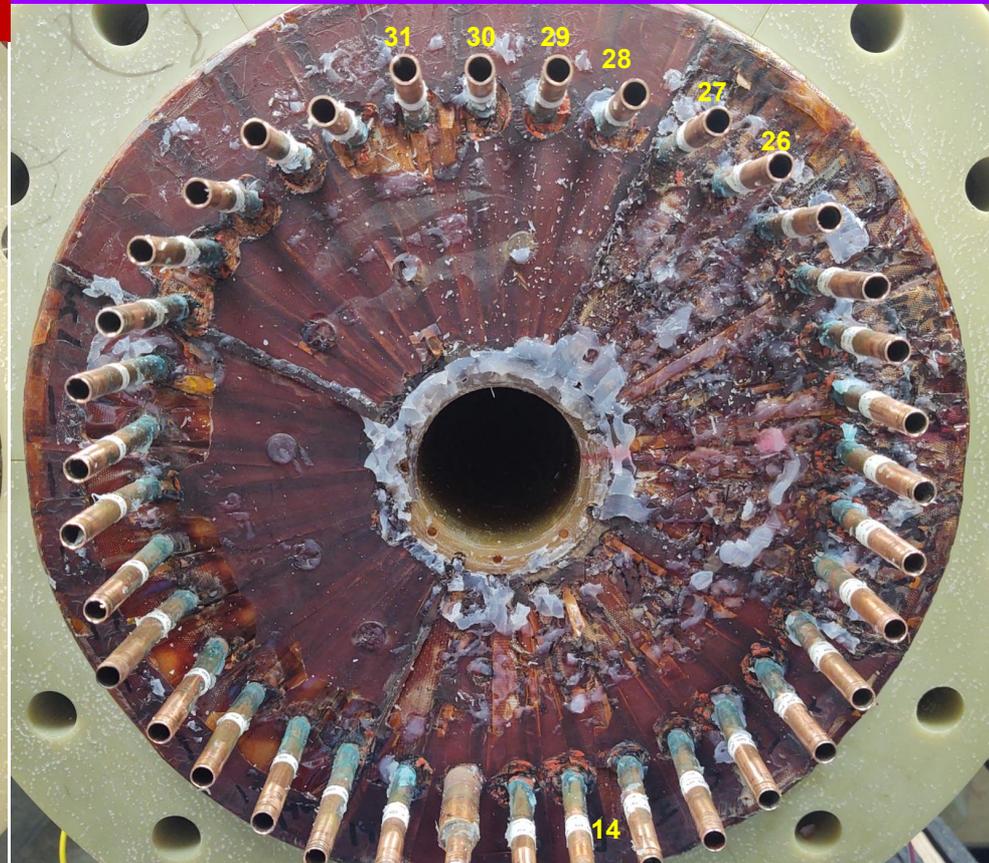
Immediately After G10 Cover Removal (2021)

Similar Cleaning Story for the Bundle Bottom
Unfortunately - No Improvement in IR After Cleaning

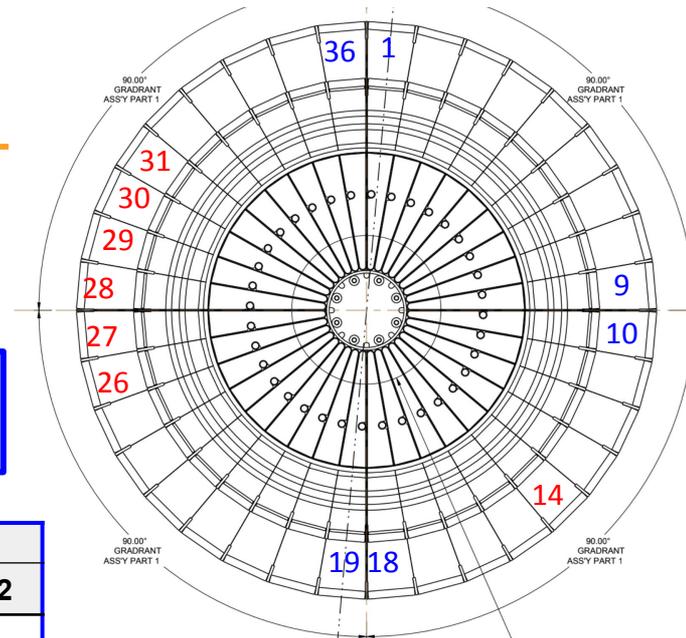
Reduced Insulation Quality Detected Between Non-Adjacent Turns

Clear communication between turns 26 & 31 inclusive; 14 may also be communicating

IR (Mohms), 10 min values (7/22 & 7/26)		(+) - all other floating									
		14	24	25	26	27	28	29	30	31	32
(-) - all other floating	14				369	350	758	516	390	415	
	24			7110	5070	5000		4340	4950	4820	
	25		7110		762	652	1060	679	655	652	
	26	369	5070	762		96	479	281	116	139	3770
	27	369	5000	652	96		446	279	76	78	5160
	28	758		1060	479	446		509	630	718	
	29	516	4340	679	281	279	509		206	245	
	30	390	4950	655	116	76	630	206		85	3560
	31	415	4820	652	139	78	718	245	85		3470
32				3770	5160			3560	3470

- Separate, unrelated test suggests the axial “centroid of resistance” is ~70% “up” between the flags.
- May be either localized, or a distributed resistance

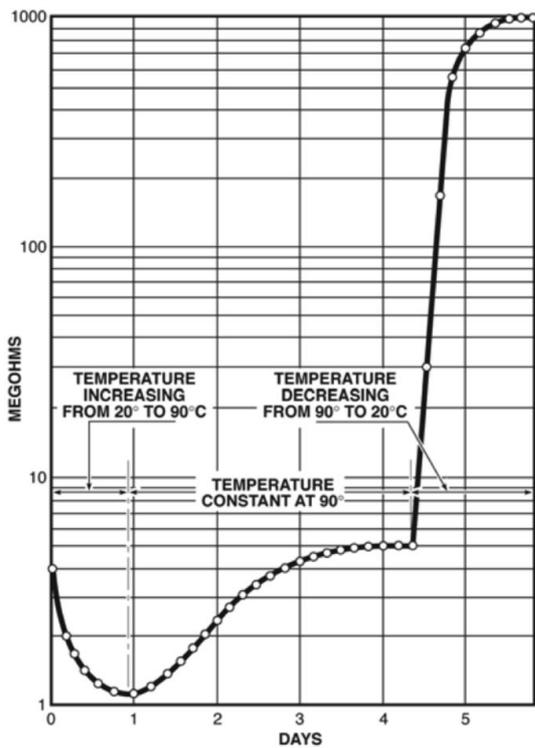
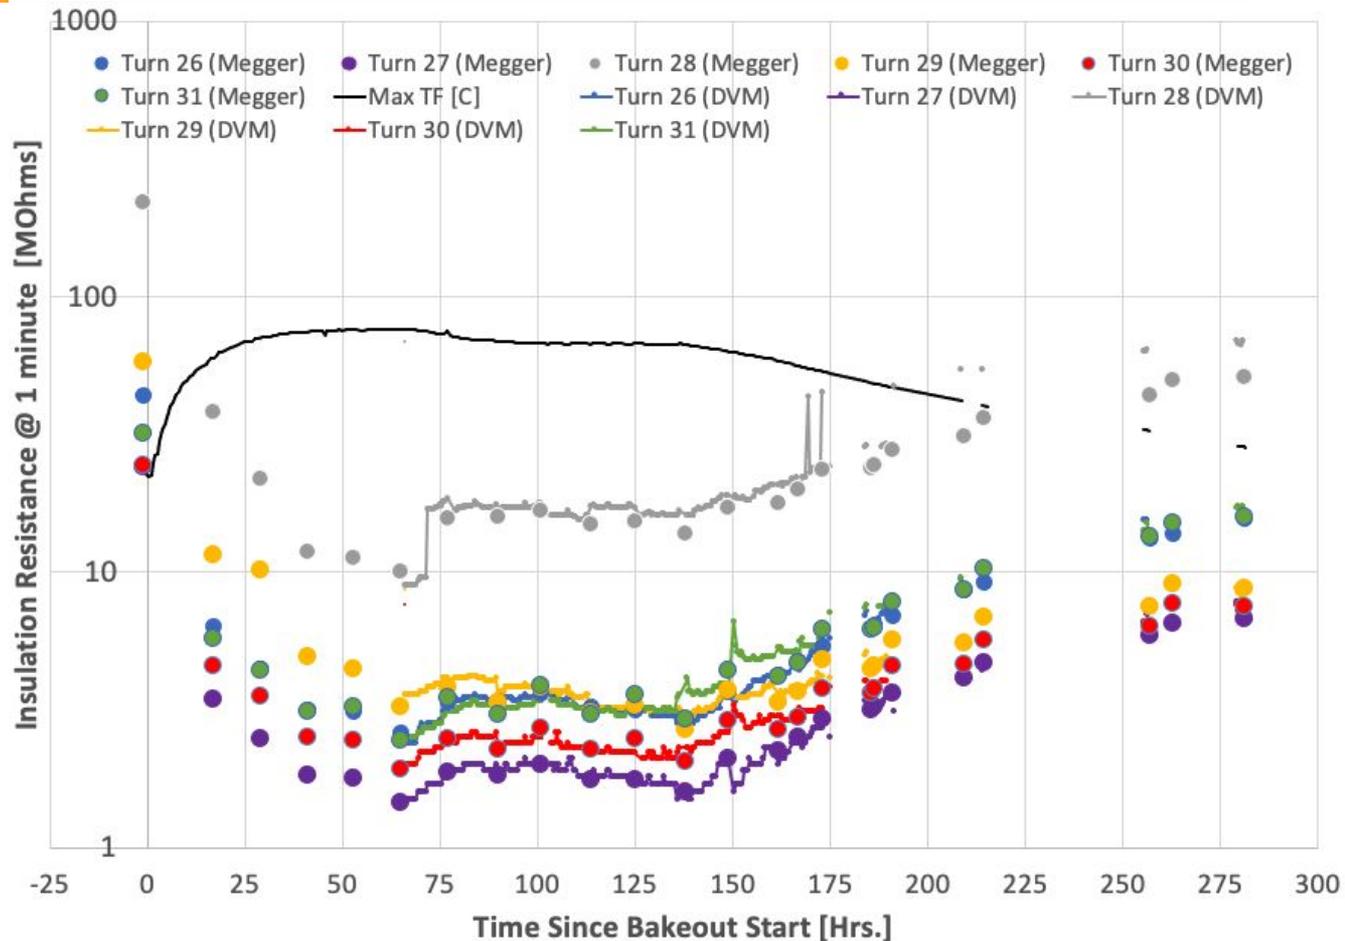
IR Measurements During Bakeout Showed Apparent Reduction in IR

Typical Drying Curve for a Wet Transformer

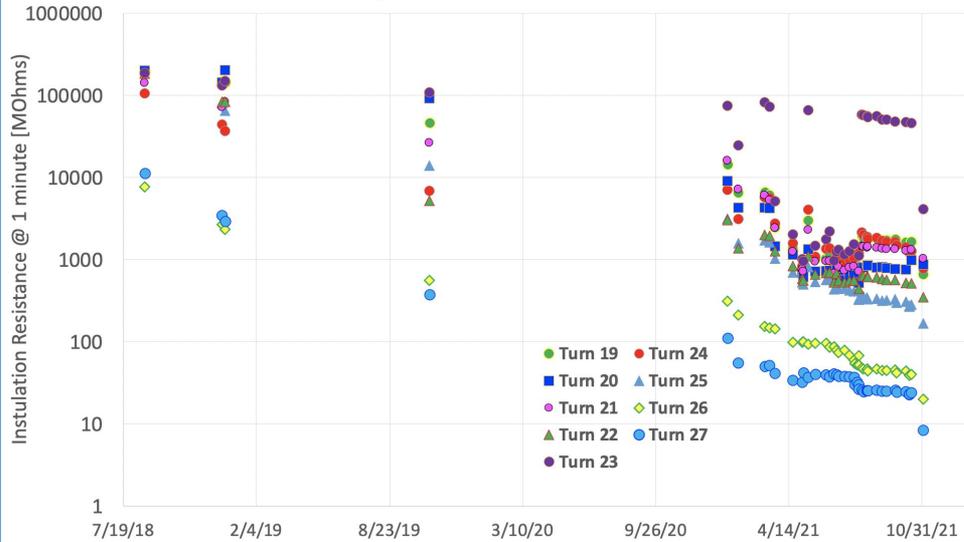
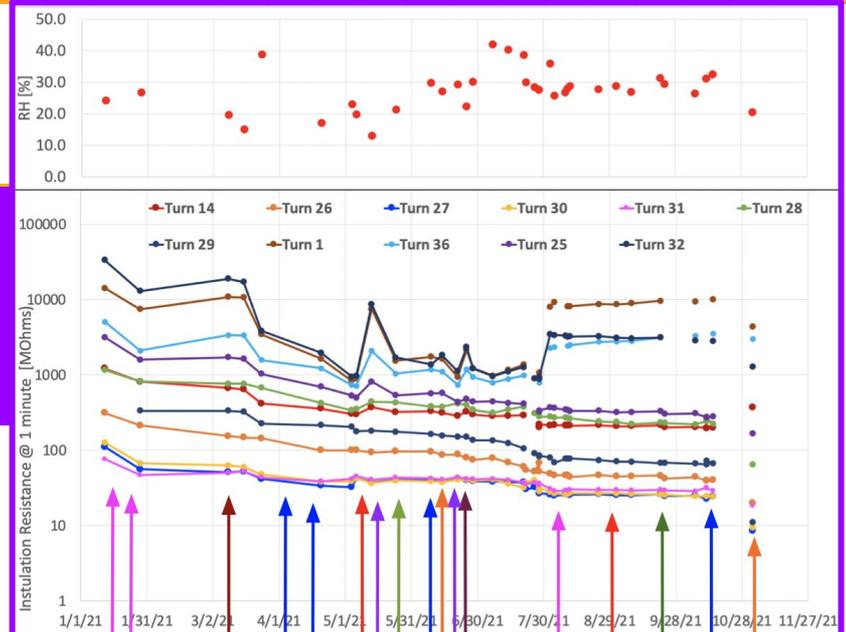
Quadrant #3 IR Values

No Activity to Date Has Arrested the Downward Trend

Bottom Line - Downward trend continued over this time, despite many changes to the bundle configuration

Quadrant IR Data Since 2018
Note: IR > 20 GΩ at time of fabrication

- Clean While Vertical (1/12/21-1/29/21)
- Lay Horizontal (3/5/21)
- Clean in slits, Water Fittings
- Clipped Aquapor Wires (5/6/21)
- Remove Compression Stack (5/12/21)
- Removed 1/2 of Lower Weldment (5/21/21)
- Removed 1/2 of Lower Weldment (6/8/21)
- Pulled 7 of 9 Bolts from Lower 1/2 G10 Ring (6/11/21)
- Clean around Bolts (6/20/21)
- Clean Water Fittings Again (6/25/21)
- Removed Lower 1/2 G10 Ring (8/9/21)
- Pulled Back Upper Cap Block (9/1/21)
- Pulled Back Lower Cap Block (9/23/21)
- Cleaned Bundle Top and Bottom (10/13/21)
- Post Bakeout (11/03/21)

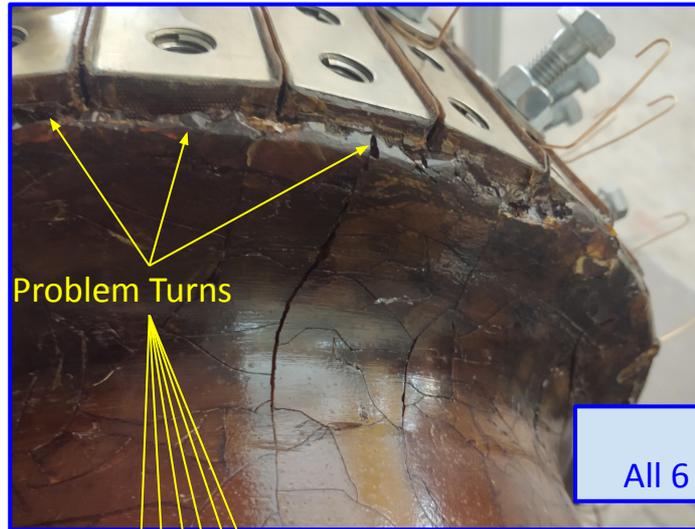
Ongoing Now - Remediation of Fractured Resin on the “Flags”

- Resin w/o glass is inherently brittle (resin rich)
- Cracks may have contamination.
- Network of cracks can allow non-adjacent turns to communicate
- Carefully sand down the cracked and extremely resin rich areas, down to the turn insulation - removal of contamination and provide a uniform bearing surface when restored.

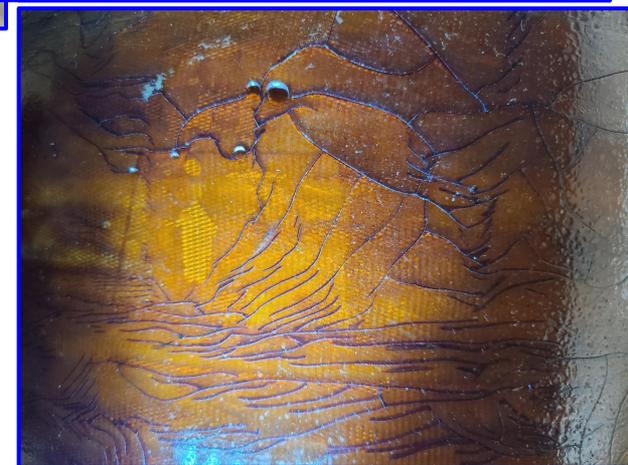
Of 6 questionable turns, 4 are accessible at the bottom
