National Spherical Torus eXperiment Upgrade

Recovery Project (RP) Magnet Field Scope

WBS 1.01.03.04

NSTX-U Recovery Project FDR – March 17-19, 2020

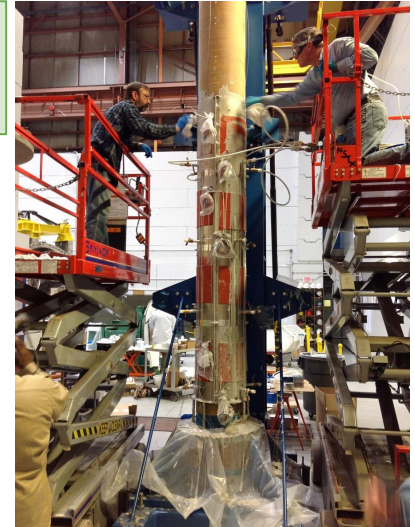
- Aquapour is a material like plaster of paris, removable with water
- A ~0.1” thick layer was applied to the outside of the TF coil, to be used as a winding surface for the OH coil.
 - Intent was to “wash” it out after the OH was cured
 - Four wires were embedded in the aquapour, to be used as “floss” to help remove the material
- During OH curing, the aquapour became saturated with CTD-425, forming a material that feels like pumice in your hand
- Wires and aquapour could not be removed.

Aquapour being applied to coil TF coil

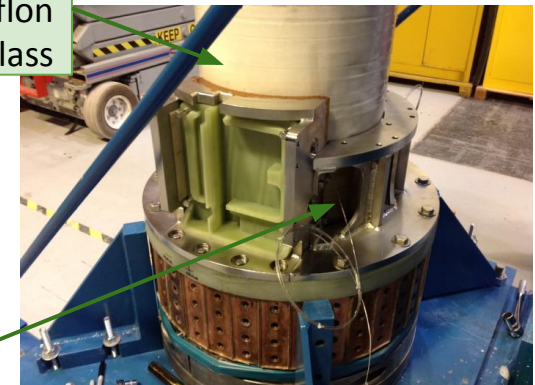
Aquapour under a layer of Teflon and epoxy/glass

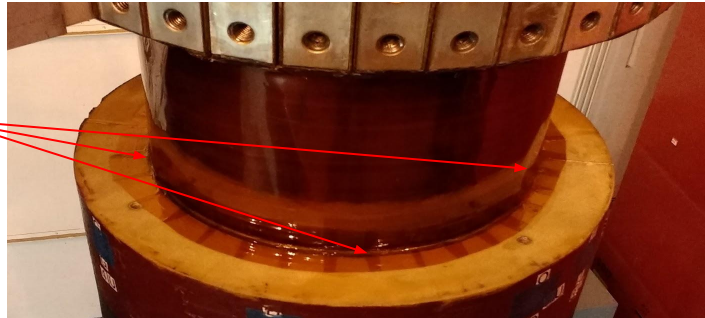
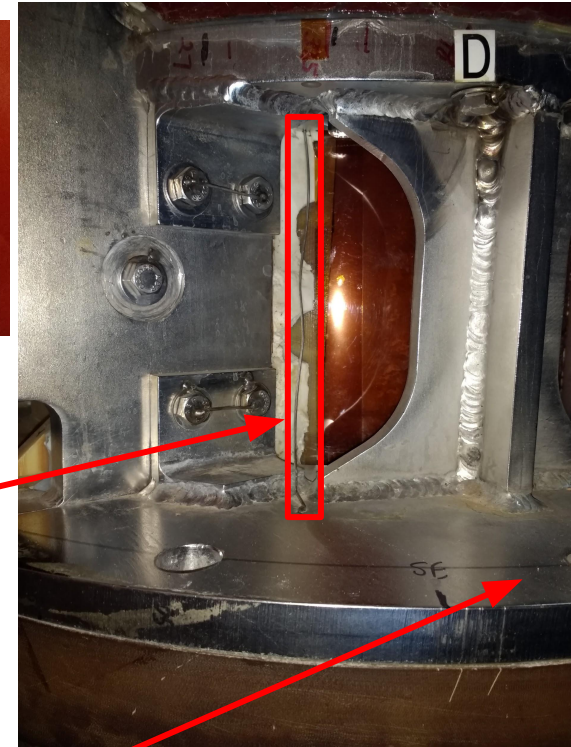
(4) SS Wires located between OH and TF

At the top (3) of the wires are isolated and wrapped under kapton the 4th is broken below the OH face

At the bottom the wires are bare and welded to the pedestal.

This area is covered by the OH skirt normally

Top of wire lengths remain the same - encapsulated and wrapped in kapton

- Encapsulate in high strength heat shrink into aquapour region
- Transition to 20kV 18 AWG insulated Cu wire (Wiremax UL 3239 150°C) through Terminal Crimp
- Secure insulated wire with kapton tape to OH base
- Route to a opening in the Outer Skirt and terminate in a terminal box.
- Copper wire can be terminated to ground, tested individually etc.

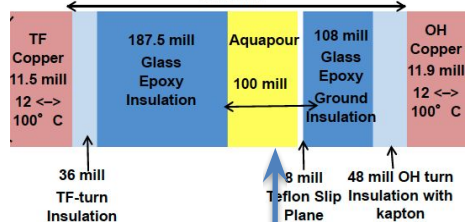
TF-OH Gap Details
487.5 mill

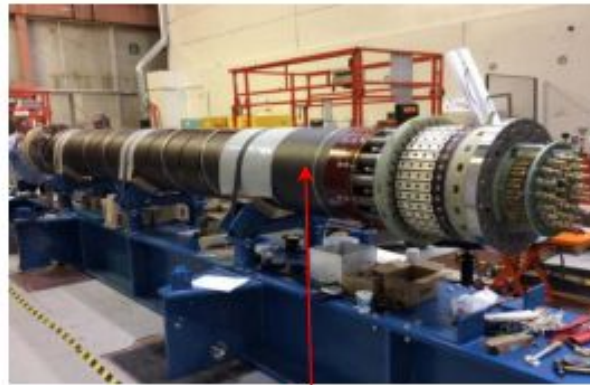
Fig. 1. OH coil with ground plane paint.

- A resistive paint was applied to the outer surfaces of the OH Coil to form an outer ground plane.
- It serves to shield the surrounding instrumentation (flux loops, thermocouples, etc.) from the transient voltages.

- The OH Ground Plane keeps the electrical field in the insulation to shield the surrounding instrumentation.
- Ground Plane has induced currents
- The voltage on the ground plane decays rapidly, from 600V to 50V in less than 30 milliseconds; therefore, the power dissipation is not a concern.
- Paint Resistivity should be between 400 ohms/square to 1000 ohms/square.
- The total resistance for the OH Ground Plane is 1000 ohms to 2500 ohms
- Apply Von Roll Corona Shield P8003 Paint and measure ground plane until within set resistivity range

OH Ground Plane Paint will be Remediated

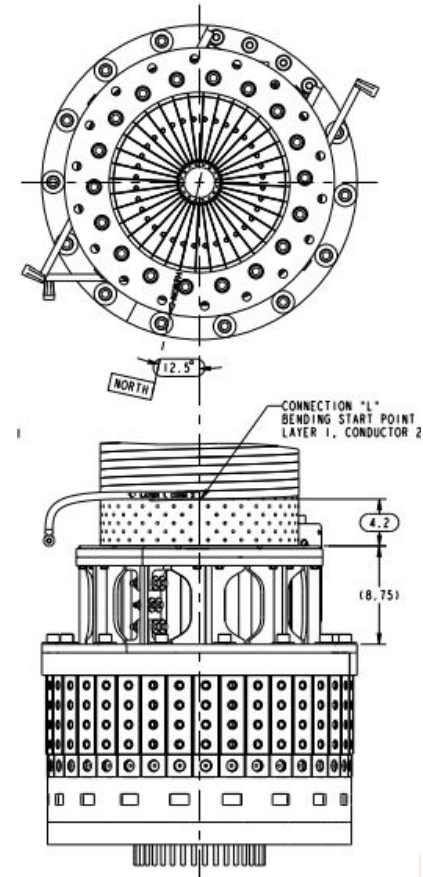
- Turn to turn testing was completed on December 2018 and October 2019
- At 41% Relative Humidity, readings were in the MOhm range; when the humidity was reduced (<35% RH) readings were in the GOhm range
- Meeting held with Facilities to discuss the desired environmental operating conditions as they pertain to the HVAC system within the NSTX-U Test Cell (NTC)
 - Facilities agreed to add additional dehumidification to the NTC as part of an ongoing project.
- We will now operate the TF Bundle in a controlled humidity of <35% all year around.

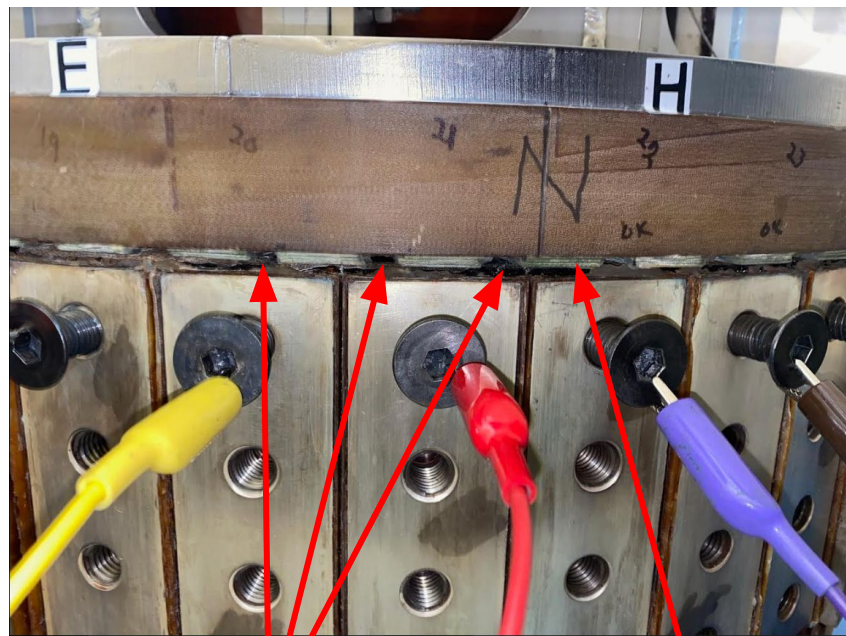
As Found G10 Shims/Gaps Will Be Potted In Place

G10 Shims Installed with bead of RTV to hold in place

Issue	Consequence	Solution
Ability of the shims to work their way out under loads	Casing may become loose, compromising alignments and stressign coil leads	Installation of a band of wet layup around the shims, which prevents them from coming loose. (fiber glass painted with epoxy)
Non-uniform loading of the TF bars due to point contact on the localized shims	May apply vertical loads to the TF flags in a fashion inconsistent with assumptions of the inner-TF analysis from summer 2019	Install mold release between gaps, and install thixotropic grout to improve the uniformity of the preload

Spray all gaps with mold release, and inject grout. Wrap with fiberglass and epoxy

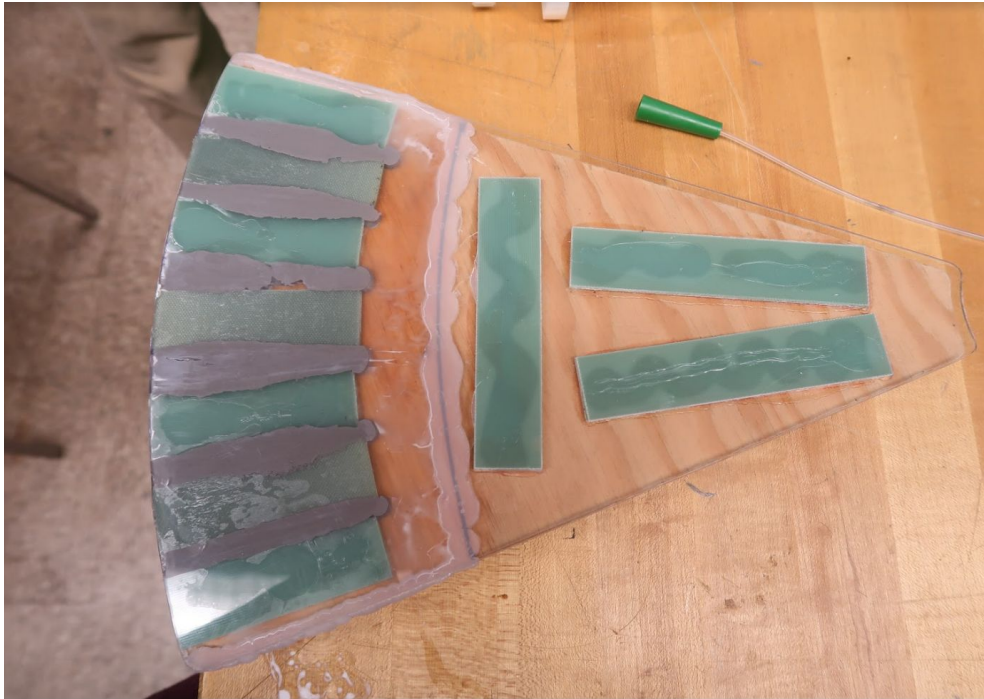
Solution with Structural Filler Chosen to Enforce Uniformity of Loads Uniform and Trap Shims

- Extensive Prototyping Program
 - Technician who performed work, installed the G10 shims currently deployed
 - Multiple types of epoxy were tested in the Materials Test Lab
 - Multiple wooden prototypes were tested to see how the epoxy would flow, fill, and expand in the injected area
 - Epoxy injection was done “blindly” to mimic the as built configuration, ensuring the technician can fill the gaps without seeing the epoxy flow
 - Mold released samples of CTD 425 and G10 tested to ensure epoxy will not adhere to the surface
- Spray gaps with PTFE Mold Release
- Inject Loctite 9394C to fill the gaps between the shims

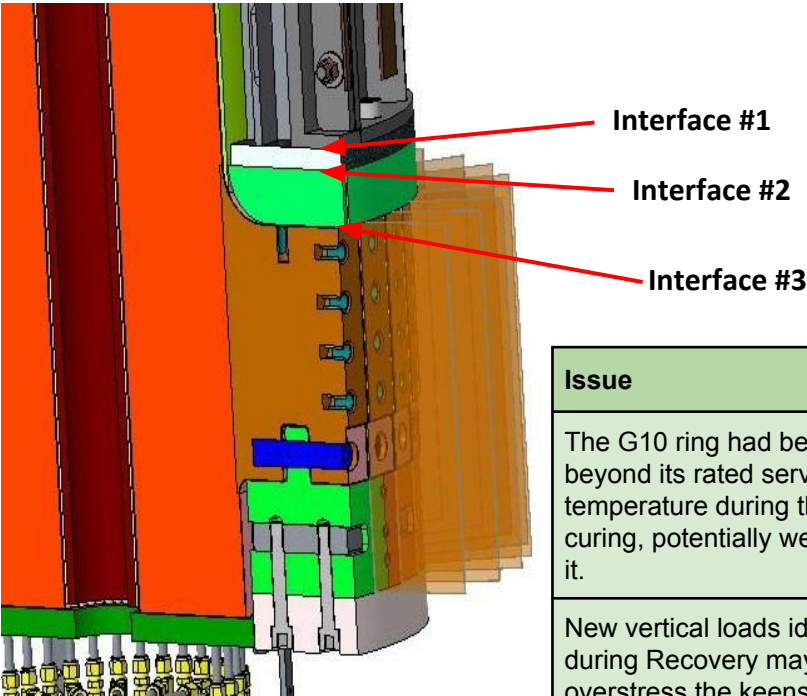
PPPL Revisited Loading of G10 Ring at Base of OH Coil

Issue	Consequence	Solution
The G10 ring had been baked beyond its rated service temperature during the curing, potentially weakening it.	The tensile capability of the keensert compromised, resulting in them failing and the casing coming loose.	Calculation shows loads of 600-1000 lbf; these are less than the allowables (link , link)
New vertical loads identified during Recovery may overstress the keenserts and G10	The tensile capability of the keensert exceeded, resulting in them failing and the casing coming loose.	Calculation shows loads of 600-1000 lbf; these are less than the allowables (link , link)
Lack of positive restraint at the three interfaces listed in Table 1.2-2.	Casing may slide “sideways”, compromising alignments and stressing coil leads	-Grout Type 1 Bolts to register the skirt interfaces to provide positive restraints at skirt interfaces -Rely on the aquapour & friction to provide restraint at the G10/TF interface
