**TO: M. JAWORSKI, M. SMITH, S. GERHARDT**

**FROM: M.L. REINKE**

**SUBJECT: IMPACT OF SMALL GAPS IN CENTERSTACK TILES**

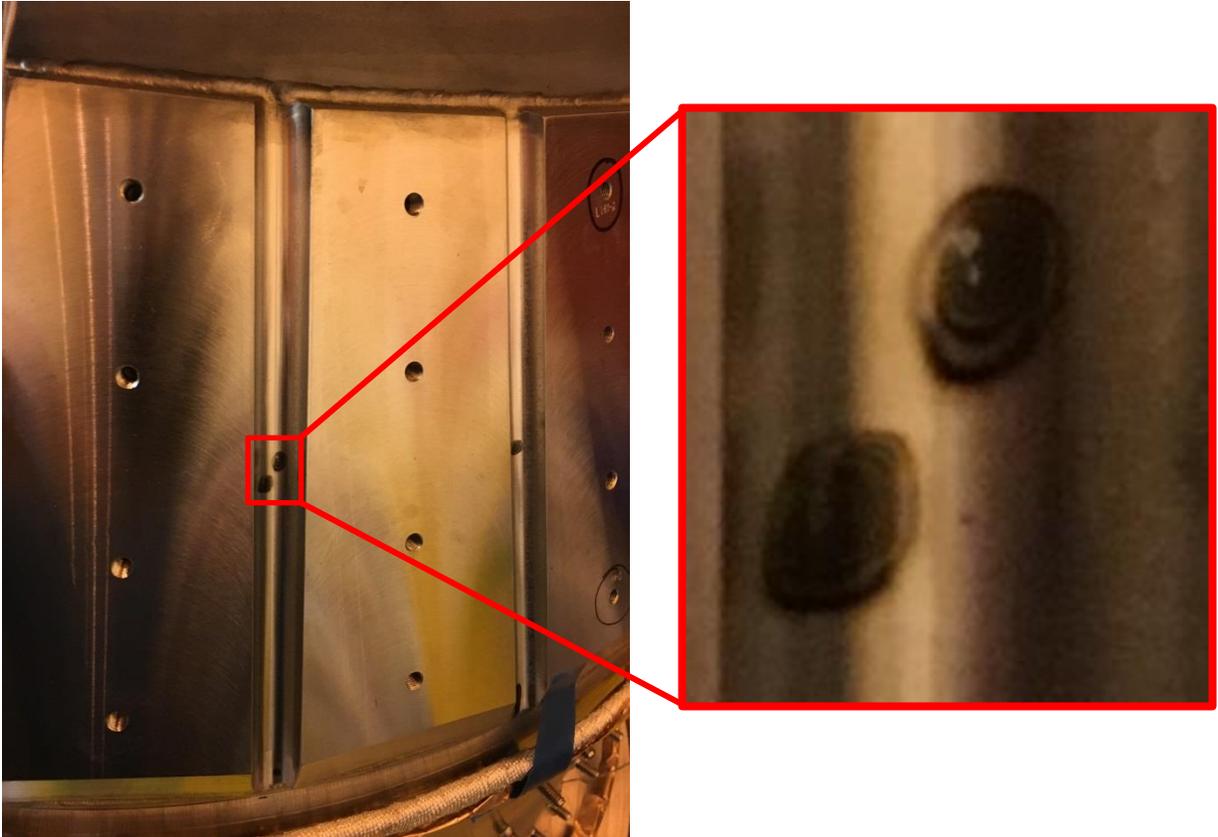
Post run inspection of the surface below the CSAS revealed a series of markings between the two tile rows on the CSAS, as shown in Figure 1 (image courtesy of M. Mardenfeld).

Figure 1: Picture (Jan 2018) of lower mounting surface for lower CSAS PFCs, highlighting deposit.

To gain insight into the impact of these coatings, it is recommended that the Recovery project, either via the PFC or Vacuum Vessel and Internal Hardware WBS teams, develop an inspection and cleaning procedure. The goal is to document the before and after, as well as any specific methods necessary to clean these surfaces as well as any indication of permanent surface damage. This would allow these gaps to act as a method of confirming acceptable sizes to underlying vacuum vessel/centerstack surfaces for PFCs, helping to improve Section 3.3-c,d of the PFC System Requirements Document [1].

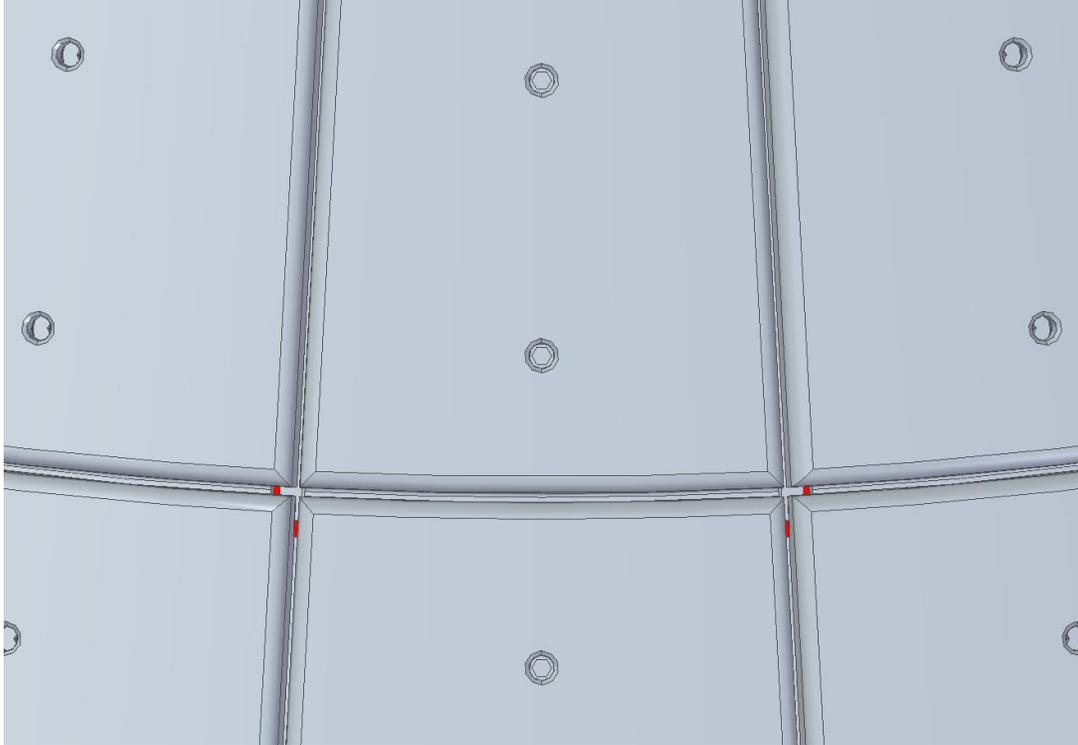
The location of the discoloration occurs near the gaps between the CSAS tiles, motivating an inspection of possible gaps in the FY16 PFCs. Figure 2 and Figure 3 show investigations of the CAD model, where line of sight through the PFCs is revealed as red. A normal incidence view (Figure 2) reveals a pair of gaps near the corners, while for even a steep incident view, approximated by Figure 3, this line of sight is eliminated.

**Figure 3: CAD of CSAS tiles with the gaps between tiles revealed by the red regions that would allow access via normal incidence. These gaps become hidden when viewed at an angle as from heat/particle flux from the plasma.**

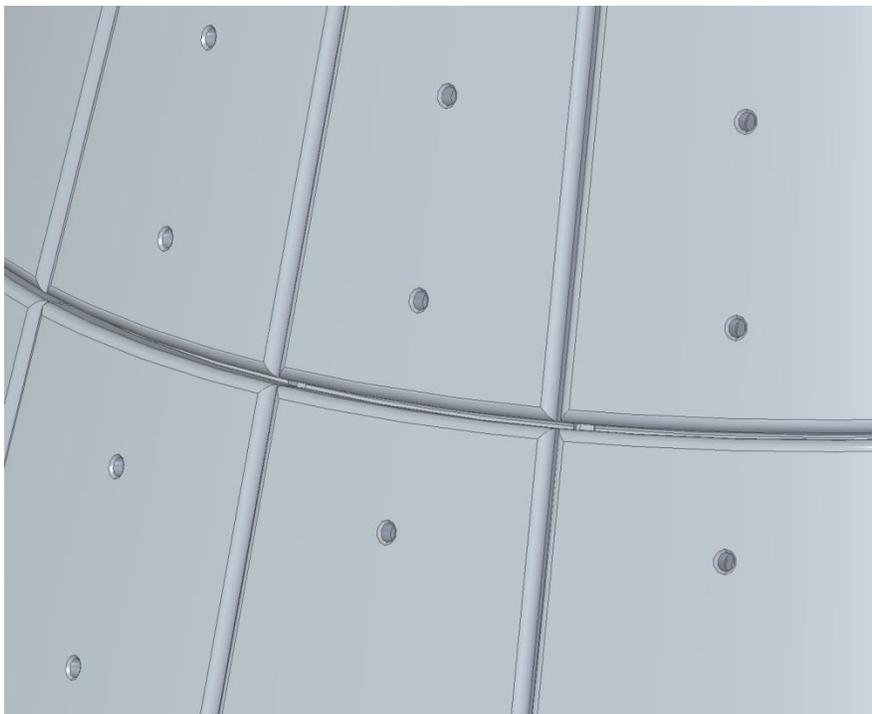
**Figure 2: CAD of CSAS tiles viewed from angle showing the lack of access to the centerstack surface by the absence of the red as shown in Figure 2.**

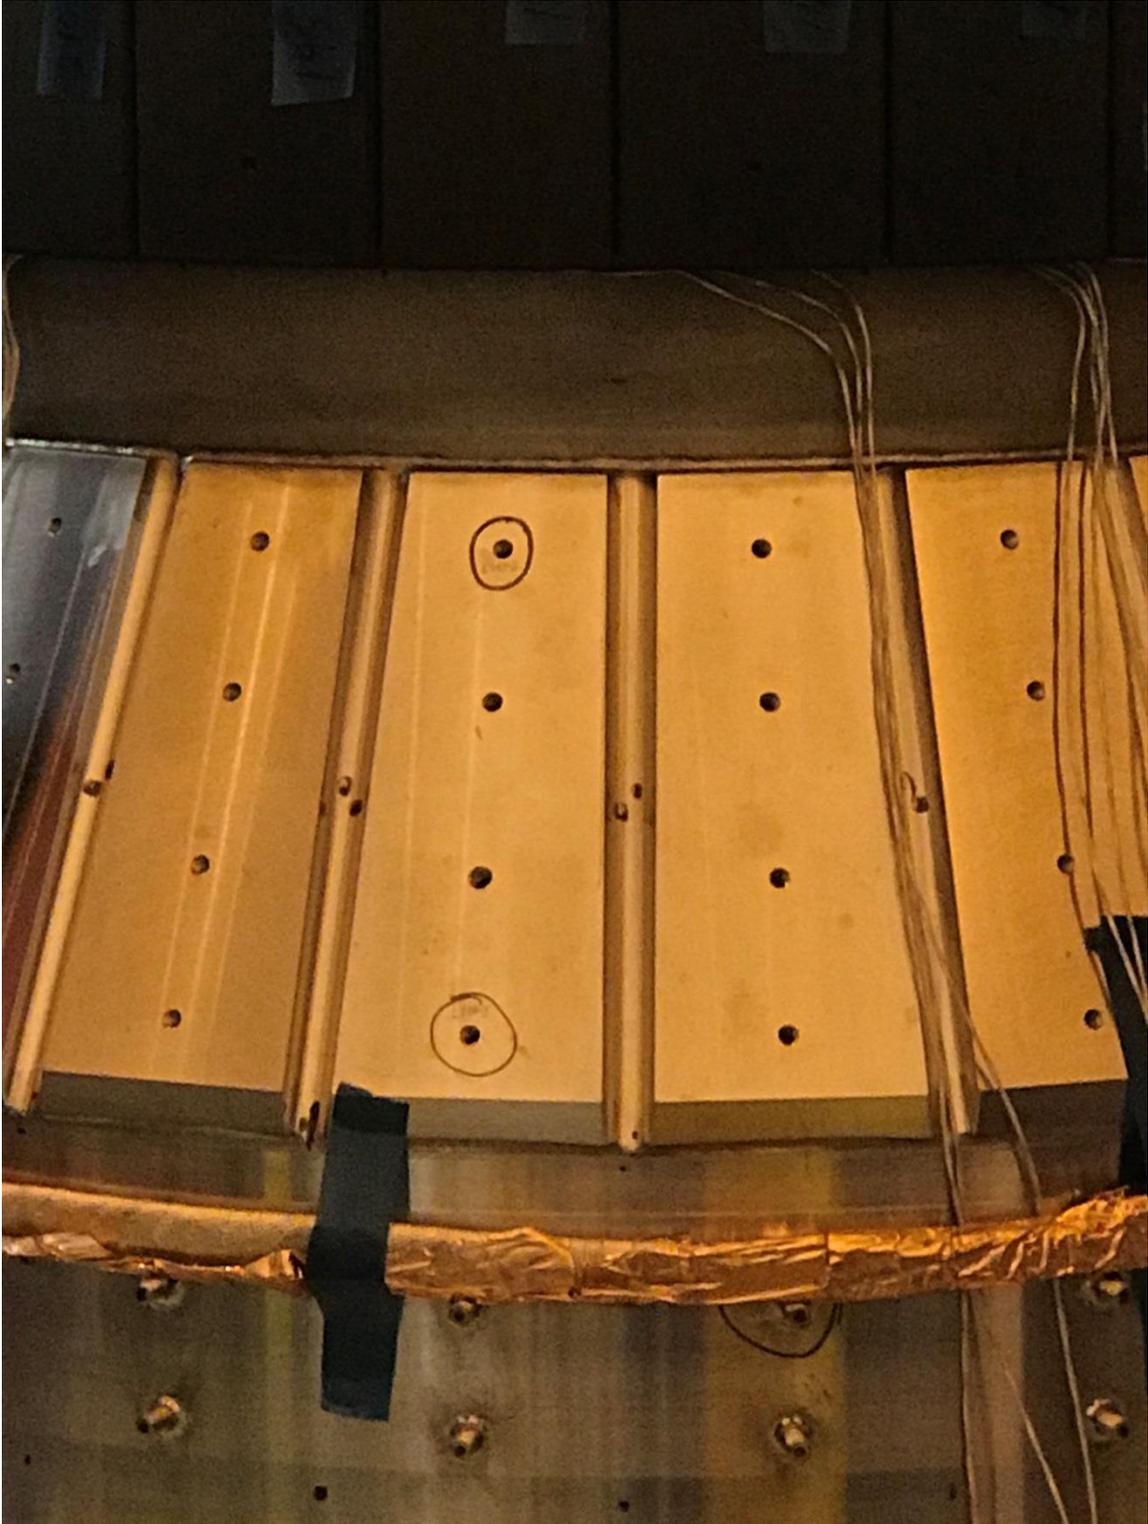
This suggests a normal incidence deposition and excludes a direct plasma interaction. Further visual inspection of the centerstack demonstrated that the alternating pattern of gaps, e.g. top/bottom and left/right justified, as evident in Figure 2, is manifested on the centerstack, shown in Figure 4. Additional inspection of Figure 4 indicates the possibility of a slight smearing of this discoloration suggesting that it is a coating that could be easily removed.

**Figure 4: A wider view of the centerstack mounting surface for the lower CSAS (January 2018). The repeating pattern of gaps that is evident in Figure 2 is seen on the centerstack.**
