# Resolution of the NSTX Neutron Conundrum - Circa 2005

**NSTX Physics Meeting  
July 11, 2005**

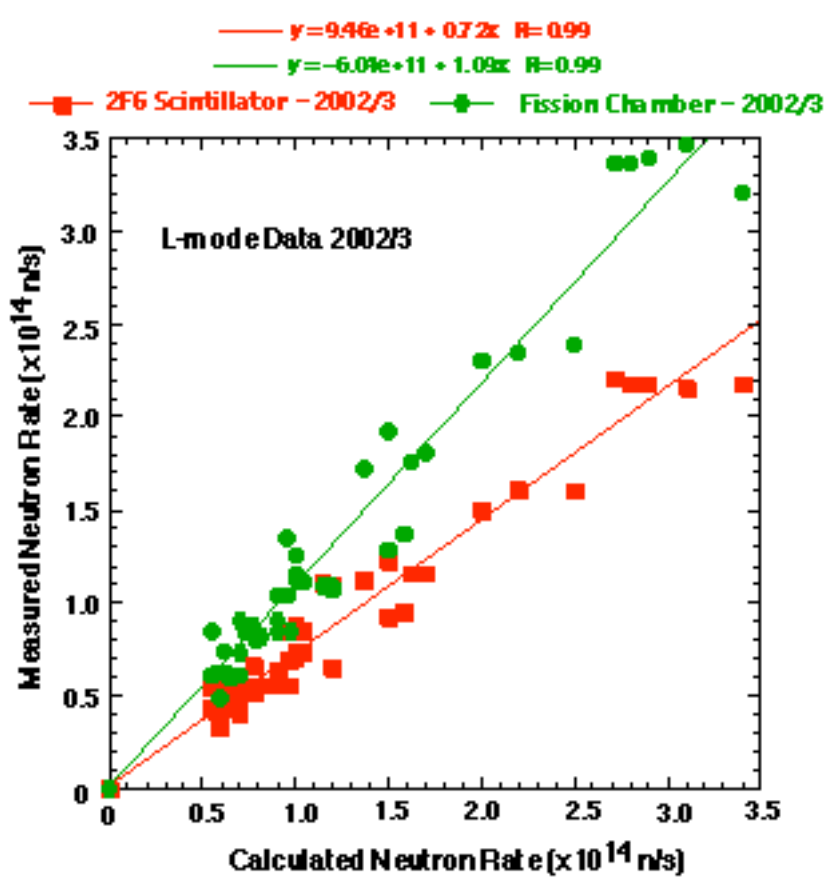
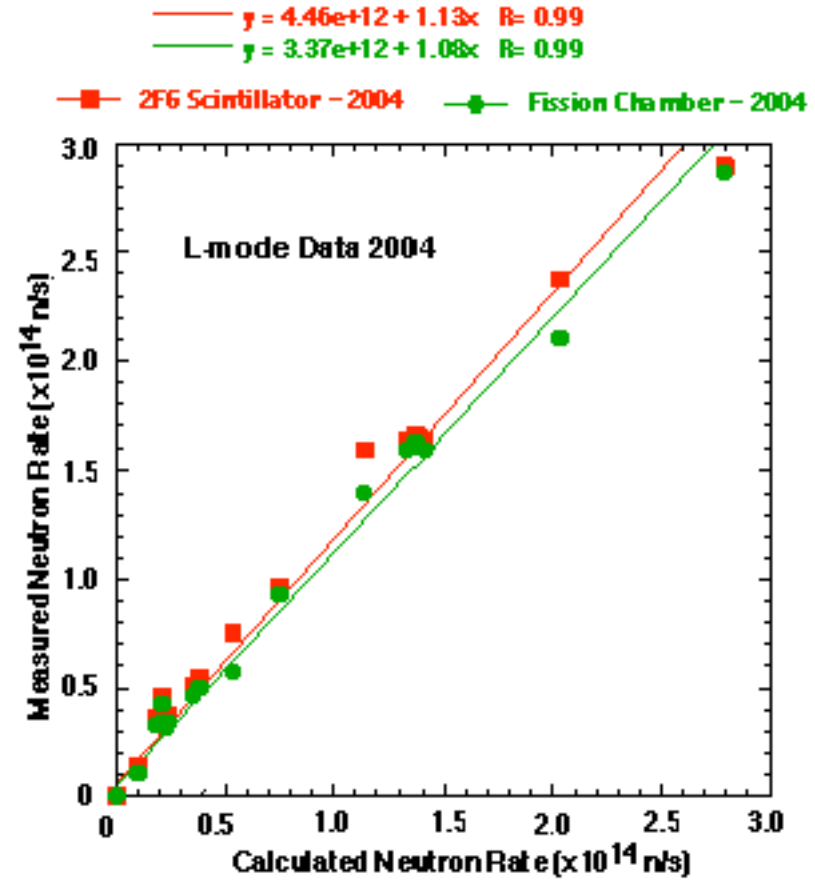
# Comparison of Measured and Calculated Neutron Rates in L-mode Discharges

- Fission chamber measurements modestly (~ 8.5%) exceed TRANSP calculations.
- 2FG scintillator measurements changed drastically over time.

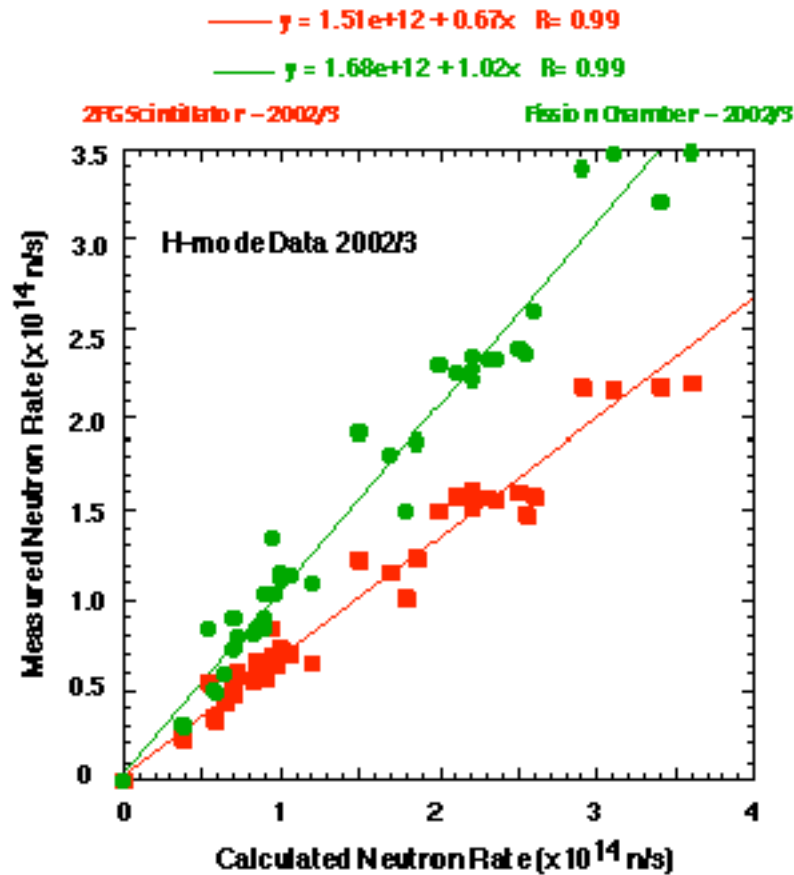
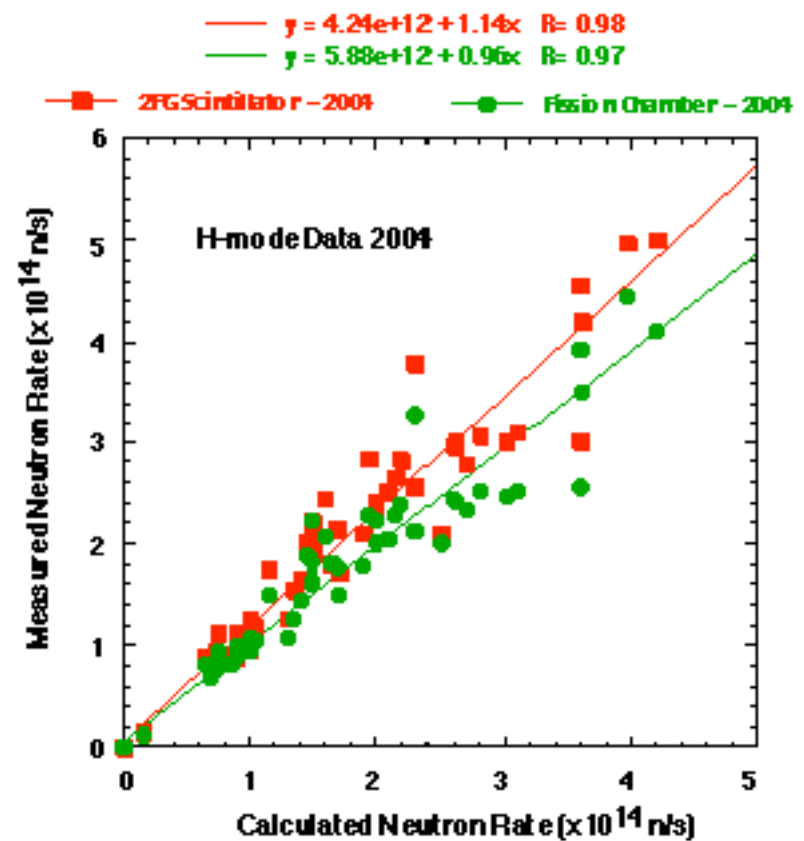
# Comparison of Measured and Calculated Neutron Rates in H-mode Discharges

- Fission chamber data are close to TRANSP calculations, in contradiction with NPA energetic ion loss observations.
- 2FG scintillator measurements changed drastically over time.

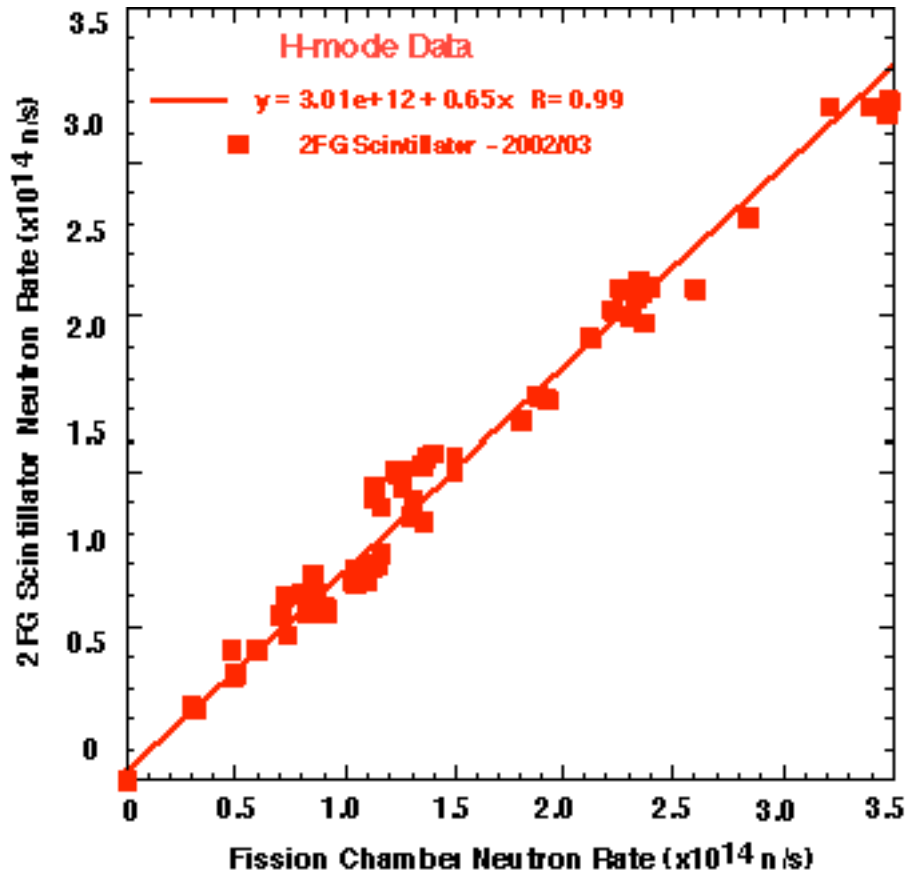
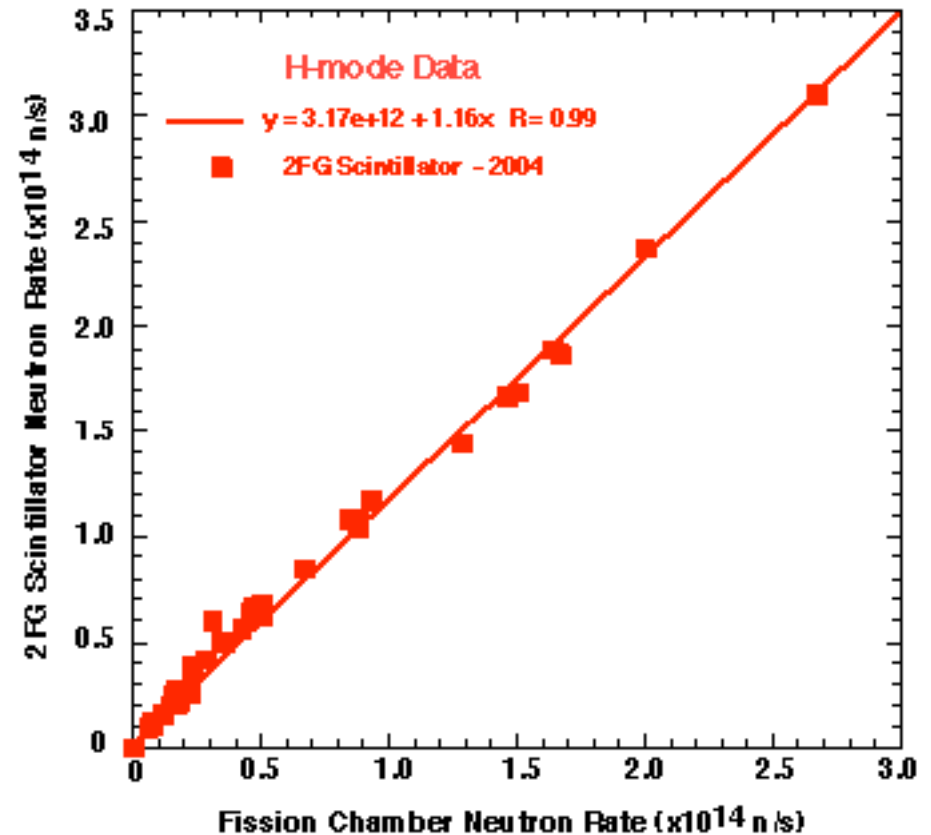
# Comparison of Fission Chamber and 2FG Scintillator Measurements in H-mode Discharges

- The fission chamber and 2FG scintillator measurements have never agreed.
- The 2FG scintillator measurements are stable within selected time periods, but increased by ~ 80% in 2004 relative to pre-2004.

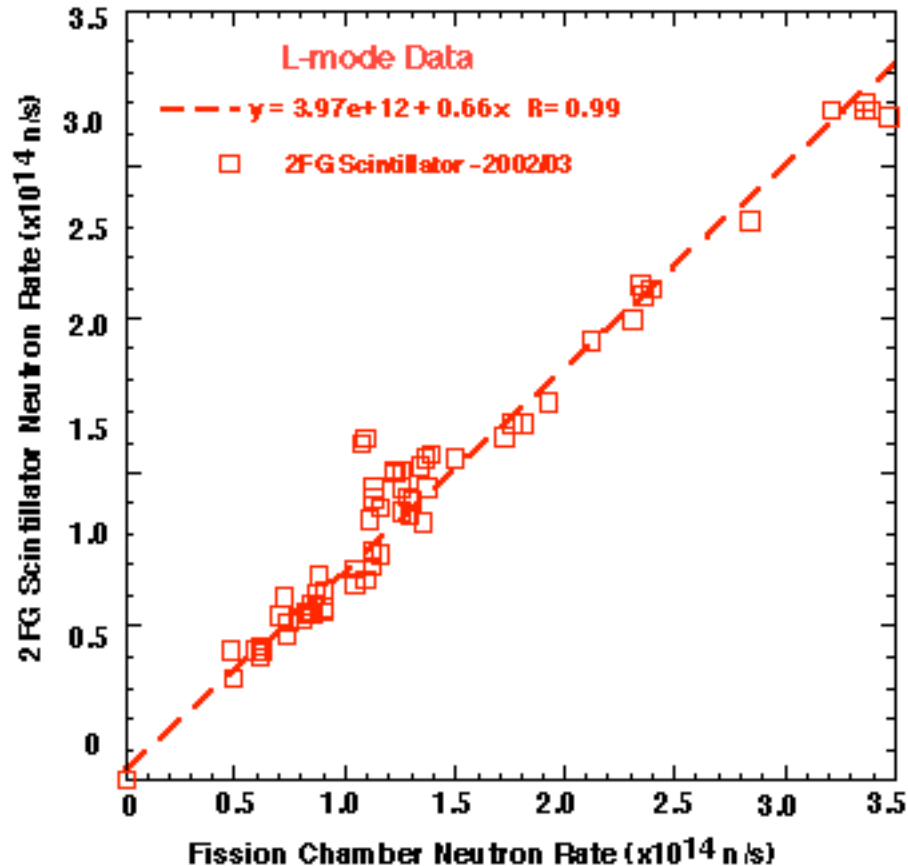
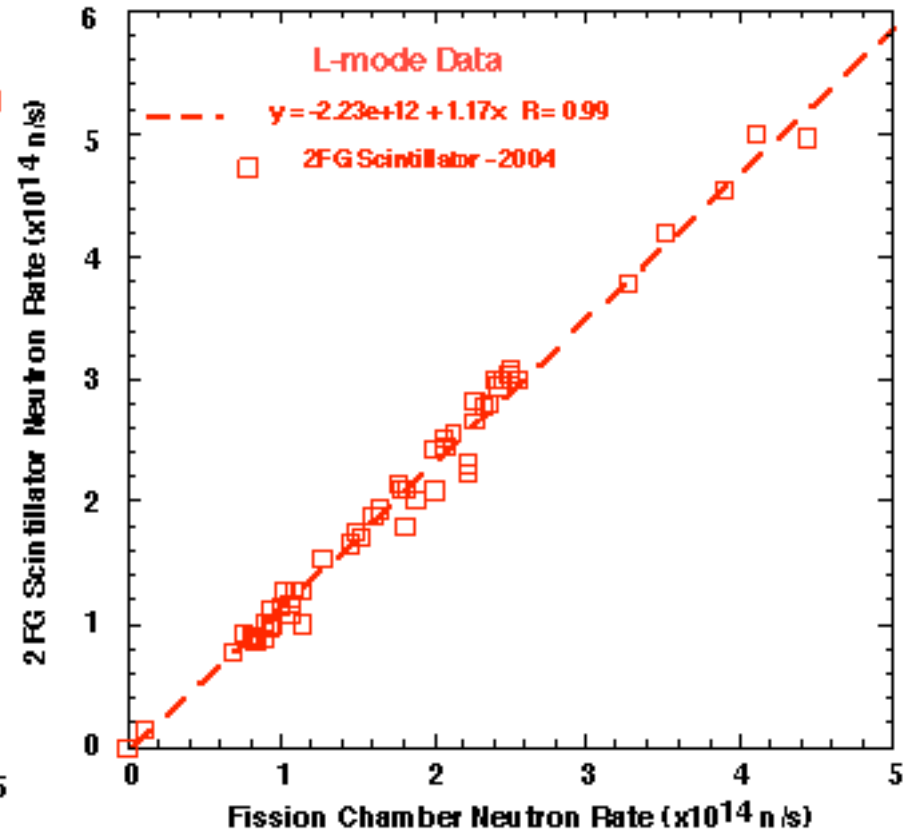
# Comparison of Fission Chamber and 2FG Scintillator Measurements in L-mode Discharges

- The fission chamber and 2FG scintillator measurements have never agreed.
- The 2FG scintillator measurements are stable within selected time periods, but increased by  $\sim 77\%$  in 2004 relative to pre-2004.

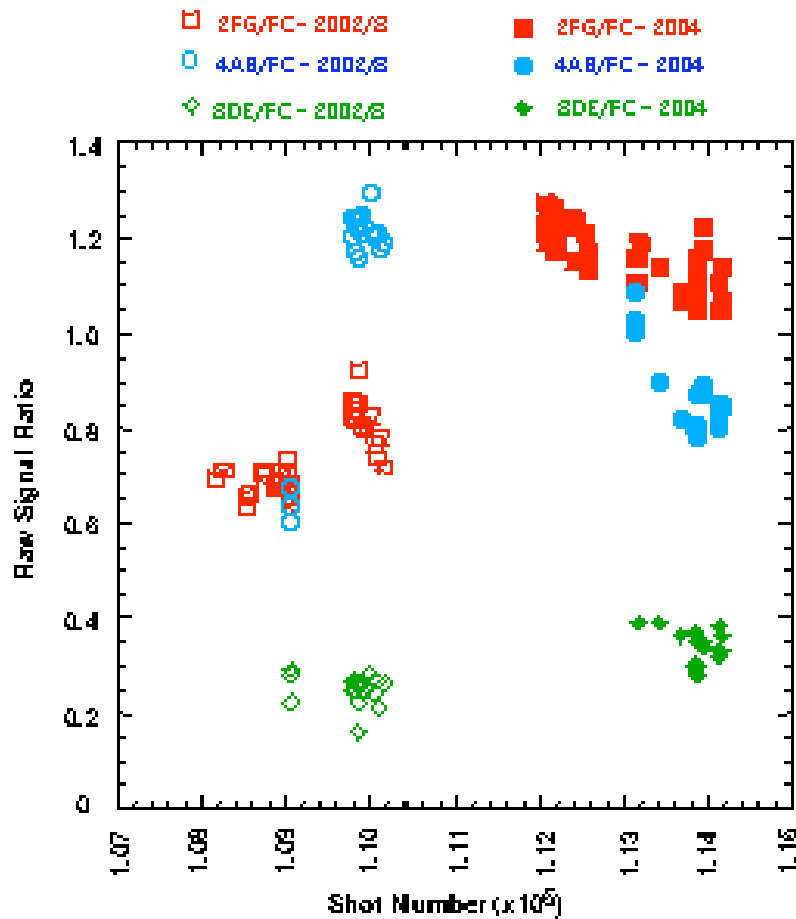
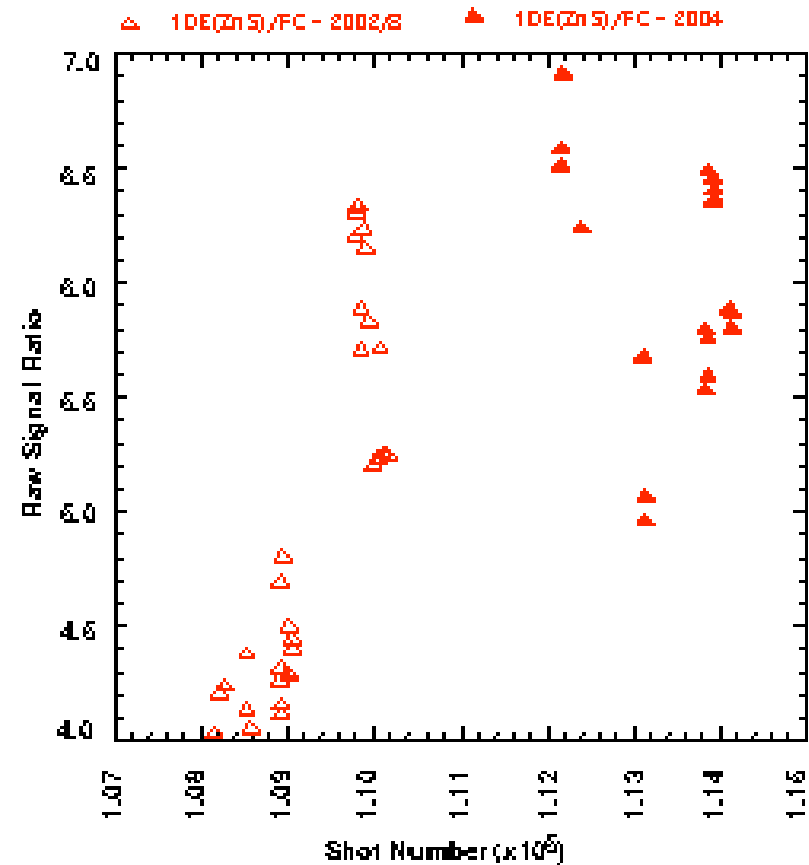
# Comparison of Scintillator/Fission Chamber Raw Signal Ratios Over 2002-2004

- Large variations in the scintillator/fission chamber signal ratios occurred in time.
- The fission chamber is stable, so the scintillator response must have changed.

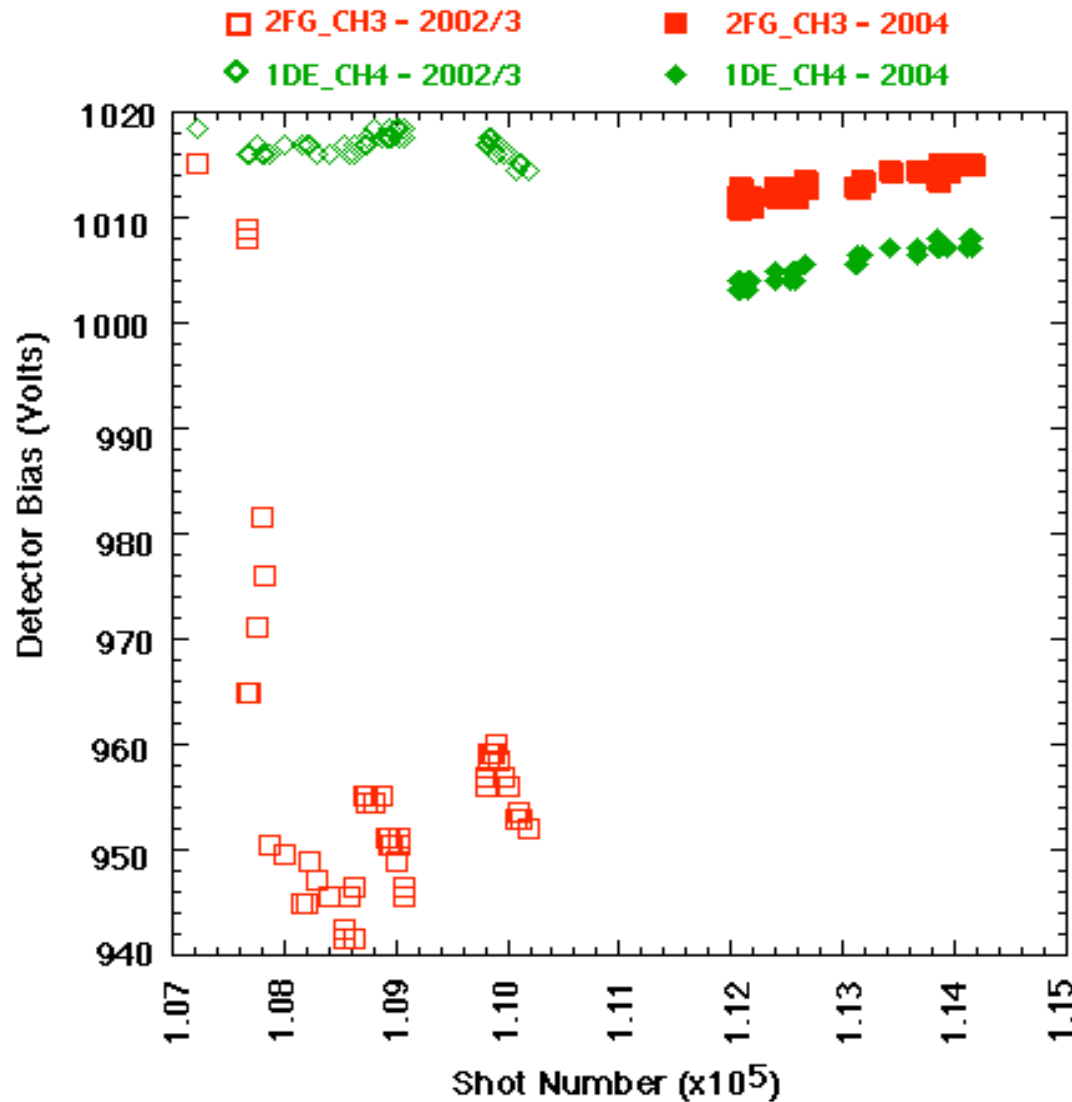
# Scintillator Operating Biases Varied Drastically Over 2002-2004

- The externally applied scintillator bias voltages have been archived since 2002.
- An inexplicable decrease in the 2FG scintillator bias occurred in early 2002.
- The 2FG scintillator bias was increased (intentionally) from ~ 960 volts in 2003 to ~ 1012 volts in 2004.
- This implies that the 2FG scintillator photomultiplier gain increased by  $(1012/960)^7 \sim 1.52$ , but the calibration factor was not updated.

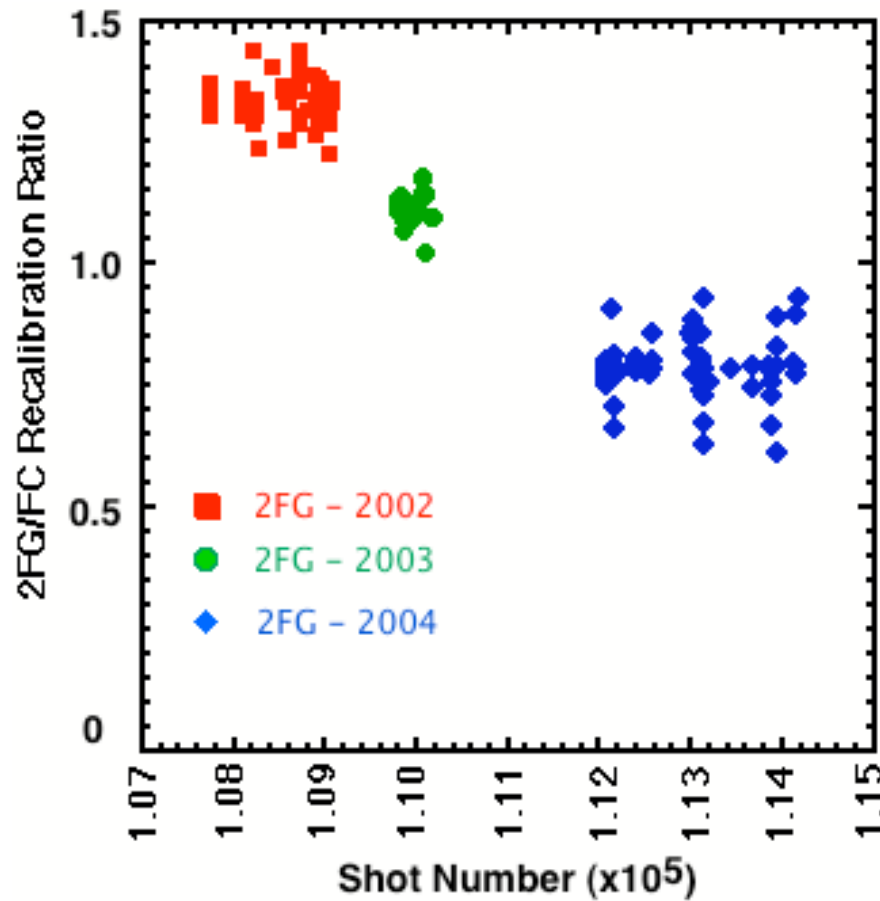
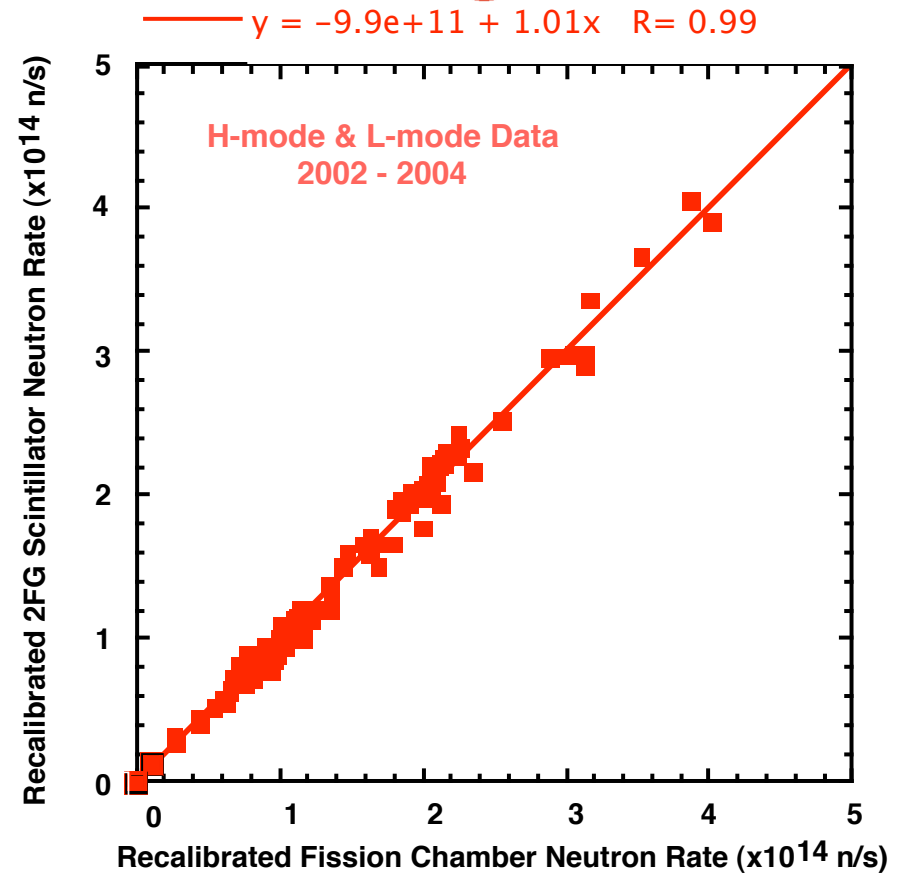
- The 2FG and ZnS scintillators and the fission chamber now agree for both L-mode and H-mode discharge conditions over the entire 2002-2004 period.

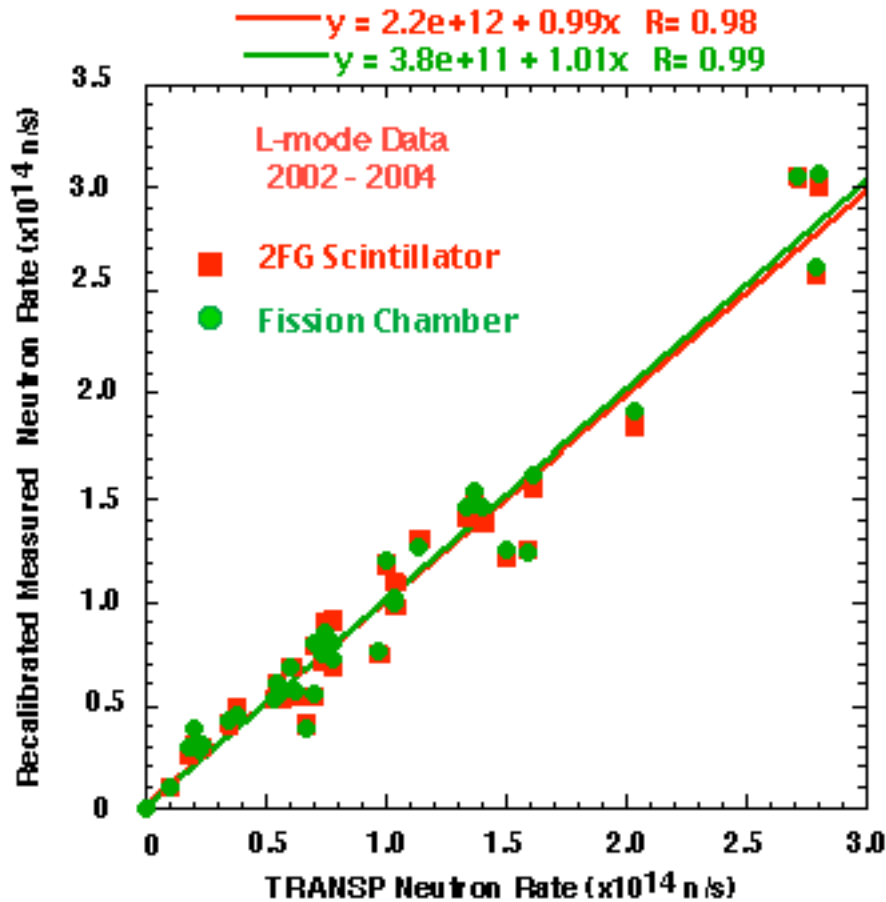
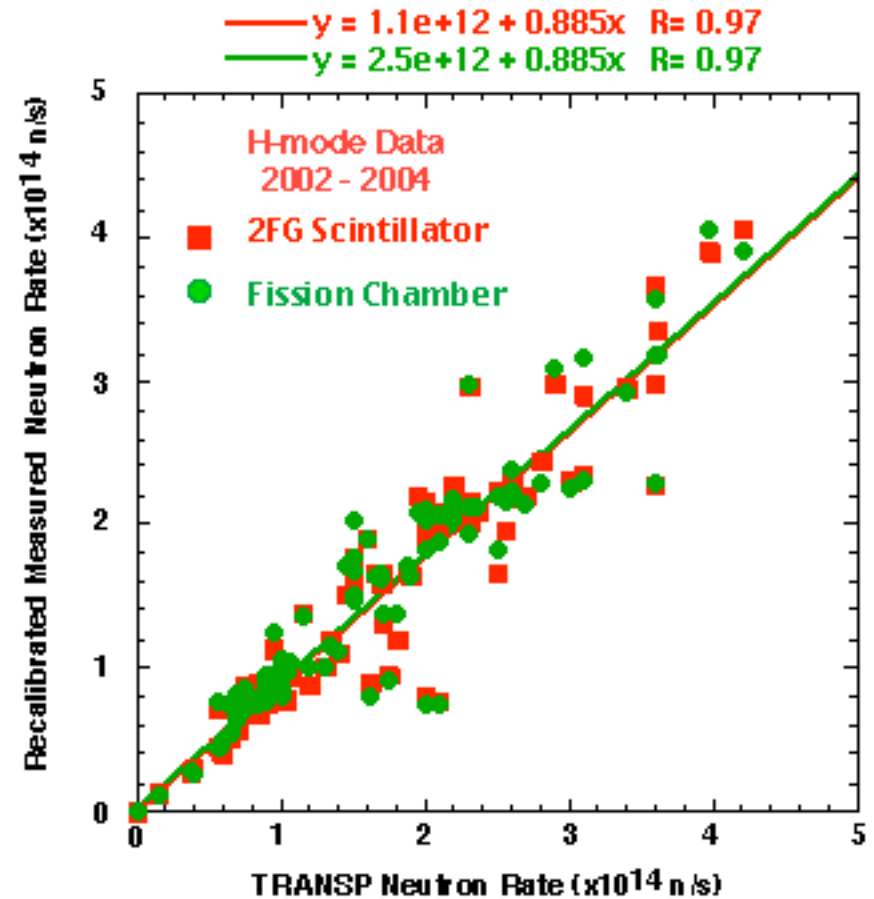
# Neutron Re-calibration Results

- The 2FG scintillator and the fission chamber agree with TRANSP calculations to within  $\pm 1\%$  for L-mode discharges over the entire 2002-2004 period.
- For H-mode discharges, measurements agree and show a neutron deficit of 11.5%
