National Spherical Torus eXperiment Upgrade

NSTX-U Team Meeting TF/OH Update

NSTX-U Recovery Team 13 December 2021

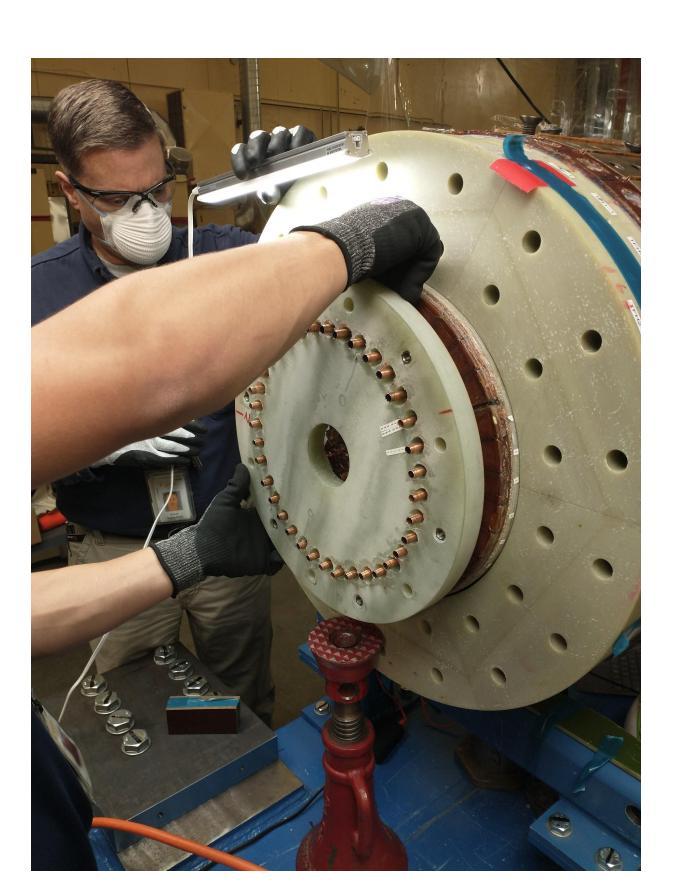
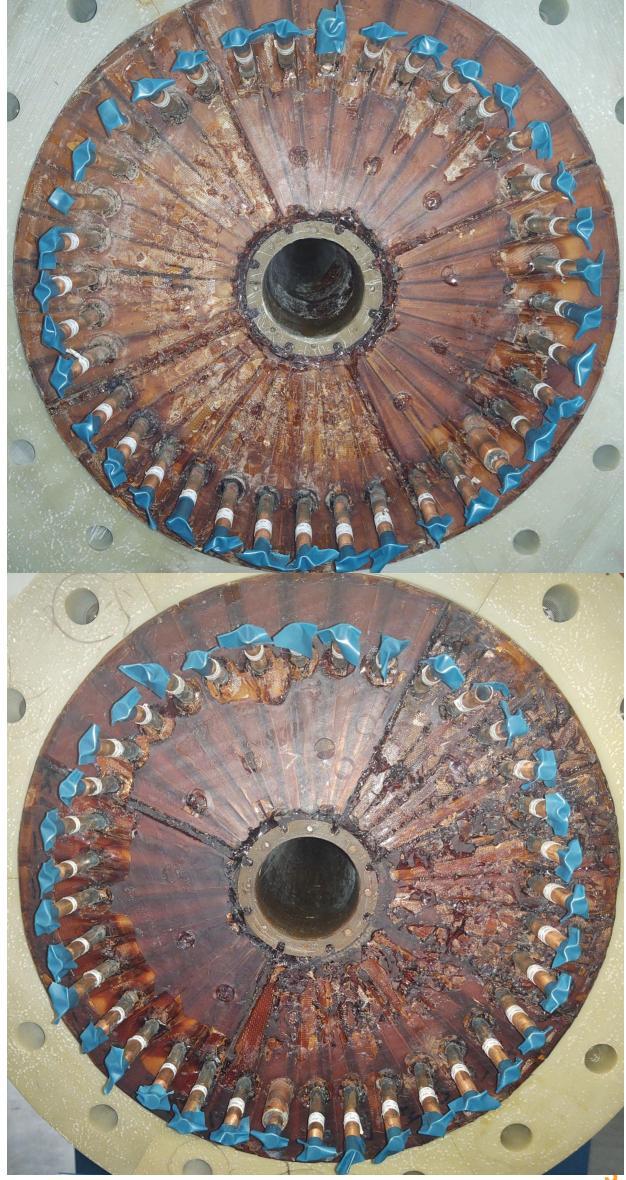
Exposed the bundle ends amongst the water fittings

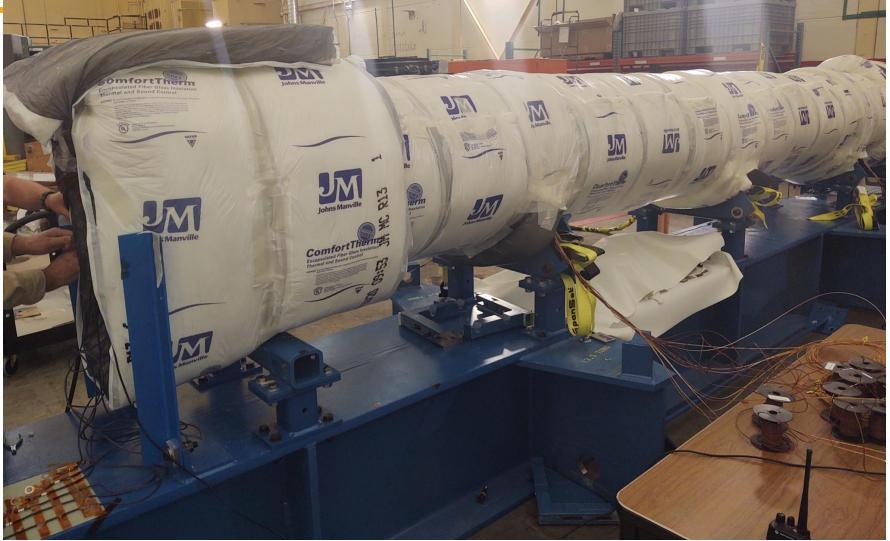
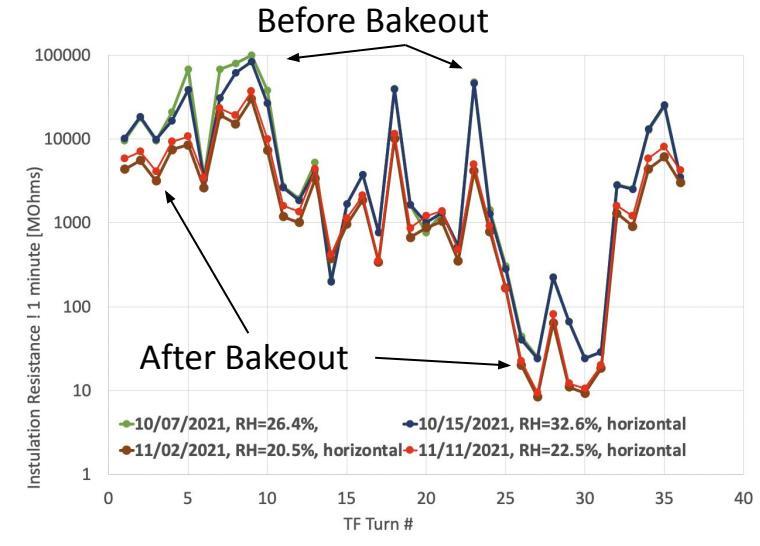
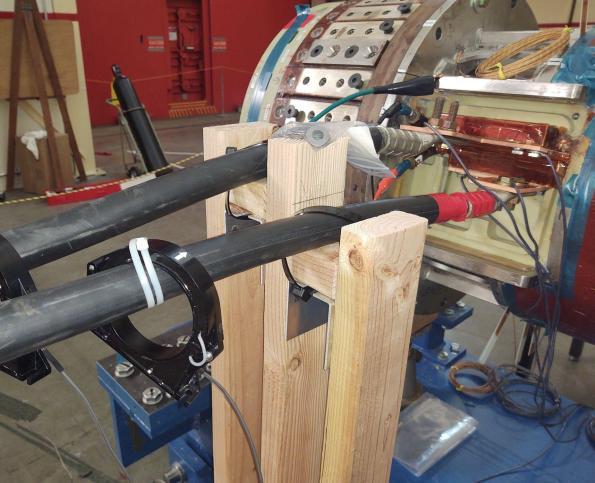
Exposed the bundle ends amongst the water fittings

• Completed an atmospheric pressure bakeout

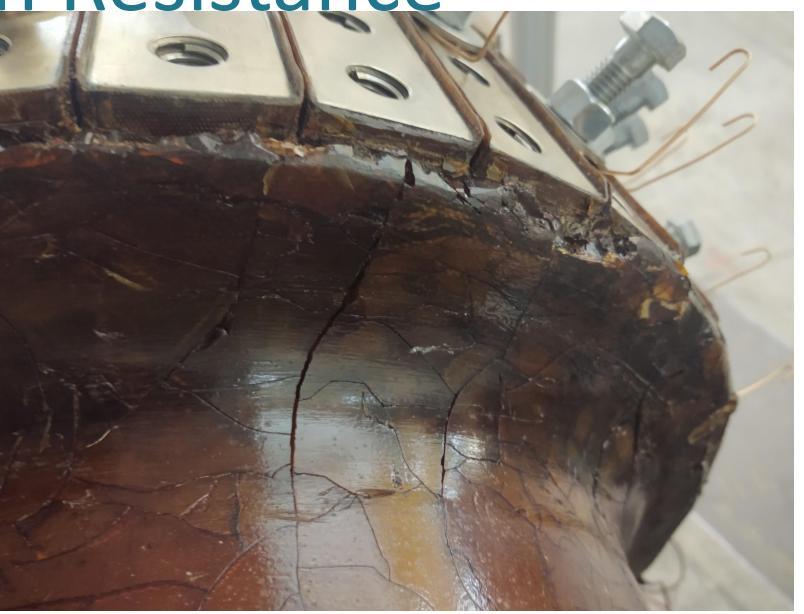
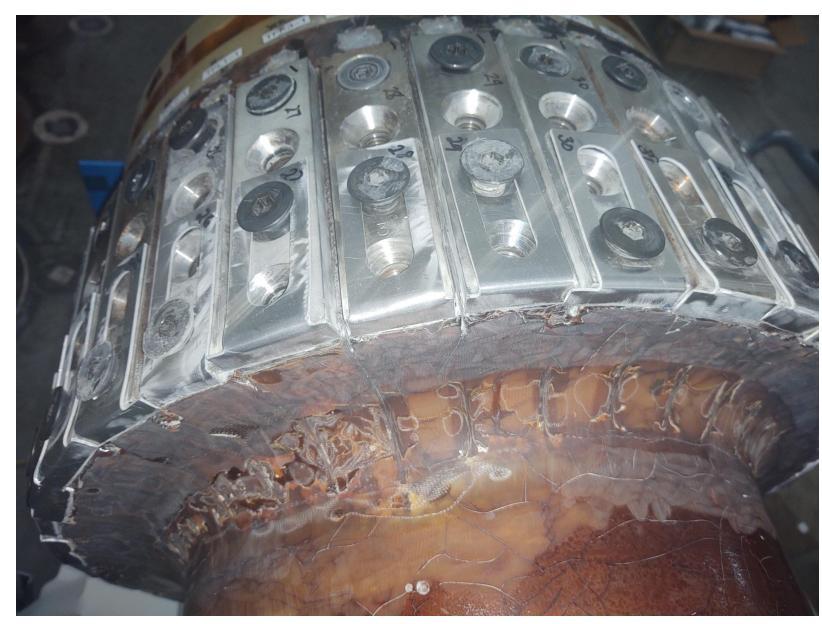
Removed a large amount of cracked or loose resin on bundle ends

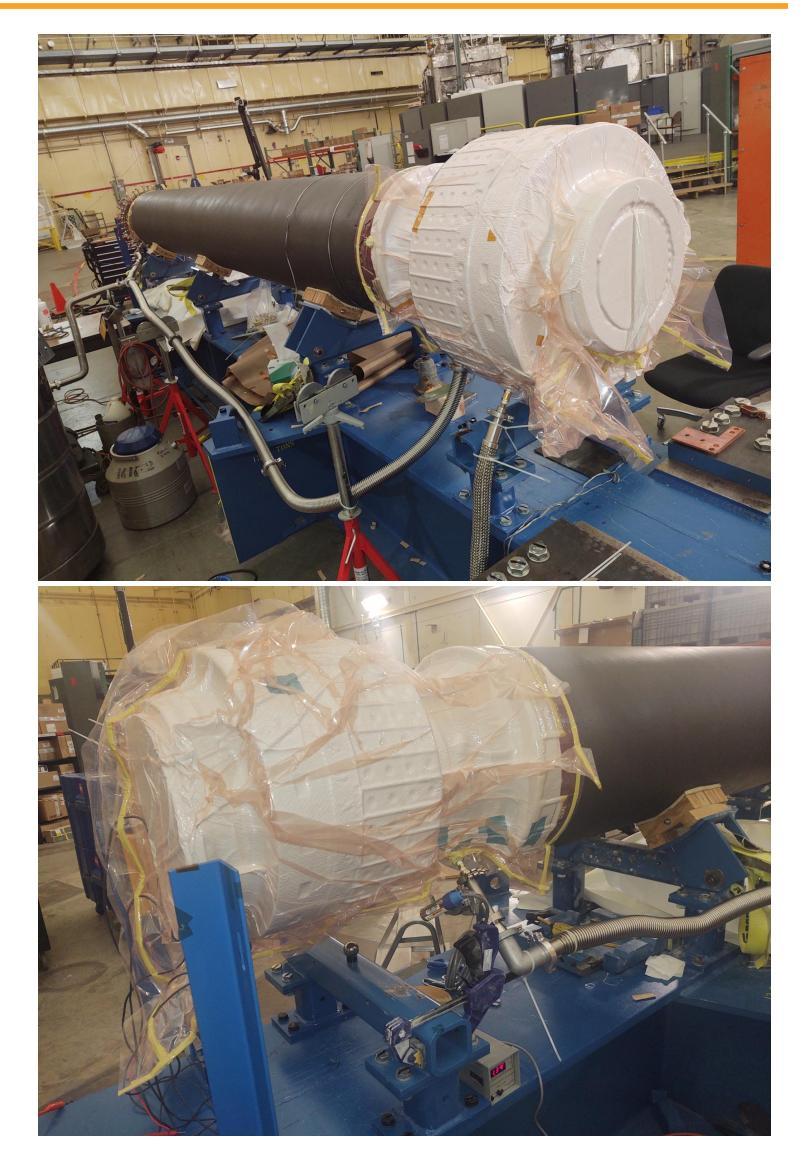
Did a vacuum test for 10 days

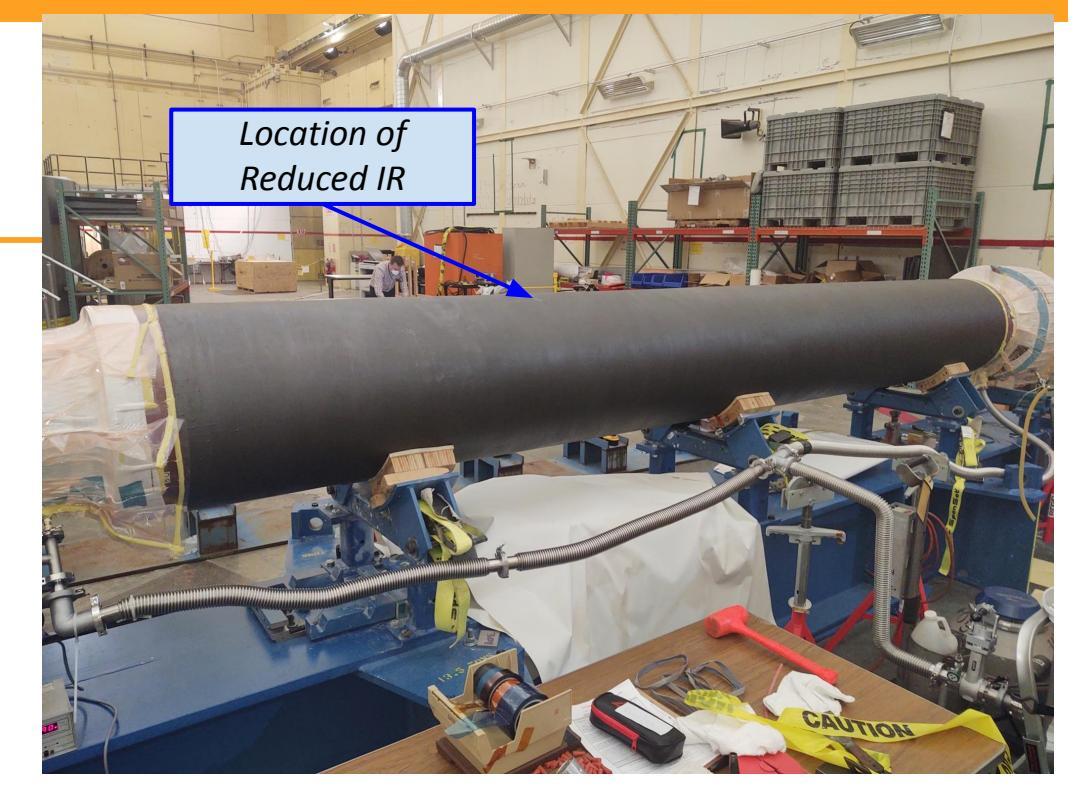
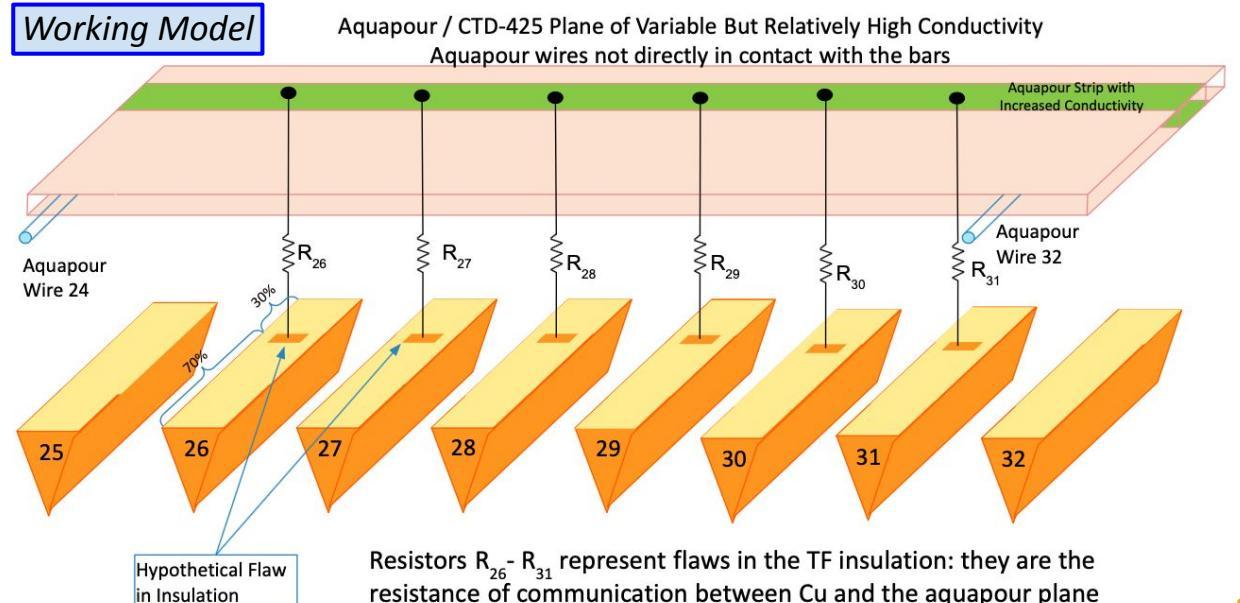
Issue Located - In the OH/TF Gap

- Measurement method developed to locate the flaw axially
 - Method underwent peer review w/ external participants
 - Localized the location of communication between turns to 70% up the bundle.
- Wires embedded in the aquapour found to electrically communicate with the TF Blades.
 - Point of communication is at 70% up the length of the blade.
- The wires appear to be probes, not the root cause.

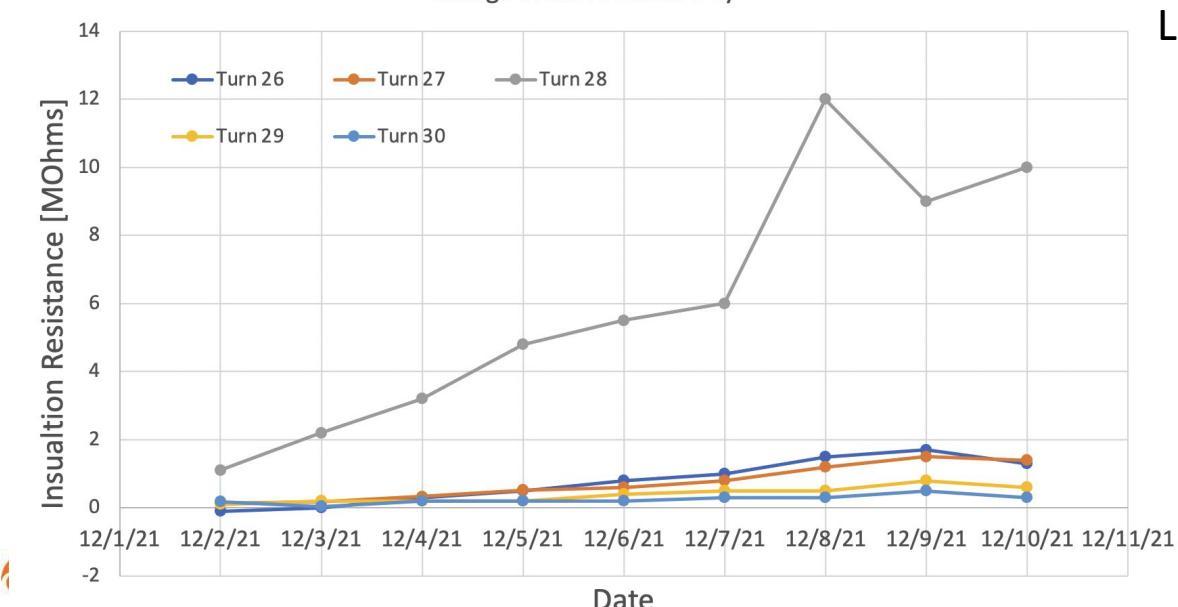
Turn Insulation Resistance Trends During Vacuum Pumping

Turn 26	Turn 27	Turn 28	Turn 29	Turn 30
12/2/21	-0.1	0.14	1.1	0.1	0.18
12/3/21	0	0.17	2.2	0.2	0.04
12/4/21	0.3	0.33	3.2	0.2	0.2
12/5/21	0.5	0.52	4.8	0.2	0.2
12/6/21	0.8	0.6	5.5	0.4	0.2
12/7/21	1	0.8	6	0.5	0.3
12/8/21	1.5	1.2	12	0.5	0.3
12/9/21	1.7	1.5	9	0.8	0.5
12/10/21	1.3	1.4	10	0.6	0.3

Resistance Values (Floating Aquapour Wires)								
	Turn 26	Turn 27	Turn 28	Turn 29	Turn 30			
12/1/21	19.6	9.34	83.2	11.3	9.78			
12/2/21	19.5	9.48	84.3	11.4	9.96			
12/3/21	19.5	9.65	86.5	11.6	10			
12/4/21	19.8	9.98	89.7	11.8	10.2			
12/5/21	20.3	10.5	94.5	12	10.4			
12/6/21	21.1	11.1	100	12.4	10.6			
12/7/21	22.1	11.9	106	12.9	10.9			
12/8/21	23.6	13.1	118	13.4	11.2			
12/9/21	25.3	14.6	127	14.2	11.7			
12/10/21	26.6	16	137	14.8	12			
12/10/21	27.7	17	143	17.4	14.5

Last row after venting

- Isolation of the aquapour wires increased a lot
- Assessing if this gives us any route to retaining the existing OH
- Preparing the means and methods for removal of the OH coil, repair to the damaged TF, and rewind of the OH.
- Developing the procurement strategy for rewinding
