NSTX-U Project: May 2023 Performance + PF-5 Update

Dave Micheletti, Project Director

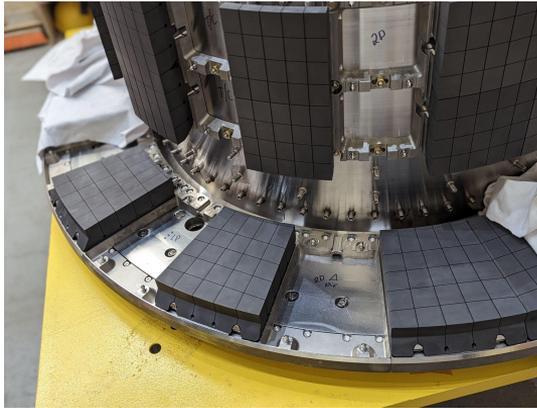
Tile fitups on the casing - including metrology

- Completed a round of tile fit-up on the casing
 - Identified some modest interferences on the frames
 - Metrology checks complete and showed good tile-to-tile alignment.

- Three tiles fractured - assessing the potential causes (excessive preload, etc)
 - Started rounding off some sharp edges on welded brackets inside the casing

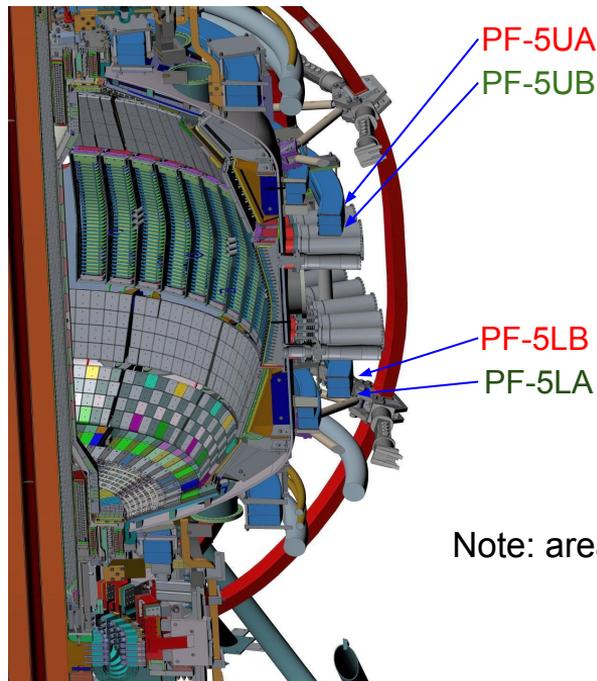
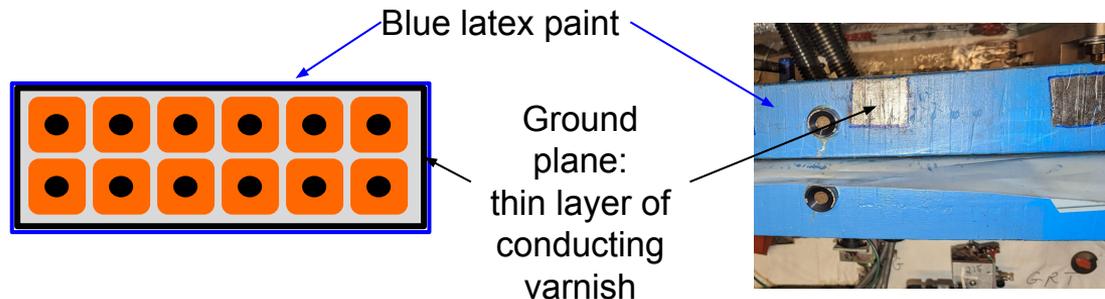
In April 2023 during planned testing, -5UA and -5LB showed ~ 10 s of M Ω s between the Cu of the coil and the ground plane.

Ground plane is a conducting varnish; not required for our voltages and duty cycles.

Note: areas near exposed Cu are sealed with red glyptal paint

While potentially acceptable, this was a substantial deviation from legacy values $> 1 \text{ G}\Omega$

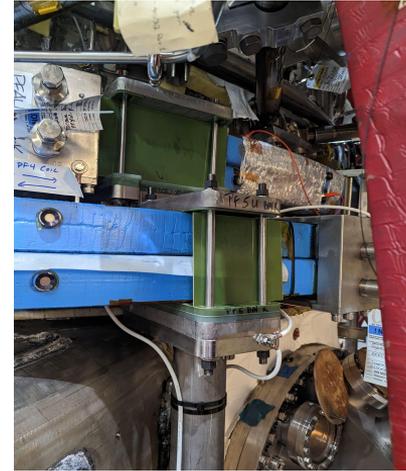
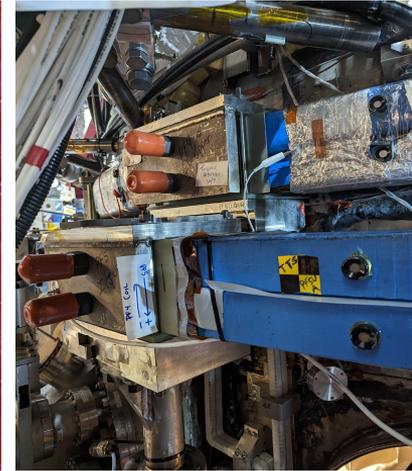
- Leak checked and pressure tested the cooling channels on both coils
 - both passed; believe the cooling channels are sound.
- Inspected around/under the coil support clamps
 - No damage or evidence of an issue found
- Periodic electrical testing on the noted PF-5 pancakes
- Electrical testing of the balance of the installed coils
 - All tested successfully
- Developed a low-voltage electrical test method which provides a rough indication of the leakage location
 - Localization testing provides indication that the leakage is in the vicinity of the current leads

- Localization testing suggested that the issue may be in the vicinity of leads
- Removed glyptal in the vicinity of exposed Cu fittings
- Removed paint and ground plane in the area of interest
 - Frequent insulation measurement provided feedback on whether actions were providing beneficial results
