**CICADA  
ENGINEERING  
SPECIFICATION**

DOCUMENT NO.  
TFTR-10B4-H404A

Timing Module Type 404

## 404A Timing Module Test, Green-Dot Modification, and Repair Checklist

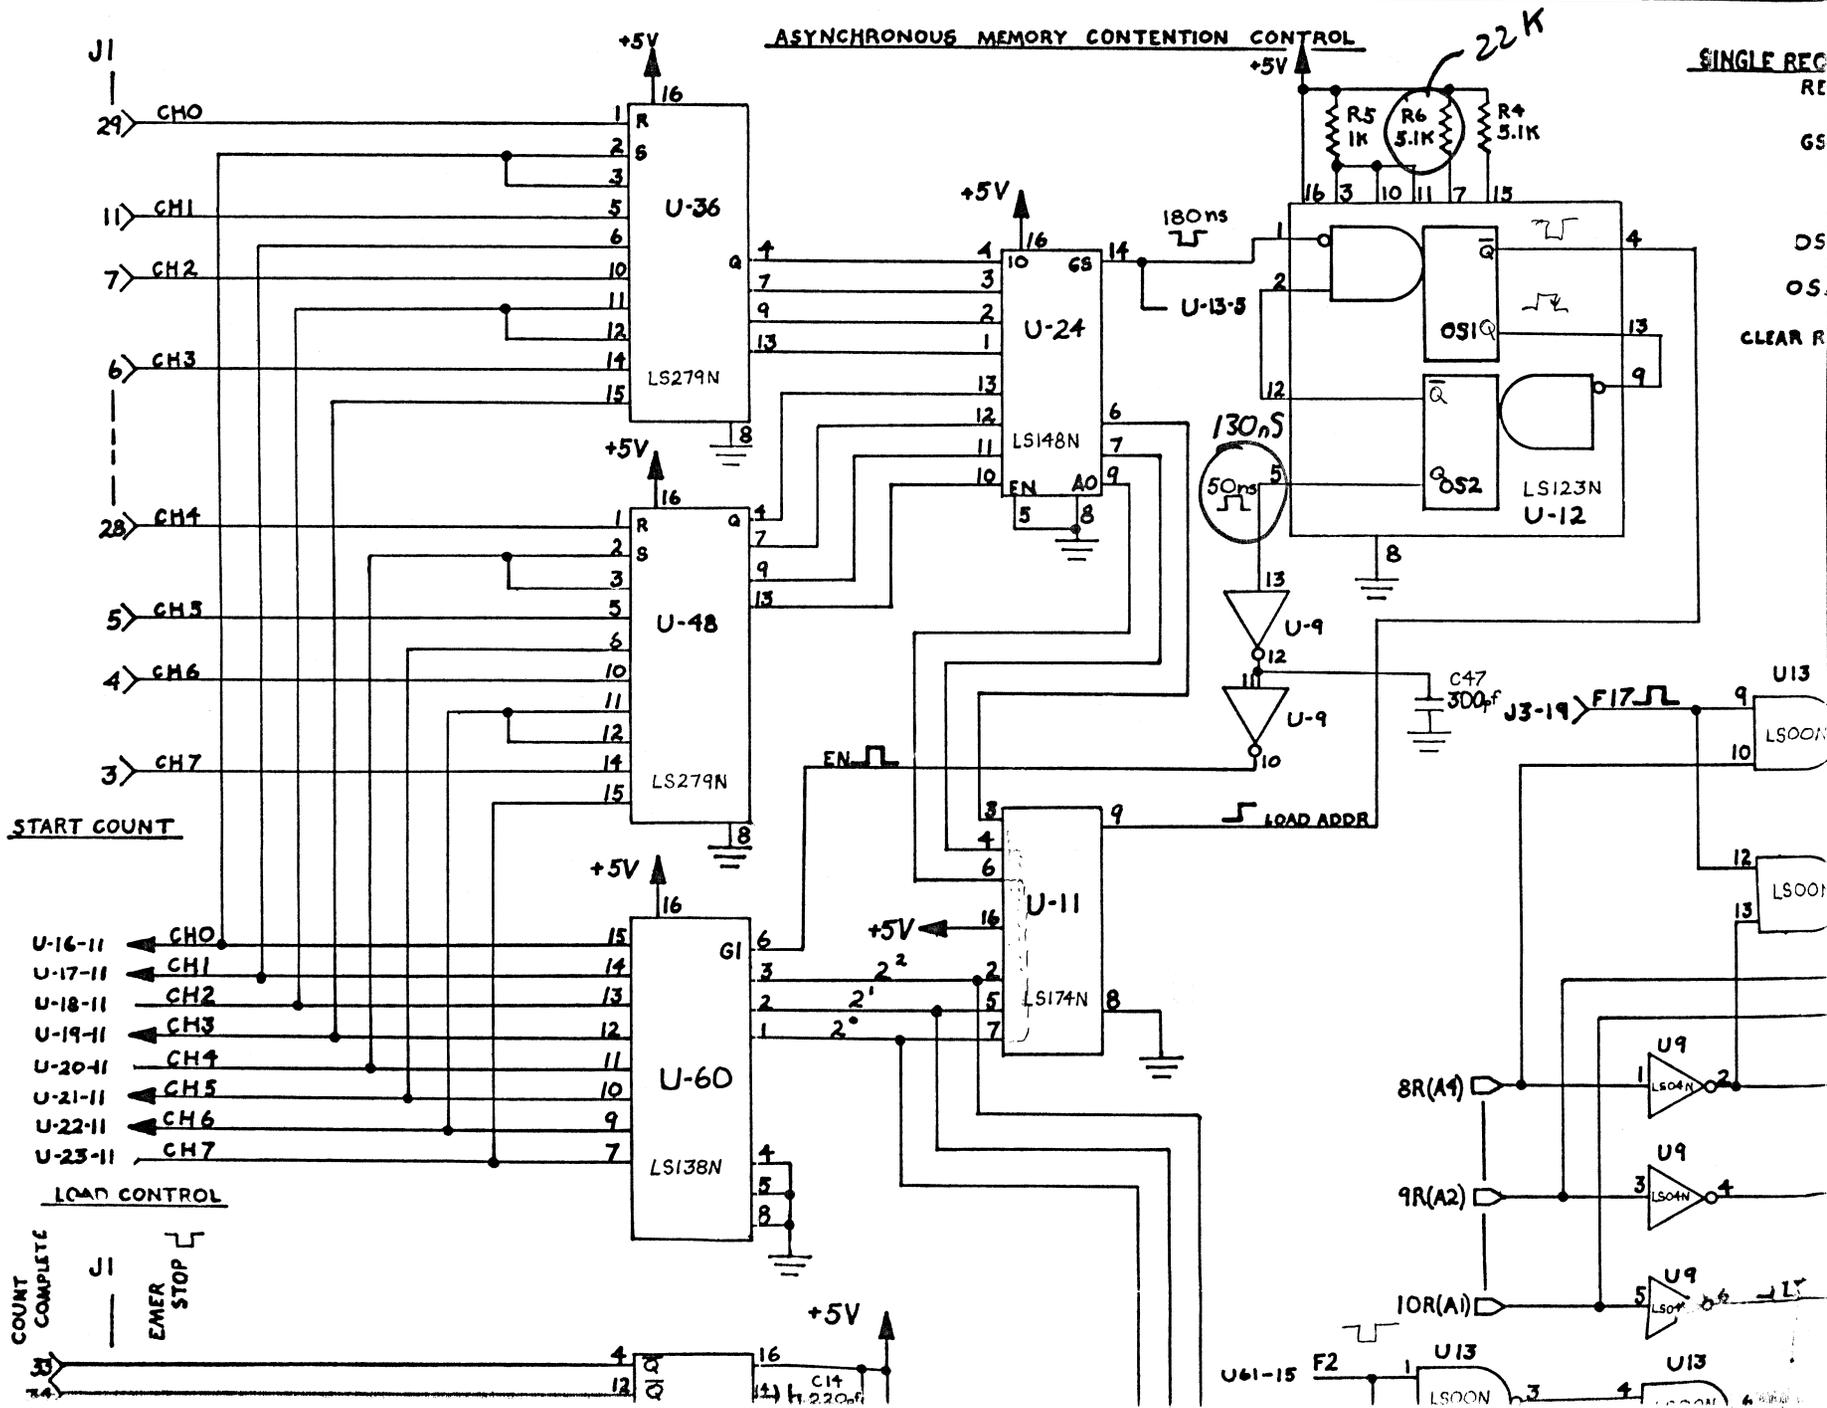
H404A TIMING MODULE BOARD 'A'  
11-4-86 P.S

When (1) and (2) happen, CH8's delay counters are inadvertently reloaded. The reloading of CH8's delay counters is due to an extraneous pulse in the H404A circuitry. The pulse is due to a race condition in the logic design.

A solution to this problem is to alter the timing of the appropriate circuitry on the H404A module. The alteration will extend the duration of a pulse generated by IC12-5 on Board A. The pulse is extended from 50 ns to 100 ns by changing R6 from 5.1 Kohms to 22 Kohms. This change will slow down the scan-and-load process for the timing module. At worst case, when all eight channels recognize the same event code, CH1 and CH8 can be skewed by an additional 1 microsecond. I estimate that the module upgrade will expend two technician hours. (retrieve, upgrade, test, install).

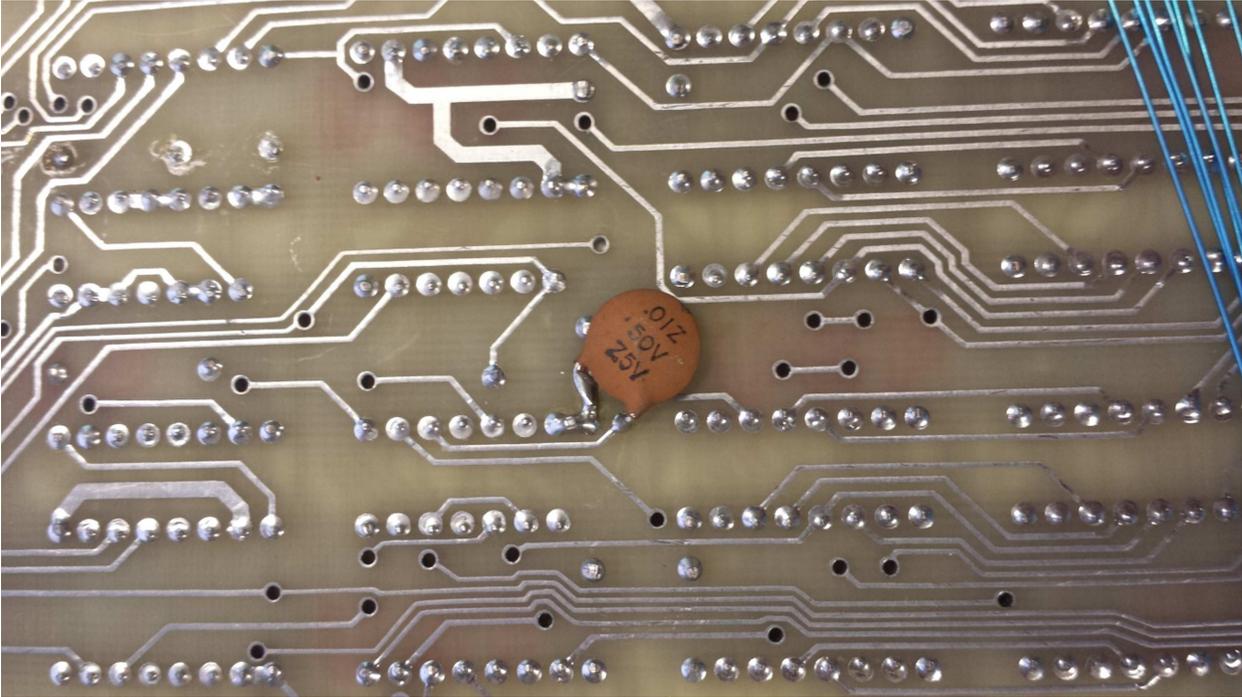
Picture 1

U29 0.01uf capacitor pin 3 to ground on B board (solder side, see picture 1)

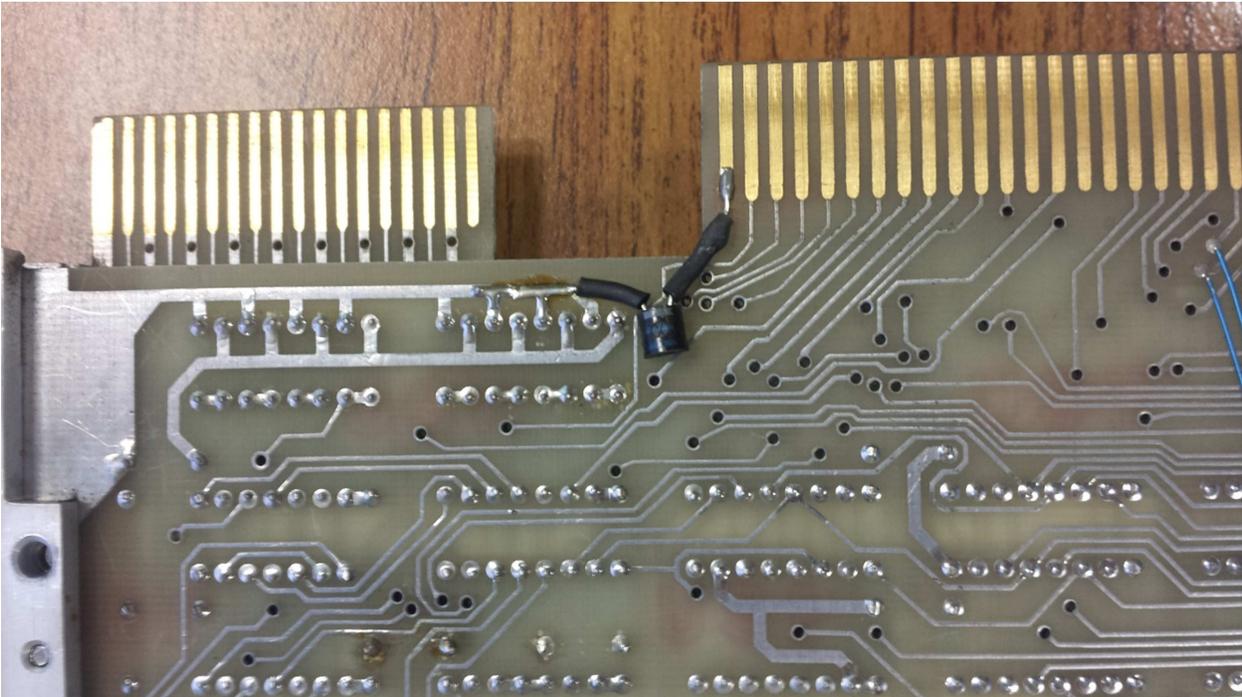
Picture 2

Schottky diode (Motrola MBD501) from dataway pin 1R (BUSY) to ground on B board. (Anode goes to ground) (See Picture 2)

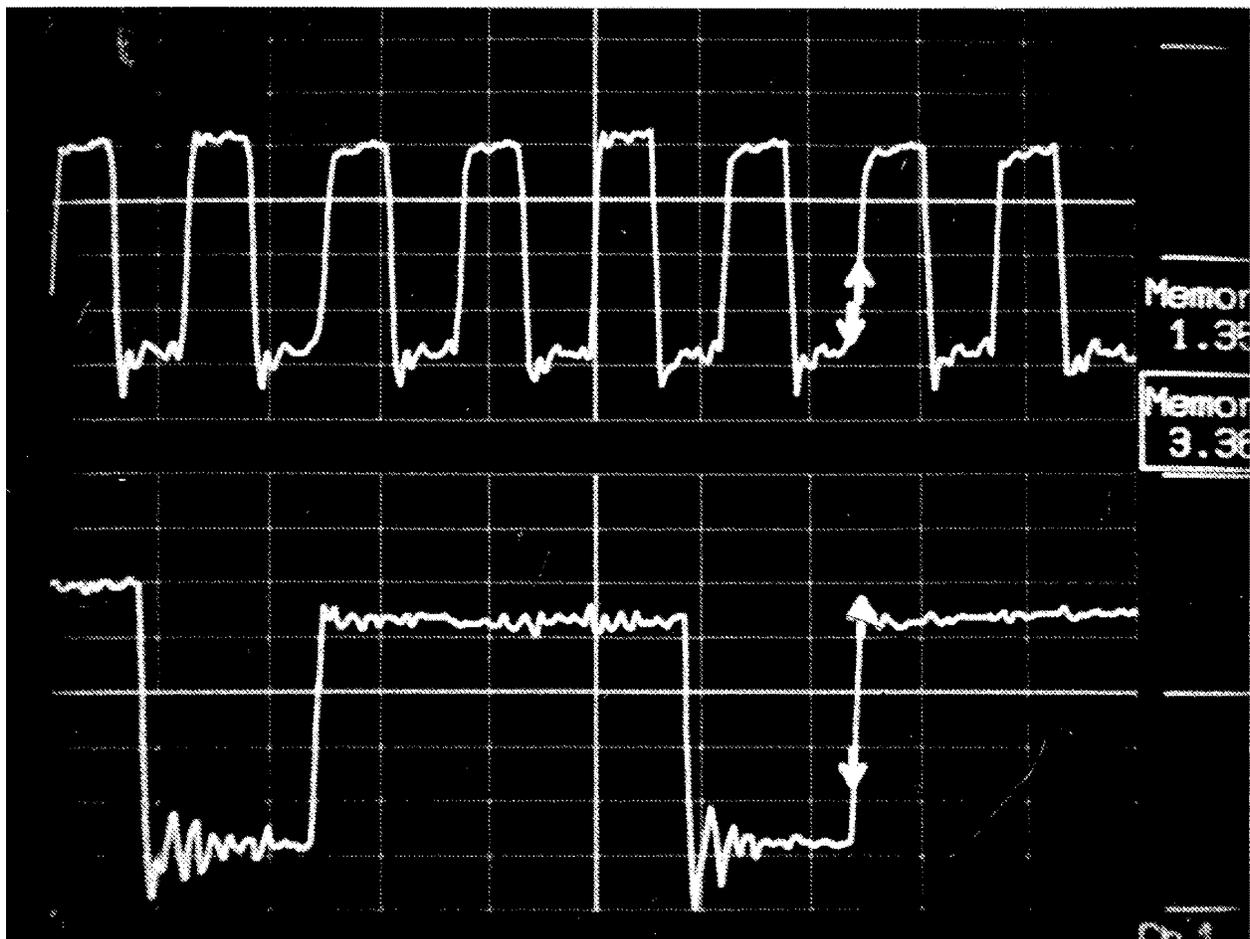
## PROPER TIMING OF 404A R6 BOARD A (LEFT)

Top trace=U60 pin 6 (Enable for 74LS193 load input, going through 74LS138)

Bot trace=U64 pin 5 (74LS193 Clock input)

.2uSec/Div, 1V/Div

The bottom trace is not allowed to go through any transition unless the top trace is low. The rising edge of the bottom trace may line up with the rising edge of the top trace, but must not happen immediately before it. Top trace=4Mhz, 8 pulses. This timing can be adjusted by changing the value of R6 on the "A" board. It is always best to start with 22K, then adjust as necessary. It is OK to use 1% precision resistors to fine tune this timing if 5% resistors don't achieve the proper timing. 1% resistors come in more standard values than 5% resistors, so it is more likely to find just the right value that works.
