NSTX Facility/Diagnostic Status

DOE OFES NSTX Quarterly Review

July 15, 2004

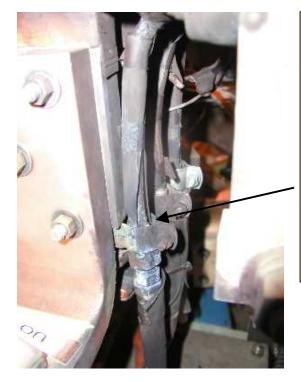
TF Buswork fault occurred on June 25th

• Fault (arc) occurred between the buswork of two TF turns.

• A circuit model explained the fault behavior

No damage to coils

Recovery was relatively quick:
Area cleaned and coils highpot tested following day
Arc likely initiated due to a small water leak in the outer TF
Water leak problem addressed and electrical insulation enhanced including

- Facility Issues:
 - The TF buswork arc incident was resolved relatively quickly
 - New TF joint data and analyses identified some concerns
 While working to resolve those concerns. TF operation limited to 1 3 kG m

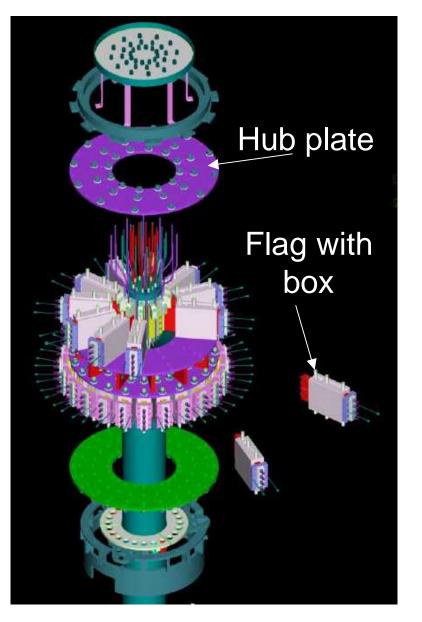
TF Joint Behavior Has Been Monitored and Studied Throughout the Run

- Resistance of all joints has been monitored throughout the run.
- In January, an integrated system test was conducted to qualify the machine.
- The results of the tests indicated that the resistance of the joints was <700n Ω at 4.5kG and the temperature rise was in accord with expectations.
- However, a closer examination of the data raised some questions requiring further analysis.

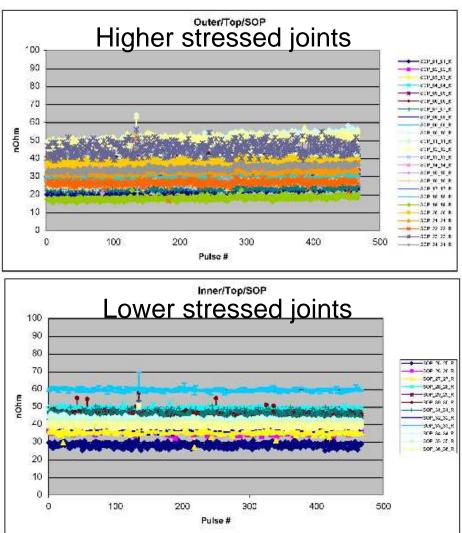
"Start-of-Pulse" Resistance

New Data and Analysis Has Identified Some Concerns About the TF Joints

- Small gradual upward drift in the joint resistance has been observed during the past month.
 - Below 700 n Ω .
- Temperature and strain gauge measurement also reveal apparent reduction over time.
- Recent, TF-flag displacement measurements show larger movements compared to design values.
- New simulations and bench test indicate the resistance measurement is consistent with larger than expected joint "liftoff".

To assure safe device operation, our highest priority, we instituted last week TF operational limit of 3 kG (joint resistance at all time < 150 n Ω) until we complete additional analysis.

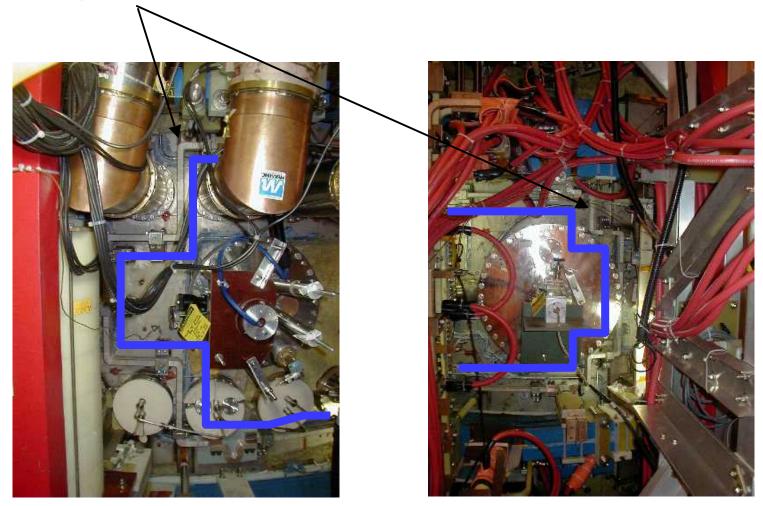
F(04-2) Fabricate Resonant Field Correction Coil System (September 2004)

• Two RWM coils successfully installed and commissioned. Experiments to start shortly.

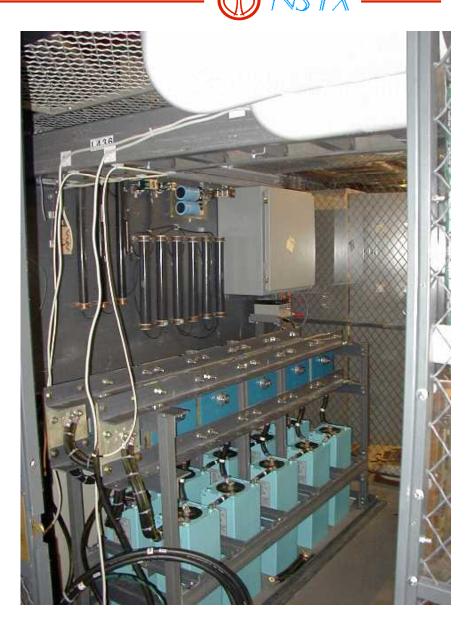
F(04-3) Implement Capacitor Bank for Transient-CHI Start-Up (May 2004)

Status: To be completed in July (2004) • Installation complete. Power test to begin shortly (this week) and experiments planned next week.

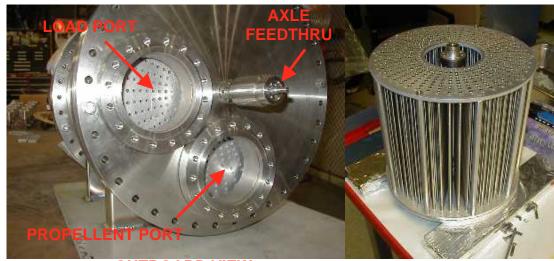
OUTBOARD VIEW

Lithium Pellets successfully Injected into NSTX NBI and Ohmic Discharges

• Solid & powder (micropellet) injection capability

- Radial injection, 10 m/s to 200 m/s
- Capacity 400 Pellets, 1 to 8 pellets per discharge
- Variable mass per pellet (< 1 mg to 5 mg)

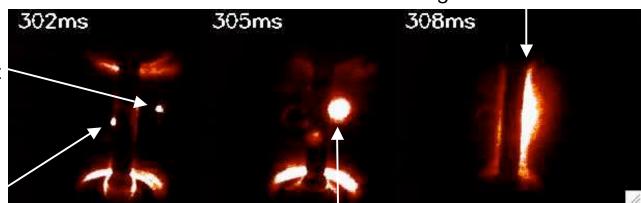
Lithium vapor spreading along the center-stack

Lithium Pellet entered plasma at 296 msec moving through plasma

In-board gas injector

400 BARREL TURRET

Lithium "vapor ball" approaching the center-stack

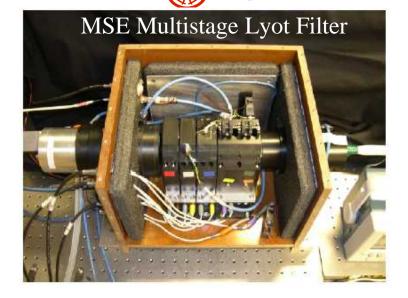
•D04-1: Install and operate a 10 channel Motional Stark Effect (MSE) diagnostic (Novastar) based on the collisionally induced fluorescence (CIF) from heating neutral beams (September 2004) Four channels are presently operational. Currently limited to 4 channels due to a vendor problem.

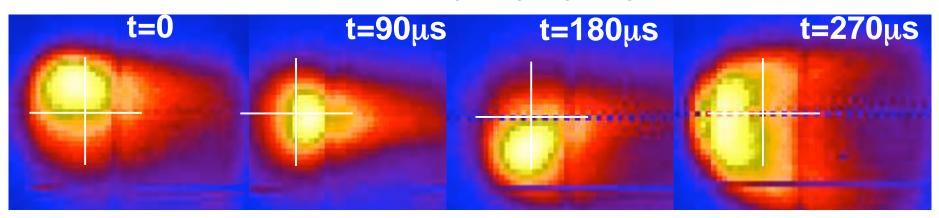
D04-2: Install a fast camera system to provide two dimensional images of the soft x-ray emission viewed along tangential sightlines (April 2004)
 Completed in March 2004 Producing intriguing images at 10 μs frame

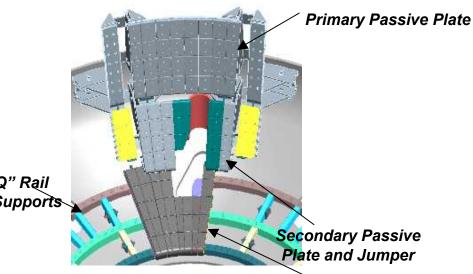
•D04-3 Prepare for installing the new poloidal charge-exchange spectroscopy (P-CHERS) diagnostic and for upgrading the time and spatial resolution of the edge rotation diagnostic "BBQ" Rail Plate Supports (September 2004) On schedule.

Looking Down At Bay-A Lower Outboard Divertor Through Passive Plates and Outboard Divertor

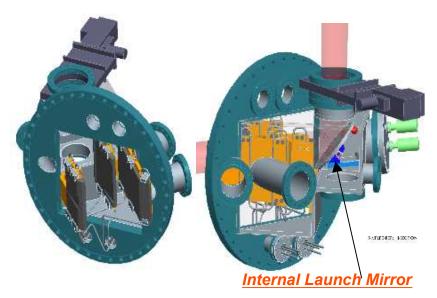
• D04-4 Assemble and test microwave sources and other components for a diagnostic system to measure shortwavelength plasma turbulence by scattering from the plasma density fluctuations. (September 2004) On schedule - Collaboratrion with UC Davis
