Be/C layer appears to form 'beads' in response to heat flux.

Thermal response of Be/C material:

Thermal response of ion damaged tungsten

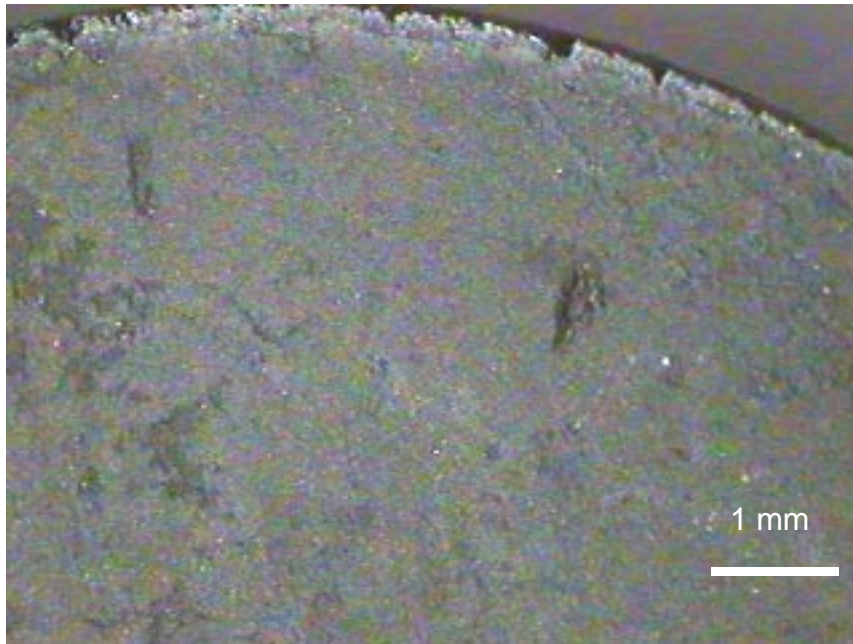
JET tile IN3-16 (vertical tile, inner divertor) before Nd laser scan

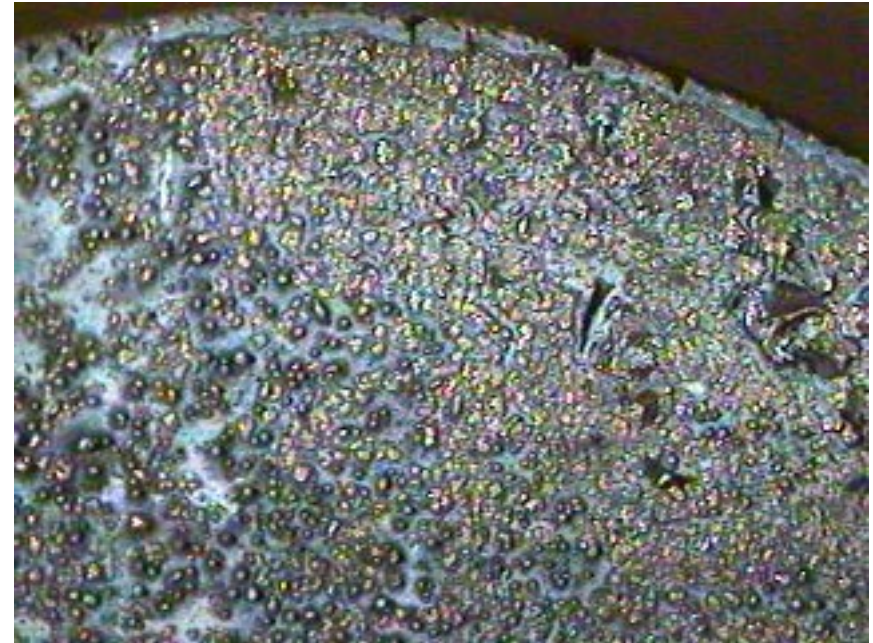
After laser scans

'Globules' of Be formed after laser heating.

21 temperature excursions above 1000 C, peak temperature 2,100 C.

Subsequent scans at same laser power and speed resulted in lower temperatures (1,601 C then 1,314 C) as layer became more thermally conducting similar to the manufactured material.

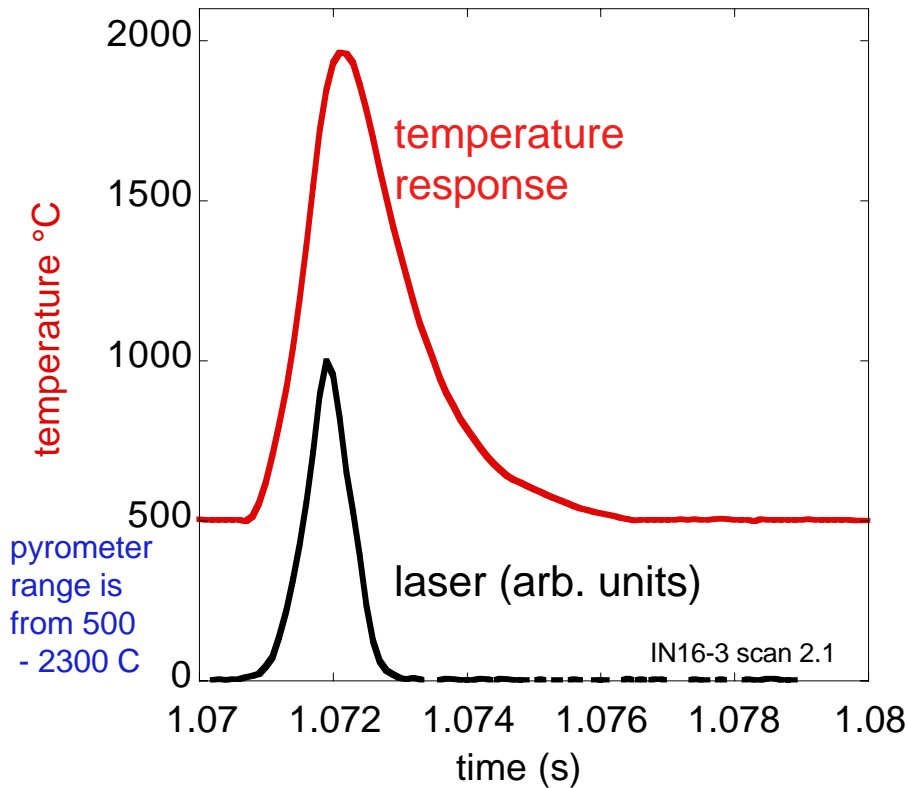
1st laser scan.
Duration over point 0.8 ms FWHM
temperature rises to 1963 °C.

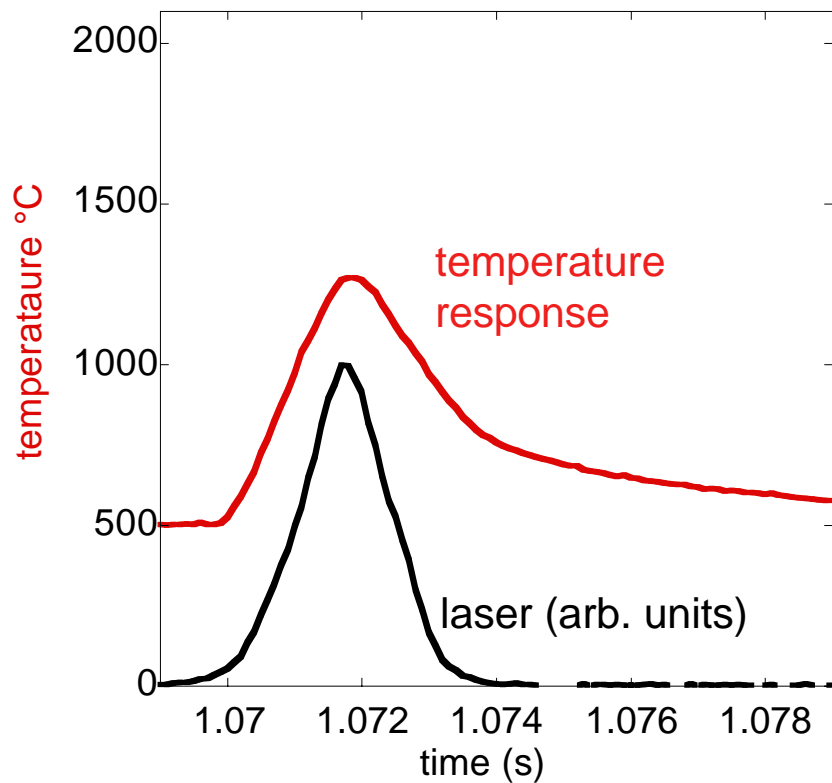
20th heat pulse over same area.
scan speed reduced x2; pulse 1.6 ms.
temperature rise only 1270 °C

- surface has changed....

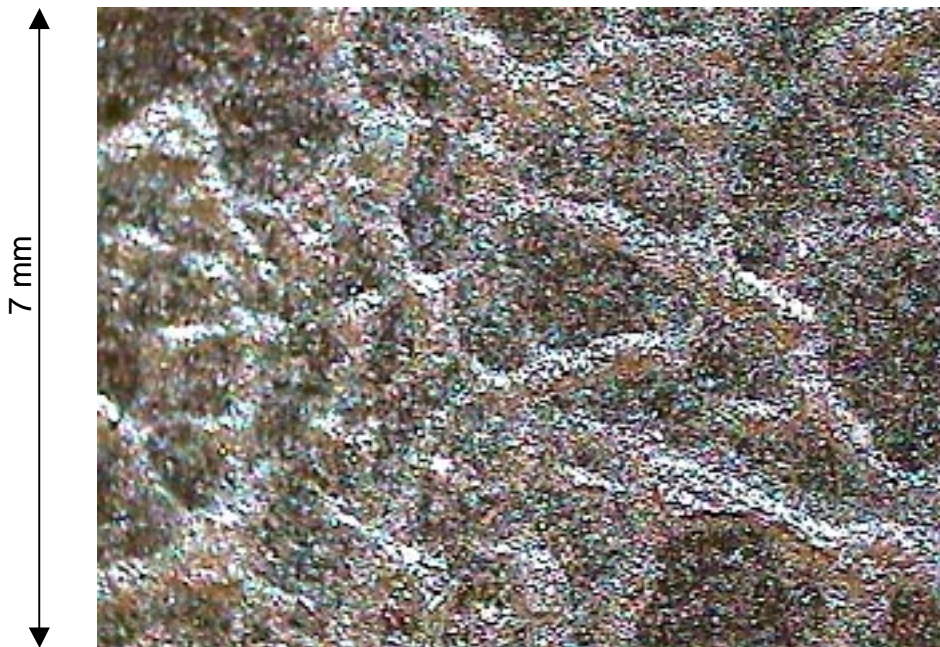
W sample implanted with $1e21$ D @ 200 eV
(courtesy of J. Roth).

low power x4
optical microscope

Ion implantation features change thermal response.
- PFC surfaces manufactured by tokamak and
may not have same properties
as factory-manufactured material.

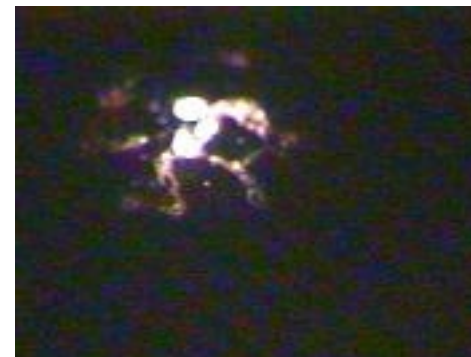
Use scanning Nd laser to transiently heat
(laser has smooth focal spot)

During laser scan

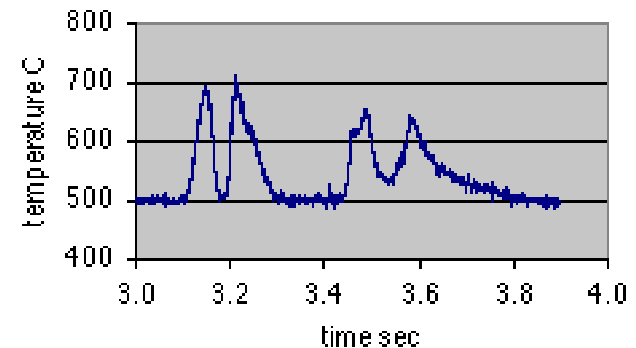
200eV D+ 1e21 raster 1 zone 1 speed 100
