# ***OH Coil Cooling Tube Arc Failure Path to re-assembly and Re-commissioning***

**Team Meeting  
2015/05/01**

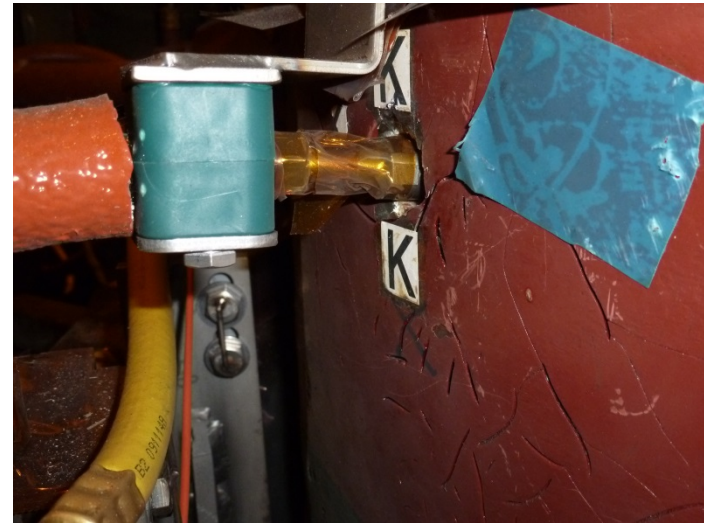
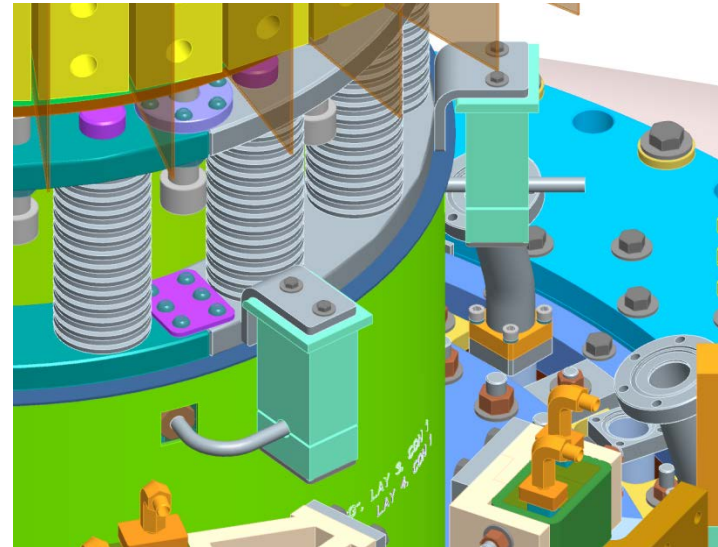
# OH Cooling tube clamps

- Clamps reconfigured so that there is larger clearance between energized and grounded components
- New G-10 disk (the blue ring) Installed between the OH coil and the OH compression stack will provide better electrical standoff for both line-of-sight and tracking path length.
- Kapton tape will be applied on all the grounded metallic surfaces that face the cooling tubes
