National Spherical Torus eXperiment Upgrade

Recent Technical Events

NSTX-U Team Meeting – September 20, 2019

Outline - 5 reviews & 5 slides

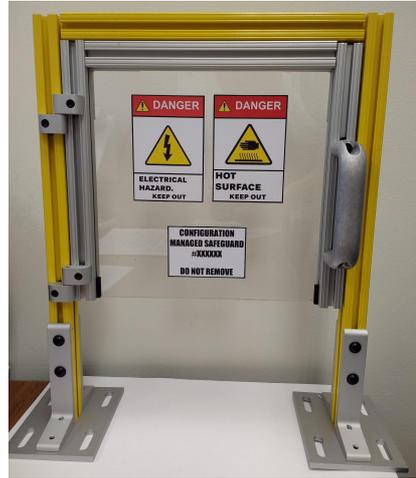
1: Configuration

Managed Safeguards - mitigate contact thermal and electrical hazards

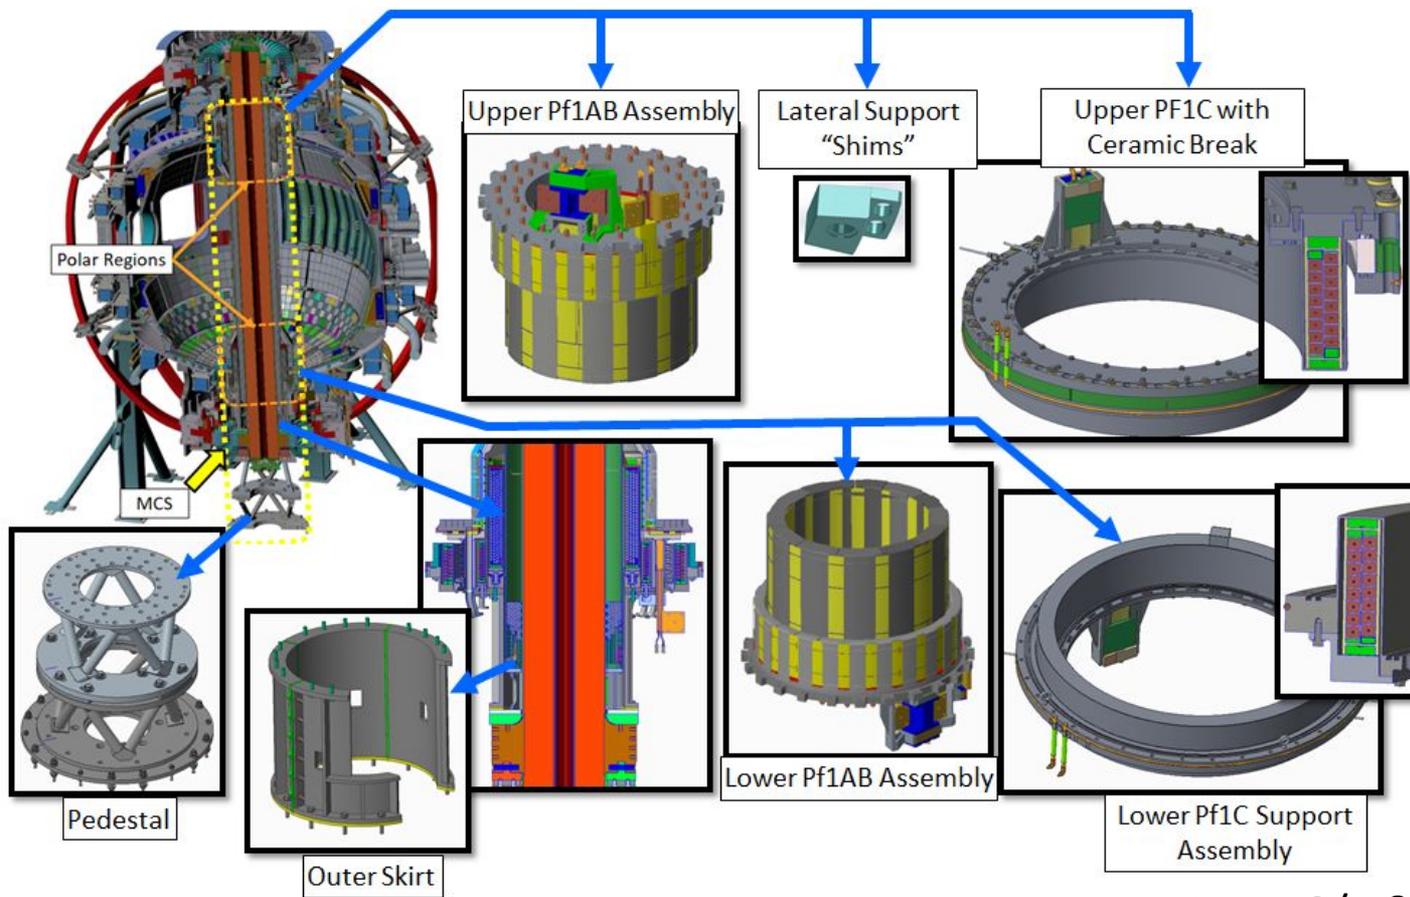
Machine Core Structures Design Validated in Final Design Review

Scope:

- PF-1a & -1b Sling assembly
- Lateral Support Shims
- Upper and lower PF-1c assemblies, including double O-ring seals and ceramic breaks
- New outer skirt
- Validation of existing pedestal.

Loads:

- Thermal during bakeout or operations
- Operations static and transient loads
 - vertical loads
 - side loads

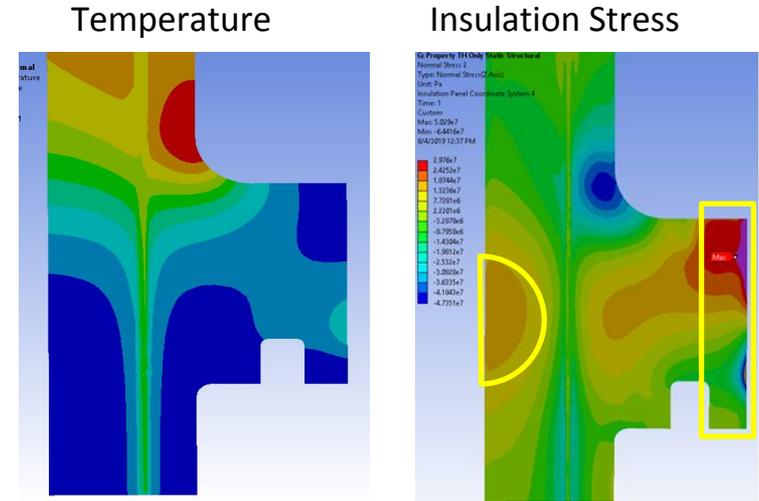
Inner-TF Bundle Concerns Resolved at Bundle Review #2

- Concern - temperature gradients in the Cu of the bundle result in insulation stresses
- Extensive sample testing done
 - PPPL coil shop fabricate samples
 - Tested at PPPL and Element
- Extensive analysis done

Conclusion:

Delamination will occur, but the GRD shot spectrum can be achieved

- The delamination will be limited in extent
- The delamination will not create electrical concerns in the flags and bus work
- The delamination will not result in over-stress conditions for other components

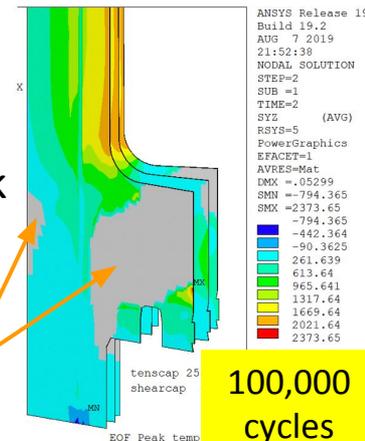
Predicted Region of Delamination

100,000 cycles

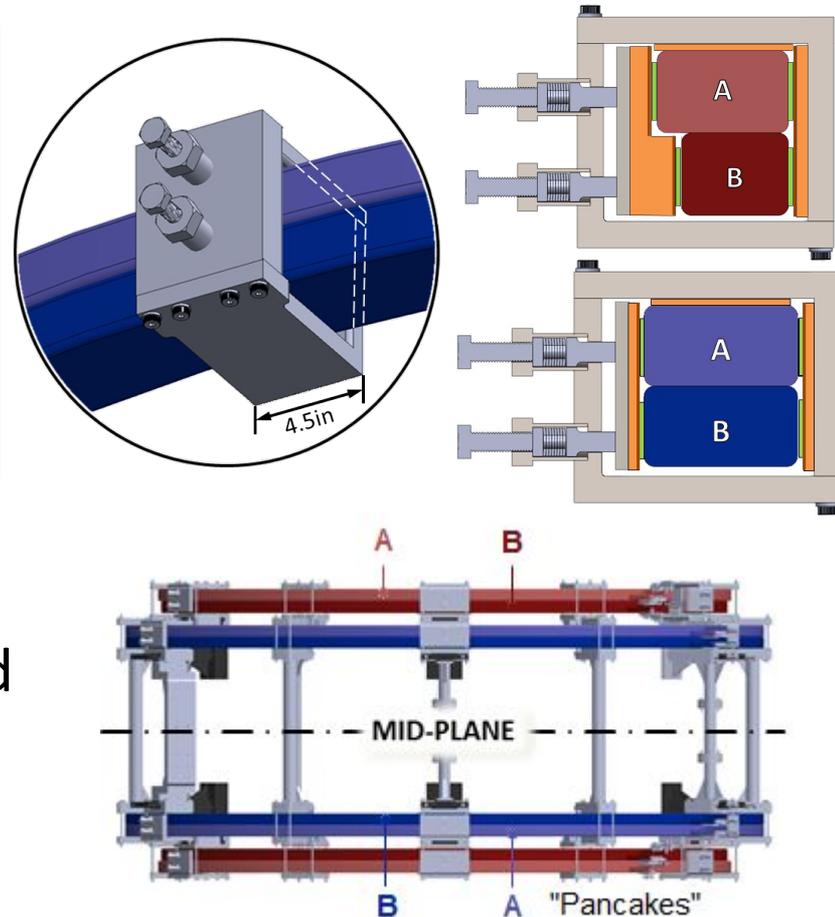
New Clamps on PF-4 and -5 Will Ensure Alignment is Maintained

- Recent metrology shows that the individual “pancakes” of PF-4 and PF-5 are acceptably aligned to each other, but the pairs need to be shifted/tilted.
- Clamp design will ensure that pancakes maintain required alignment
- Coils pairs will then be shifted/tilted into alignment with global coordinate system

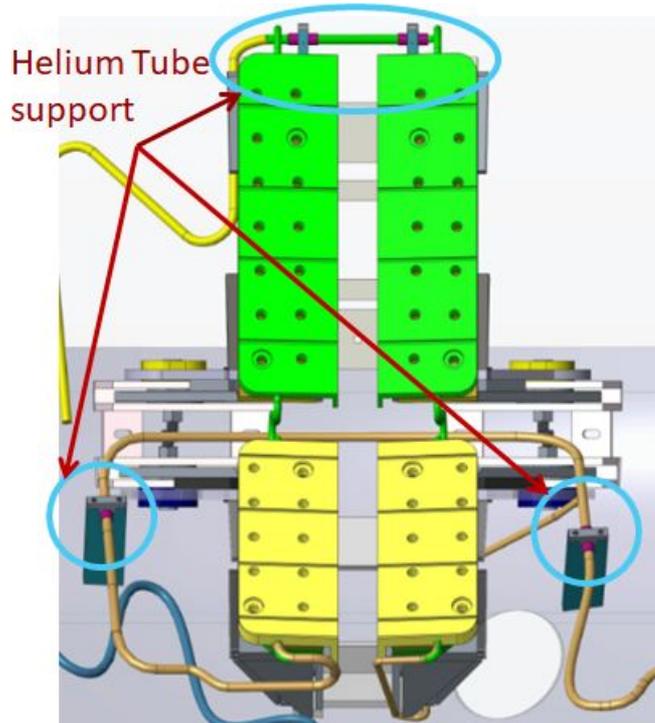
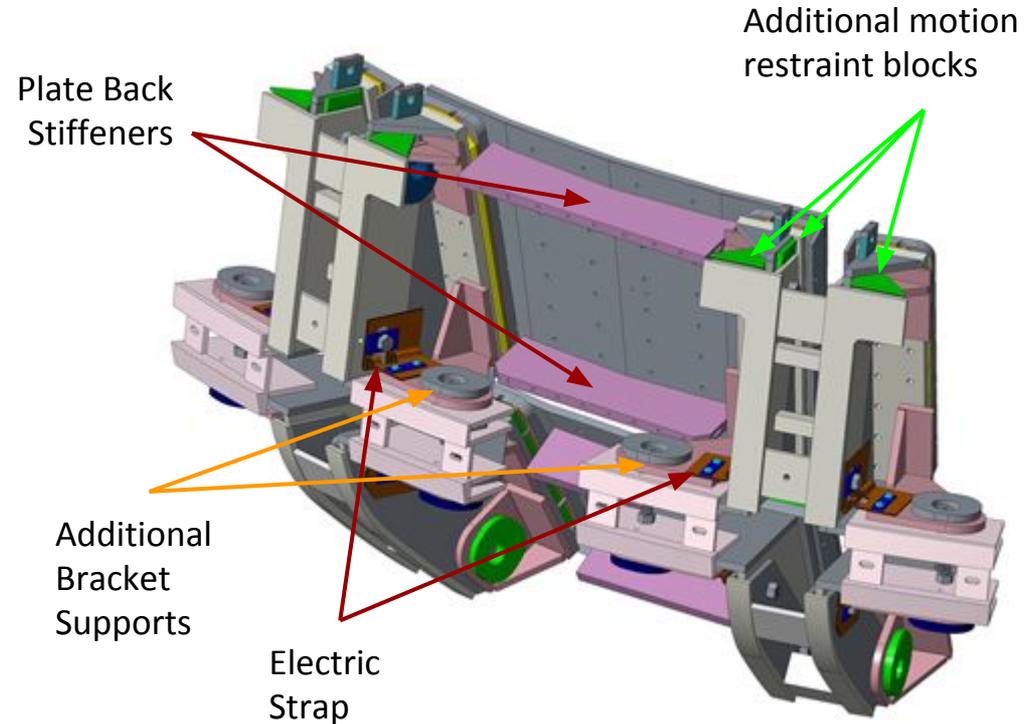
Passive Plate Review Showed Targeted Modifications Can Fix Brackets Against Disruption Loads

Solutions can be implemented w/o in-vessel grinding, or modifications to He tubing
