# National Spherical Torus eXperiment Upgrade

## PFC Diagnostics & I<sub>P</sub> Rogowski WBS 1.04.01.02 & 1.04.01.04

NSTX-U Recovery Project FDR – March 17-19, 2020

PFC Diagnostics - Brent Stratton

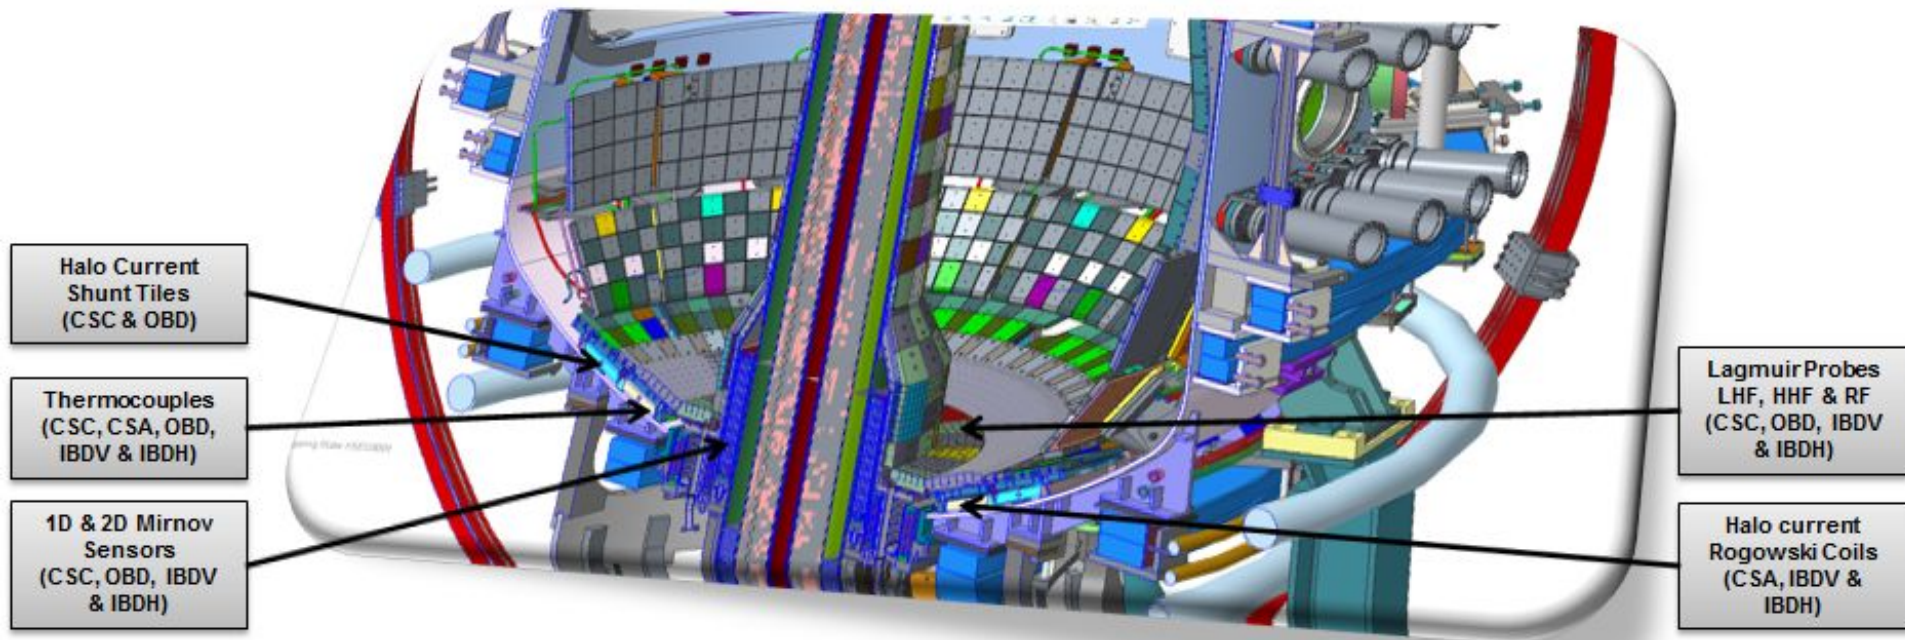
All sensors replicated on the machine top as well

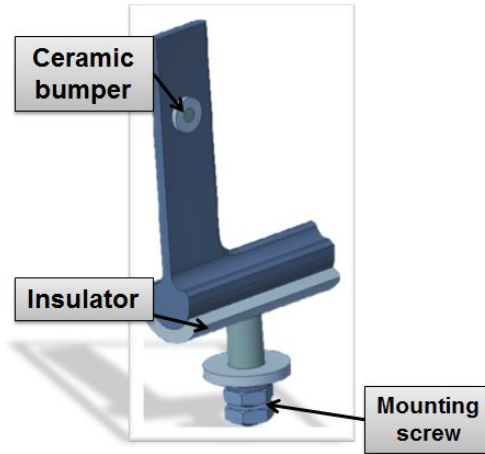
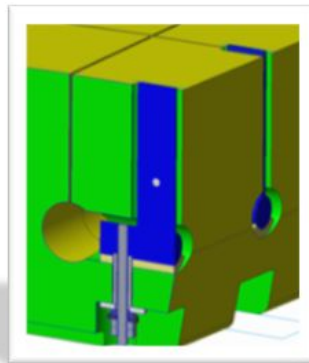
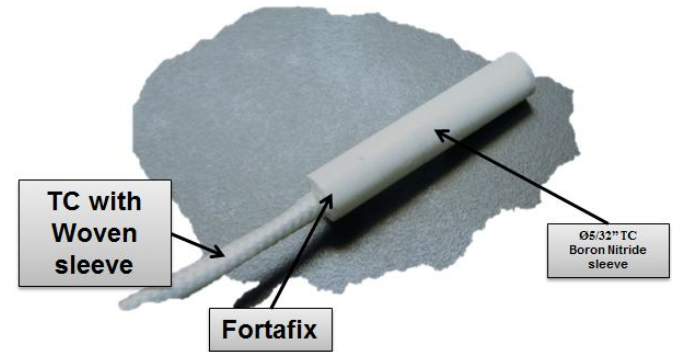
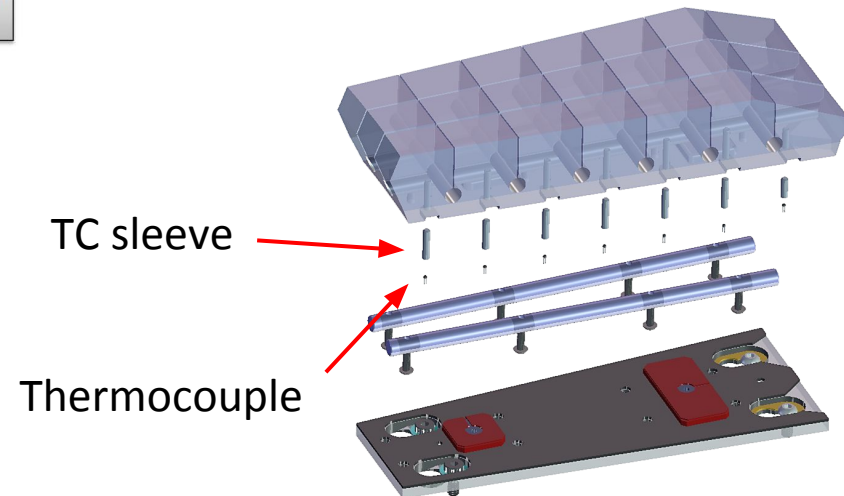
# Langmuir probes and Thermocouples have been updated

- “Rail probe” design for Langmuir probes on high heat flux tiles. (OBD rows 1-2, Inboard Divertor)
- Thermocouples have increased (500V) standoff

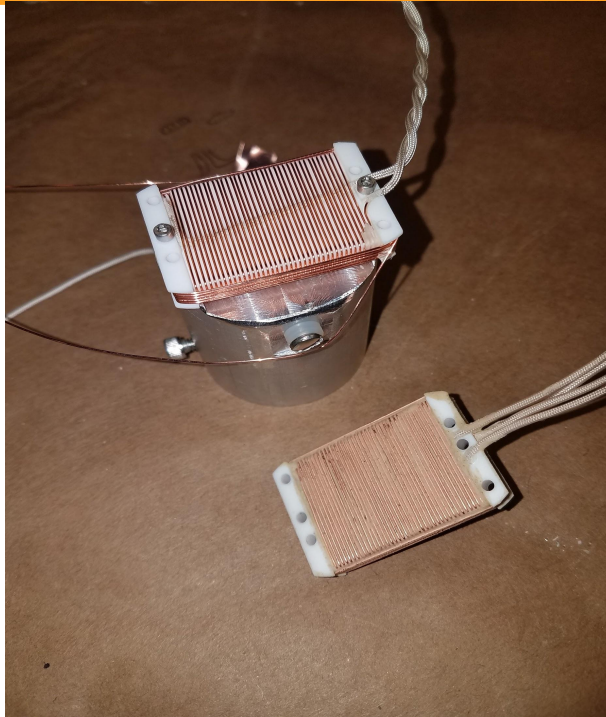
2-D Mirnov Sensor Winding

- Mirnov sensors have return wire under tangential windings.
  - Reduced height
- Grooves to center the windings
- Use of high temperature cement to prevent conductors from touching

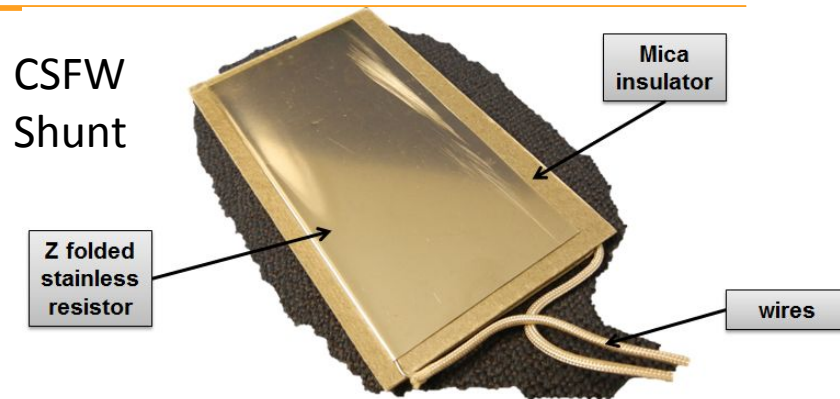
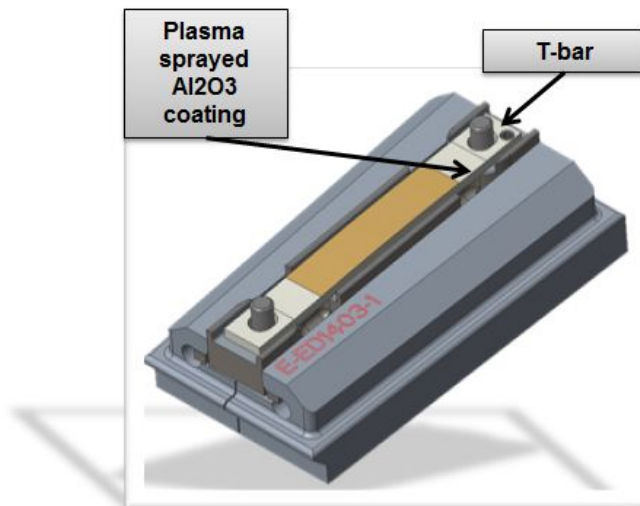
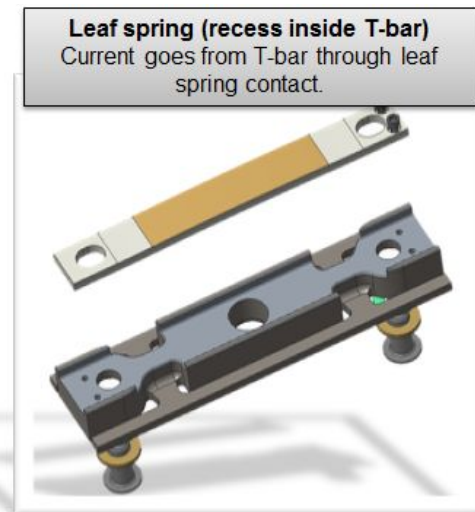
# Halo current shunts are updated

- Halo current shunts on the **C**enter **S**tack **F**irst **W**all tiles resemble previous version.
- New design required for OBD row 3-4 tiles.

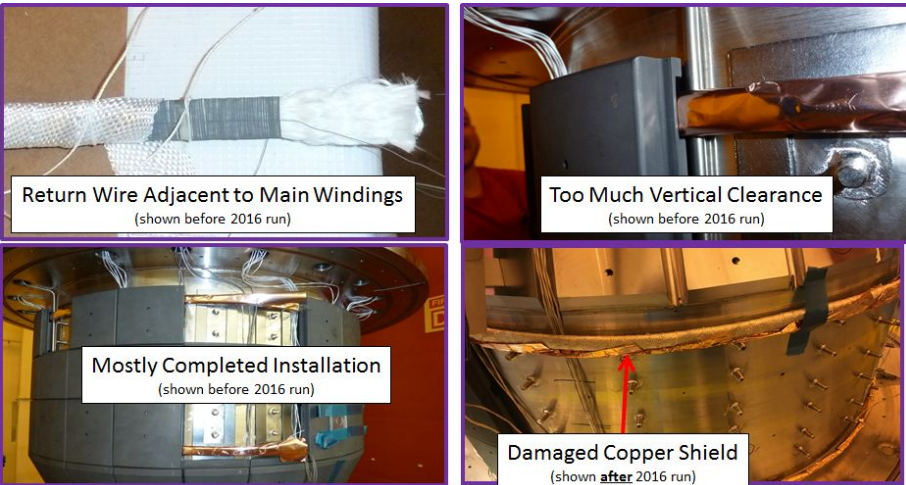
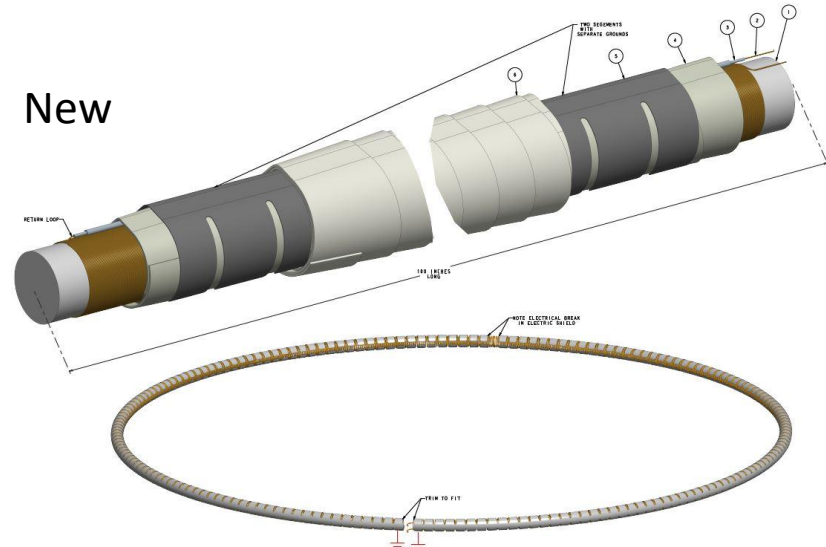
# New design for center stack halo current Rogowski coils

- Addresses problems with previous version.
  - Double fiberglass sleeve on return wire minimizes risk of short circuit.
  - Stainless steel electrostatic shield reduces electromagnetic force by factor of  $\sim 50$ .
  - Electrostatic shield is sandwiched between two layers of fiberglass wrap.
  - Motion of coils is constrained.

# Design Assurance: New CS halo current Rogowski coil

- A prototype has demonstrated feasibility of assembling and winding the coil, and fabricating the shield.
- Torsional stiffness was measured.
- Influenced decision to use stainless steel shield.
- Over wrapping of the shield, along with reduced force and constrained installation, will prevent the failure exhibited earlier.

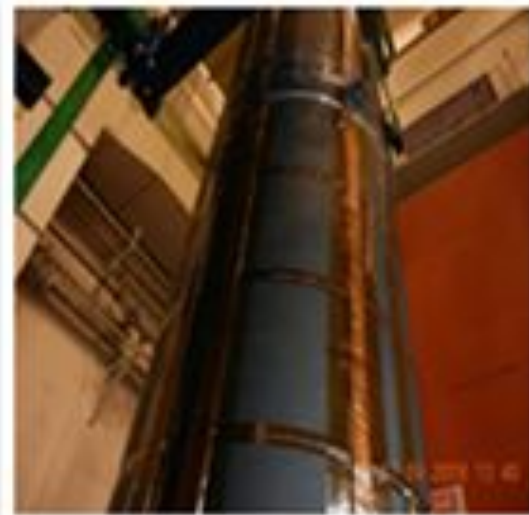
Rogowski sensor installed on CS

- Build a replacement set of plasma current ( $I_p$ ) Rogowski sensors
  - Old sensors were physically damaged during CS assembly.
  - Inadequate clearance between Center Stack bundle and CS casing.
  - Function was not impaired.
- Rebuild with identical design, ideally use the same vendor.
- New toroidal placement and larger inside diameter of CS casing minimize the risk of sensor damage.

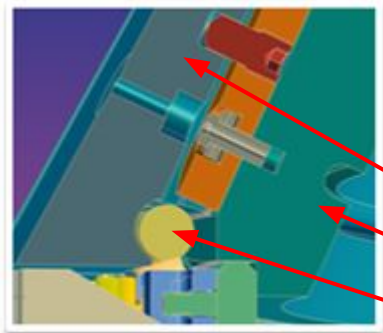
Halo Current Rogowski  
Coil Interfaces to CSAS

CSAS tile

CSAS Structure  
Rogowski Sensor

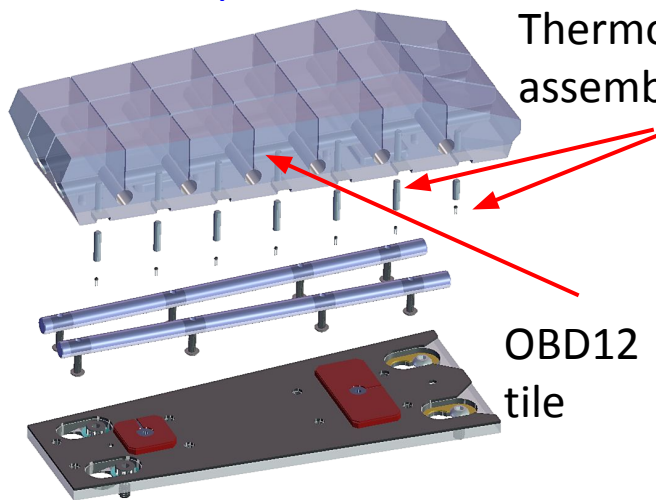
Thermocouple to Tile

Thermocouple  
assemblies

OBD12  
tile

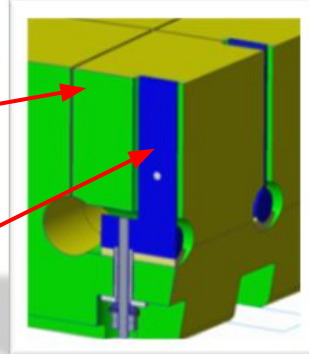
Langmuir Probe to Tile

tile  
castellation  
probe  
assembly

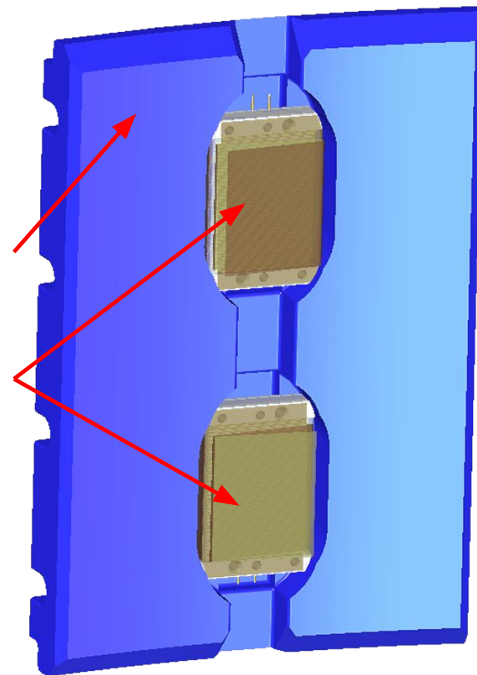
Mirnov Sensor to Tile

CSFW  
tile

Mirnov  
Sensor

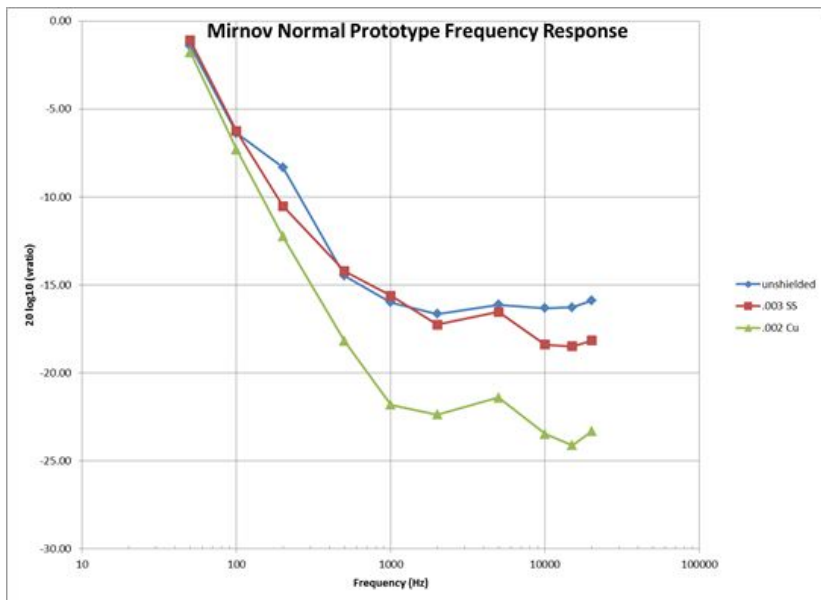
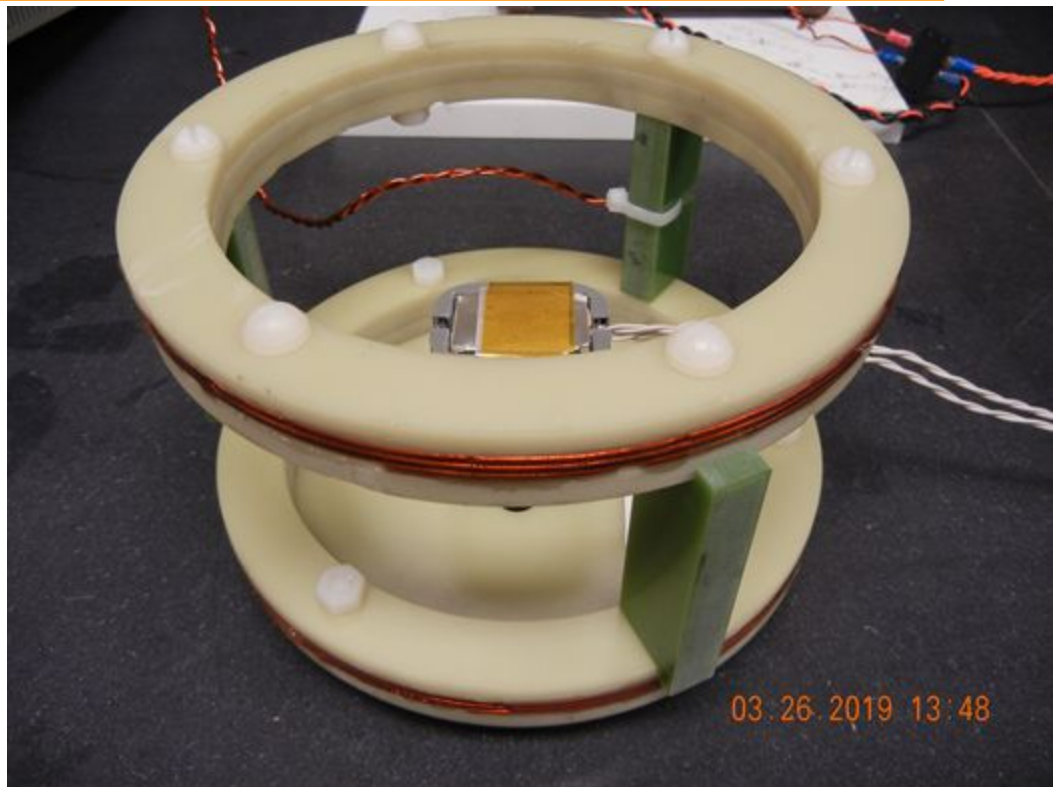
# Design Assurance: Mirnov sensor prototype tests

- Tested at varying frequencies, with a variety of electrostatic shields, in Helmholtz coil.
- Checked for short circuits between tangential and normal windings.

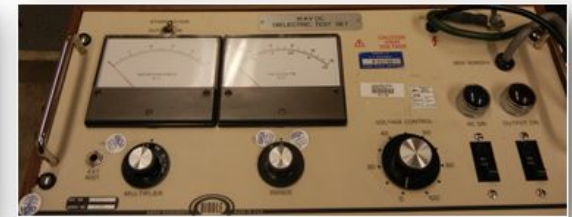
## Hi-pot Test:

- The graphite block can be connected electrically by either clamping it to a conducting plate or clamping an electrode directly to it.
- The test should then be performed on an insulating surface.
- The test voltage is applied between the wire and the graphite block.
