National Spherical Torus eXperiment Upgrade

Field Seal Repairs WBS 1.04.01.05

NSTX-U Recovery Project FDR – March 17-19, 2020

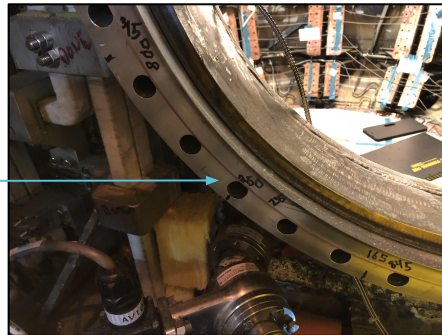
- Wire-Seal flanges function via clamping a compressible copper gasket between a mating male and female flange to create an airtight vacuum seal.
 - Wire-Seal flanges can withstand higher thermal effects than non-metallic gasket vacuum flanges.

**Wire-Seal Gasket
on male flange
(attached to
vessel)**

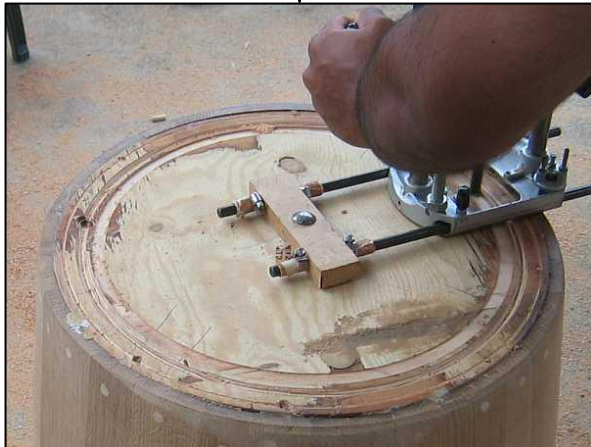
- Flange Removal Fixture is prototyped off of a circular router cutting-guide.
 - Rather than pivoting around a central fixed axis, the cutting tool is guided by the external guiding ring to provide a clean and square cut when removing flanges.

**Axis-centered
router cutting
guide.**
