National Spherical Torus eXperiment Upgrade

Machine Core Structures WBS 1.01.02.01

NSTX-U Recovery Project FDR – March 17-19, 2020

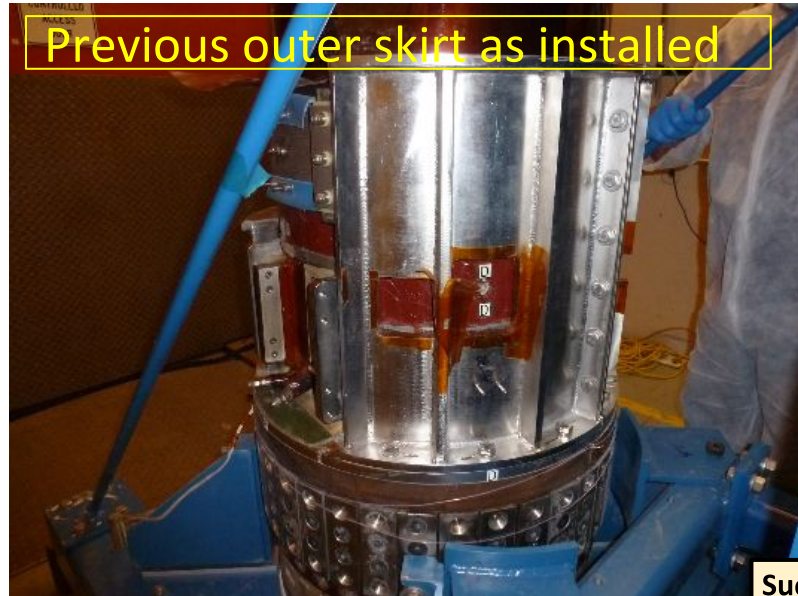
Outer Skirt - Scope

Outer skirt interfaces to the Lower PF-1a/-1b common flange and TF bundle; supports the CSC, PF-1a U/L, and PF-1b U/L against electromagnetic loads. New Outer Skirt

- To accommodate larger Recovery loads.
- To include toroidal insulating breaks.

The Outer Skirt is a 4 part weldment made from In625 with G7 dielectric breaks between each section. The sections are bolted together with hardware + dielectric bushings.

Previous outer skirt as installed

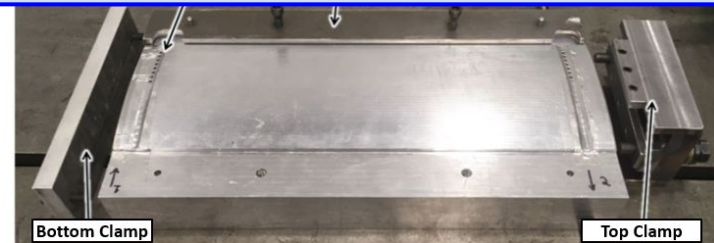
Distortion Control Weld Fixture for Slings

- Fatigue testing welded 718 dogbones - Completed
- Prototypes of slings
 - Welding, machining, distortion control- Completed
- Full size -1a mockup w/ flanges (in process)
 - Developing assembly procedures
 - Assess tolerances
- Pre-load monitoring instrumentation
 - Developing methods to control preload during assembly
- Ceramic break mockup (in process)
 - Confirm tolerances
 - Confirm electrical standoff and waterproofing techniques
- Belleville stack mockup
 - Confirm washer & pin fatigue -

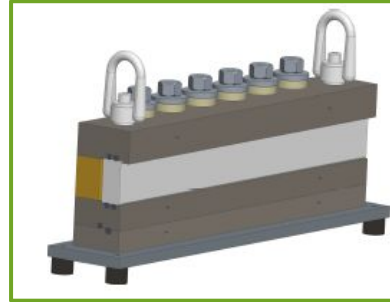
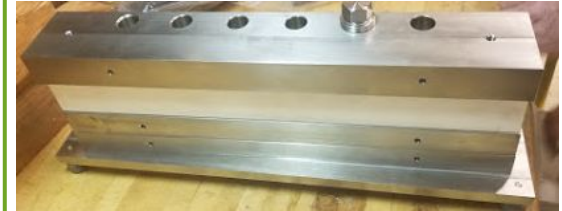
Ceramic Break Mockup
