National Spherical Torus eXperiment Upgrade

Inner-PF Magnet Replacement WBS 1.01.03.01 & 1.01.03.01a

NSTX-U Recovery Project FDR – March 17-19, 2020

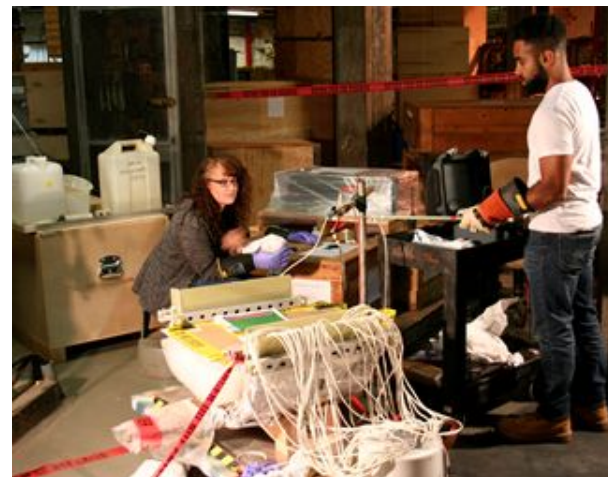
Layer to Layer Voltage Standoff

Maximum Layer to Layer voltage PF1b and PF1c
Dielectric strength

Safety factor PF1a	76
Safety Factor PF1b	38
Safety Factor PF1c	38

Could not induce failure in any coil at max limit of test equipment:
= 20kV for layer to layer testing
= 55kV for conductor to gnd testing

2.03	kV
77	kV

Turn to Ground Voltage Standoff

Maximum Turn to Ground voltage PF1b and PF1c
Dielectric strength

Safety Factor PF1a	54
Safety Factor PF1b	27
Safety Factor PF1c	27

4.05	kV
110	kV

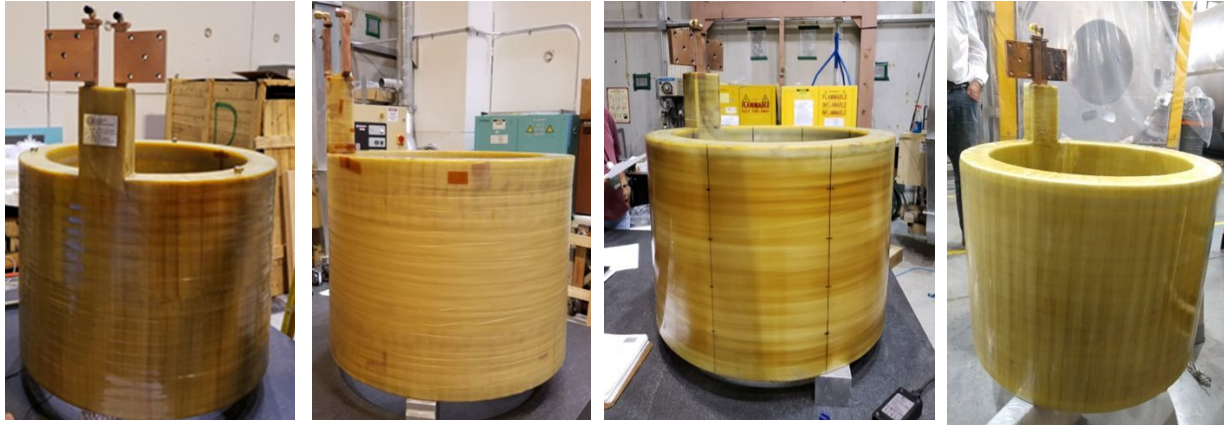
Prototype Coils Evaluated Vendors and Validated Design

- The four prototypes provided a basis to evaluate vendor quality, both the process and final product.
- The coil prototyping and testing effort was designed to validate improvements made in design and manufacturing that were based on lessons learned.
- The prototype evaluation demonstrated that the new design has generous margins with respect to preventing a repeat of the initial layer to layer electrical coil failure. The evaluation included:
 - Mechanical Inspection, metrology and hydrostatic testing
 - Low power, high voltage, and high power tests
 - Coil sectioning for visually examined
 - Turn-to-turn and turn-to-ground insulation of sectioned coils successfully tested

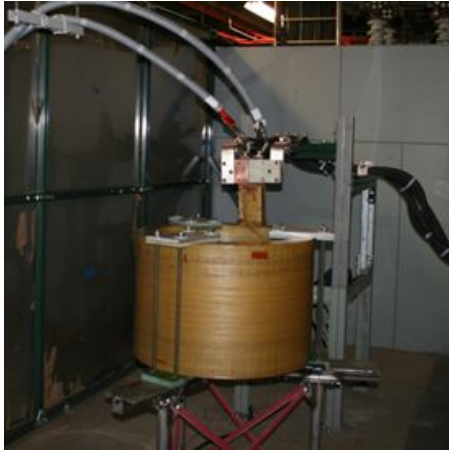
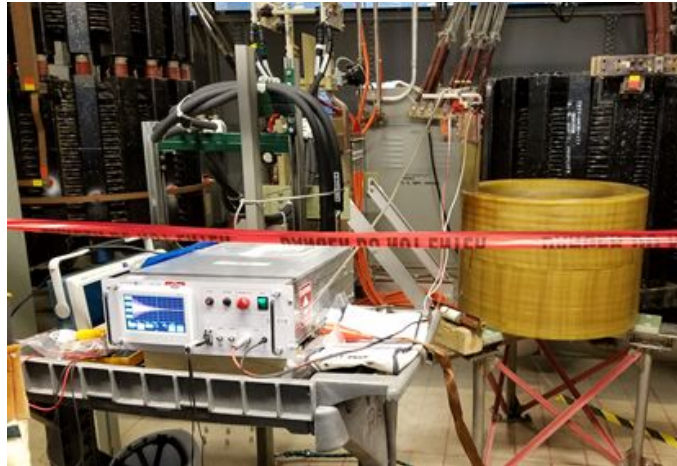
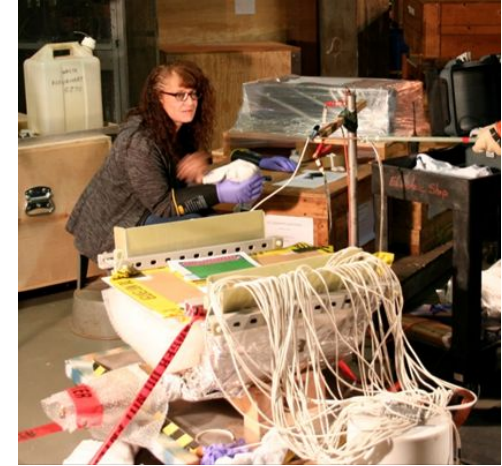
Extensive Electrical Testing Program For Prototype

- Low power electrical testing (high pot, megger, surge testing, impedance)
- High power tests (2 coils) simulating NSTX-U operation, successfully completed
- Low power electrical tests repeated and no change observed in coil properties after high power testing
- Coils sectioned, visually examined to confirm good VPI
- High voltage testing performed on turn-to-turn and turn-to-ground insulation of both halves of sectioned coil demonstrated high Safety Factor, $SF=150$ min Turn to Turn, $SF=20$ min Layer to Layer with no breakdown
- High voltage testing was successfully repeated after Corona testing to validate long term durability of insulation

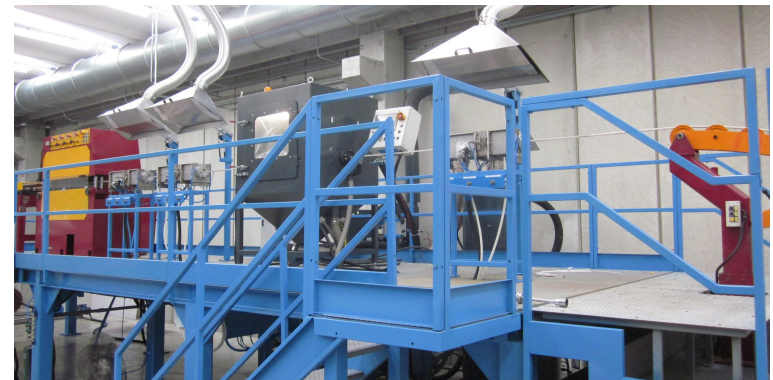
- Long lead items fabricated in advance and provided at award of contract
 - G11 Filler Pieces provided
 - Conductor purchased from Luvata in Finland 100% UT Inspection
 - Conductor sand blasted and primed by ICAS / Tratos in Italy
 - Co-wound glass / Kapton tape assembled and fully inspected at PPPL

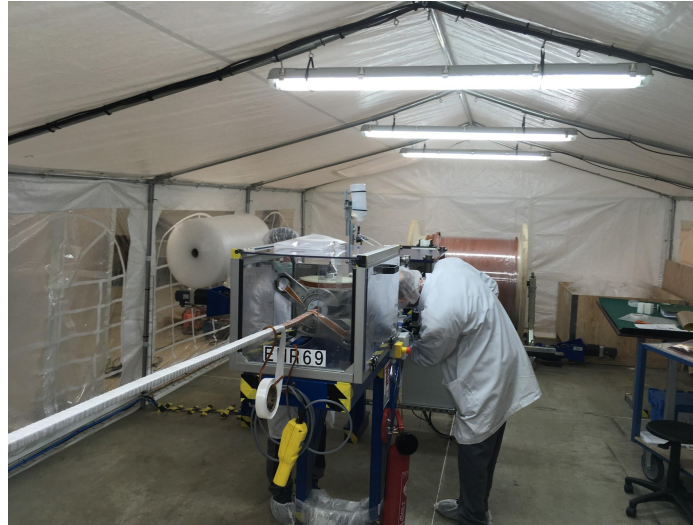
- Fabrication proceeding at Sigmaphi
- Sigmaphi rented a dedicated building for our project
- Two clean rooms established for two winding lines
- Contract requires team of 2 technicians per winding line along with dedicated supervising engineer
