National Spherical Torus eXperiment Upgrade

CS Casing

WBS 1.01.02.06 & 1.01.02.07

NSTX-U Recovery Project FDR – March 17-19, 2020

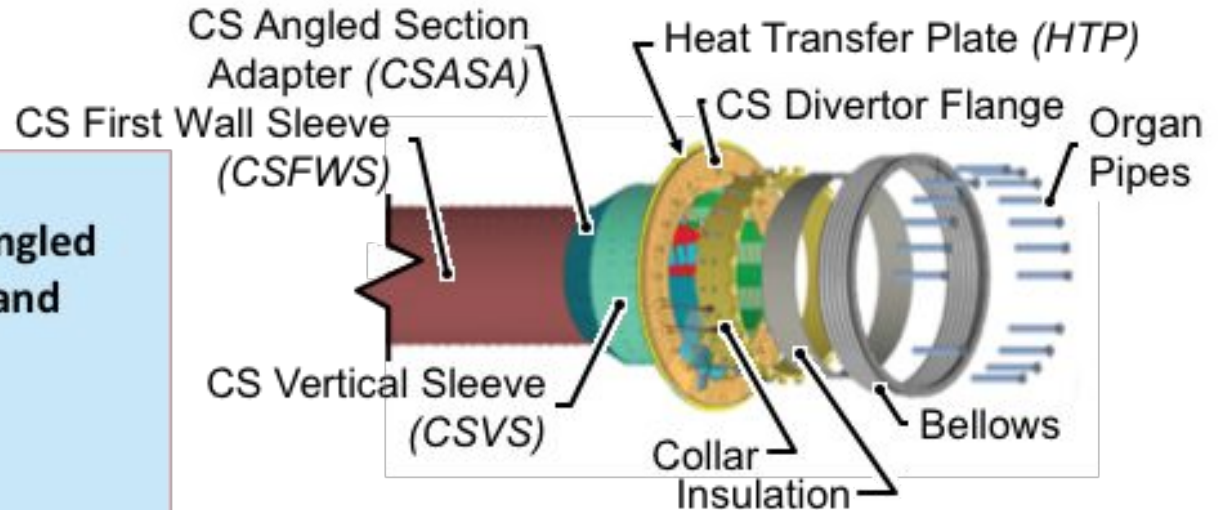
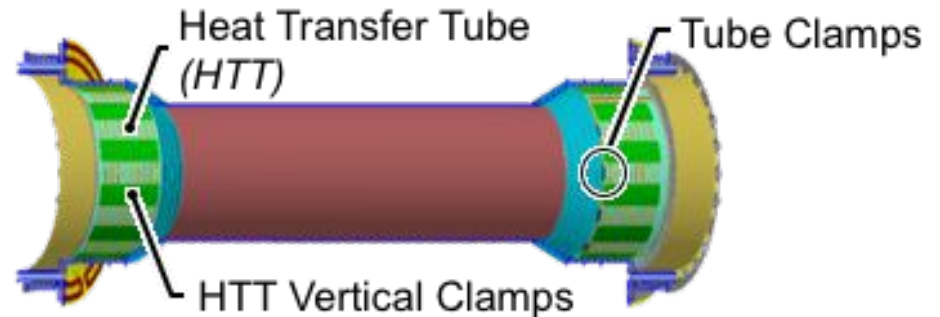
Center Stack Casing - Scope

- Integration of First Wall, Angled Section, Vertical Divertor, and Horizontal Divertor
- Organ pipes,
- Integrate collar
- Maintain vacuum and accommodate thermal growth via bellows
- Integration of Heat Transfer Plates and Heat Transfer Tubes
- Install studs on Vertical Target and First Wall

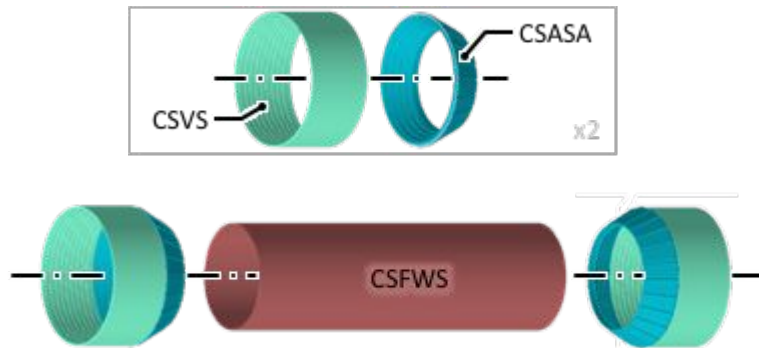
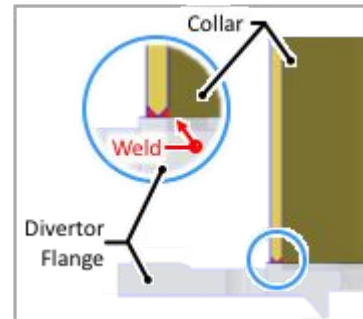
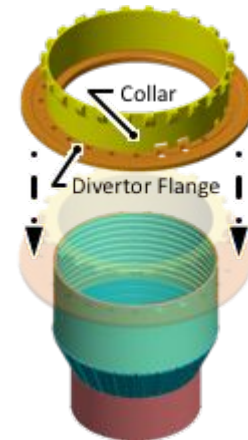
Casing Assembly - 1

1. ✓ CSFWS(x1), CSASA (x2) and CSVS (x2) were forged parts with extra thickness
2. ✓ ID of CSFWS was pre-machined
3. ✓ Assemble (weld) CSFWS (x1), CSASA (x2) and CSVS (x2)
4. ✓ Weld Divertor Flange Assembly to each CSVS
5. Post Machine Welded Assembly
6. Perform Ultrasonic Weld Inspection (UT) and Vacuum Leak Testing (LT).

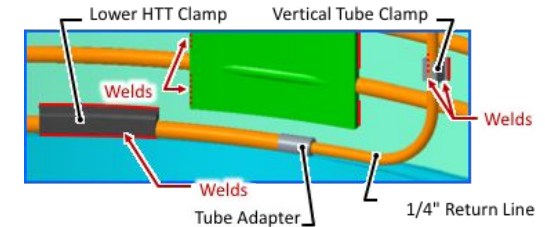
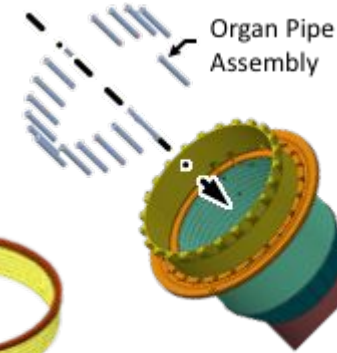
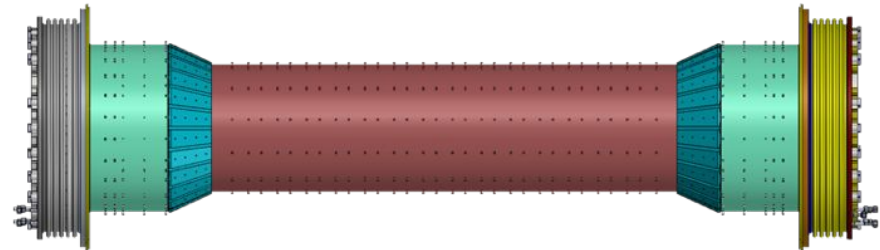
Casing Assembly - 2 Install PPPL supplied components

1. Install the HTT and HTT stub weldments
 - Perform weld inspection (WI) and leak test (LT)
2. Weld all HTT clamps (WI)
3. Install Organ Pipes (WI) (LT)
4. Weld HTP feedthrus to the divertor (WI) (LT)
5. Align and install the HTP assemblies using bolts and pins and weld the tube adapters to feedthroughs (WI) (LT)
6. Install HTP Stub weldments. (WI) (LT)
7. Weld bellows assembly to divertor flange. (WI) (LT)
8. Machine pockets and install all PFC Studs (E-DC11204)
9. Perform a final Metrological Surveys

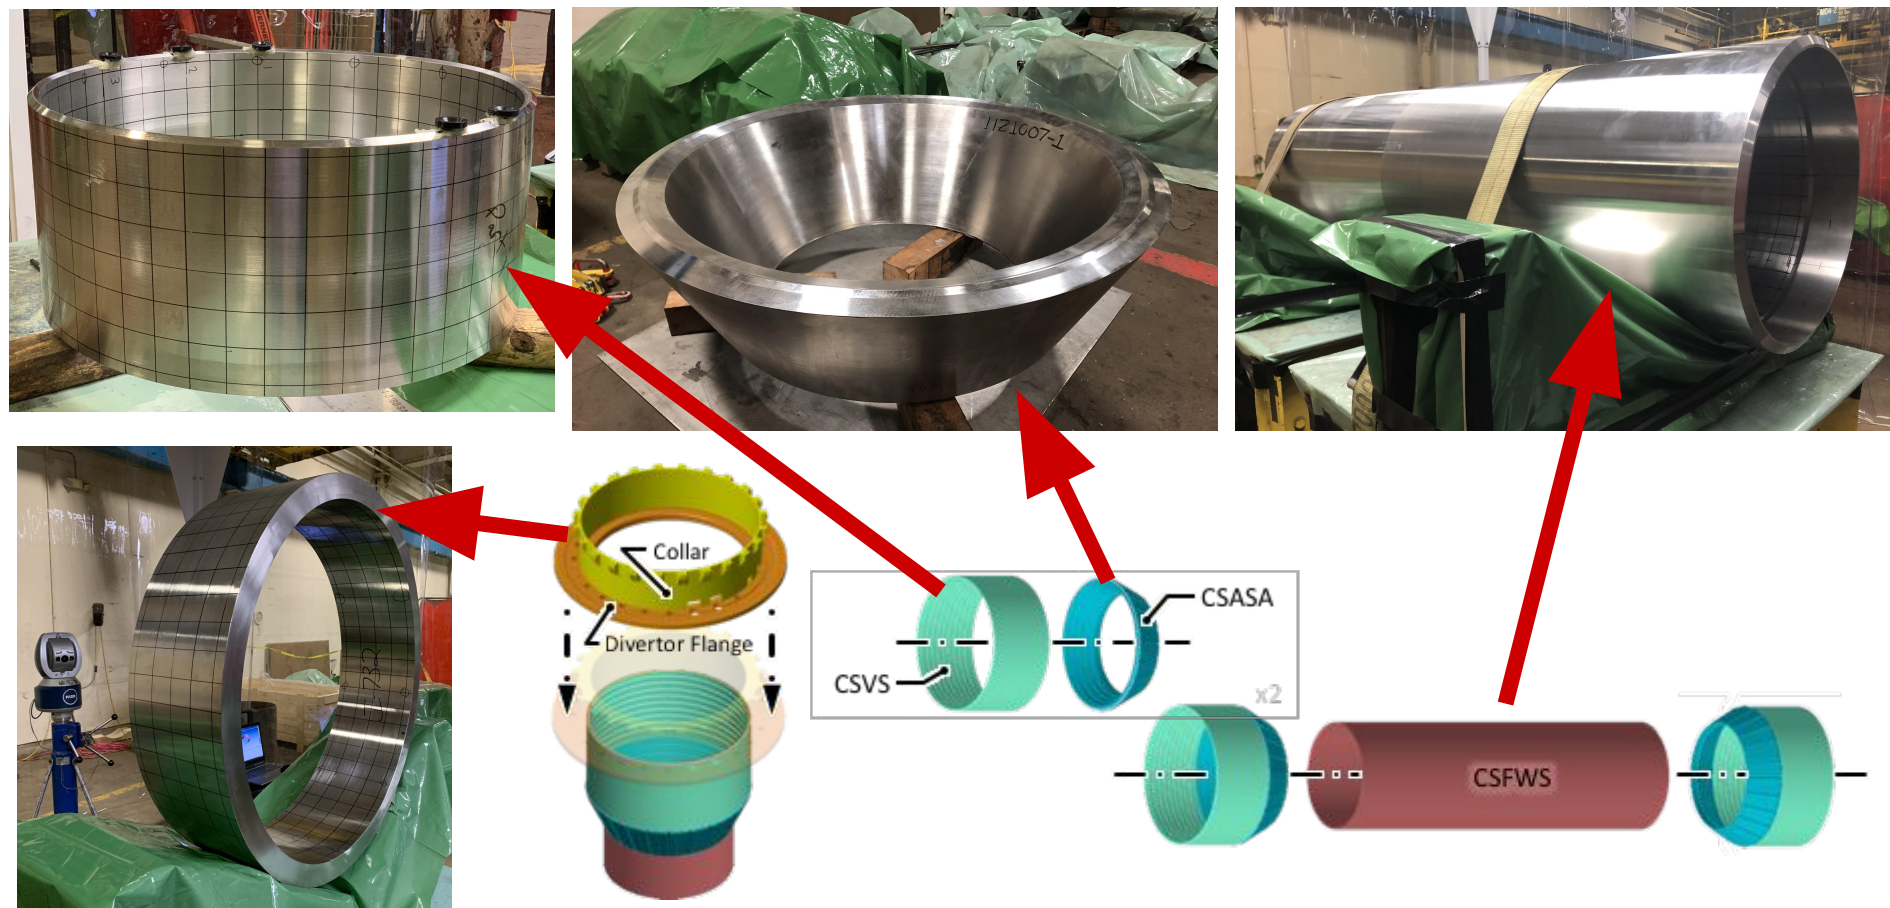
Main parts were forged by IBF in Italy

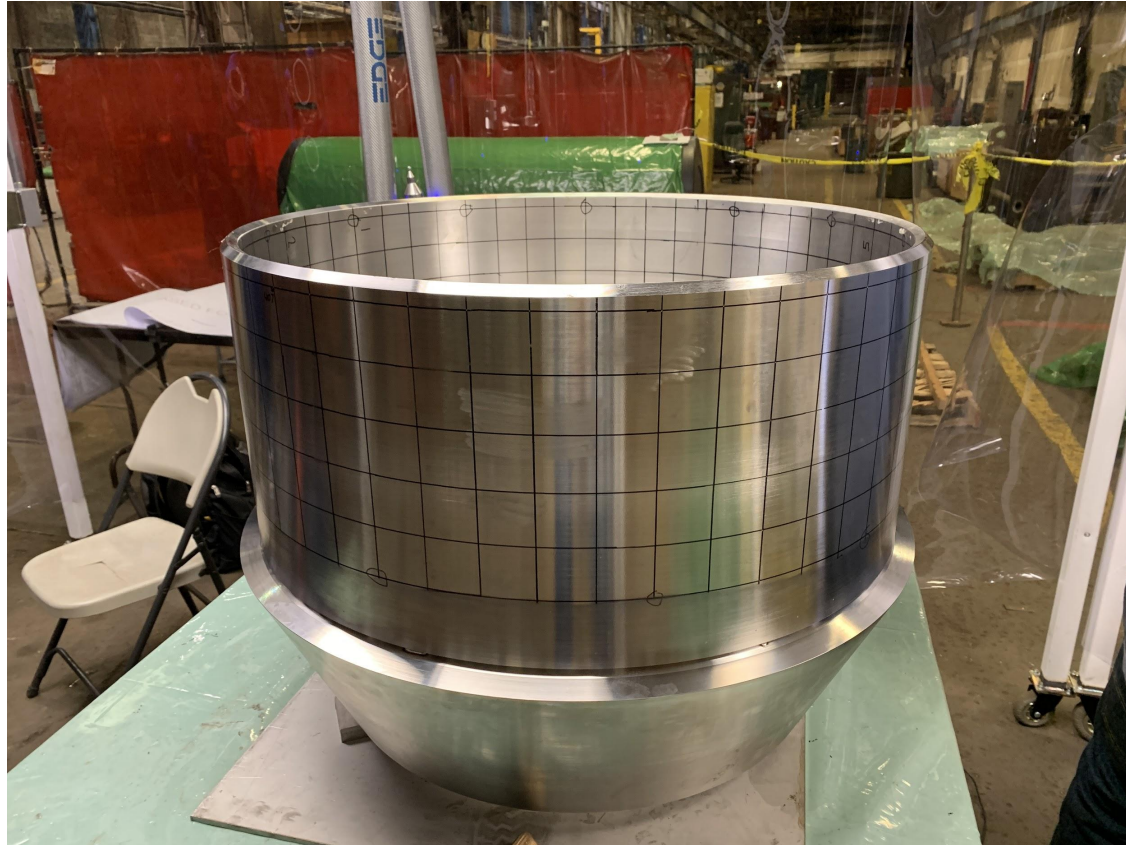
All casing parts were tacked together with great precision.

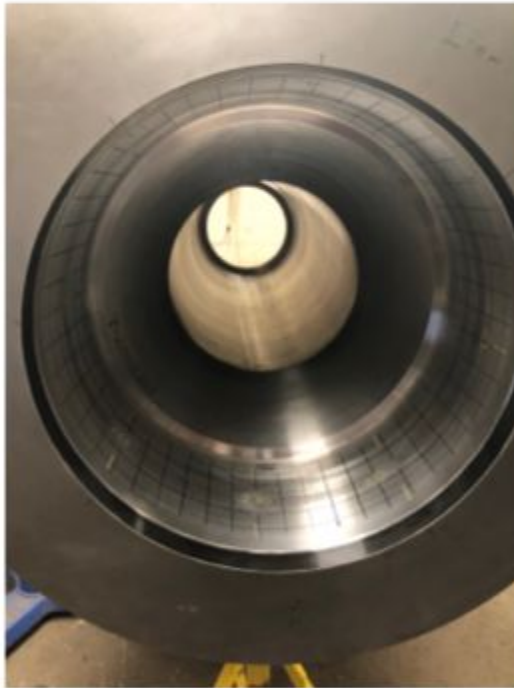
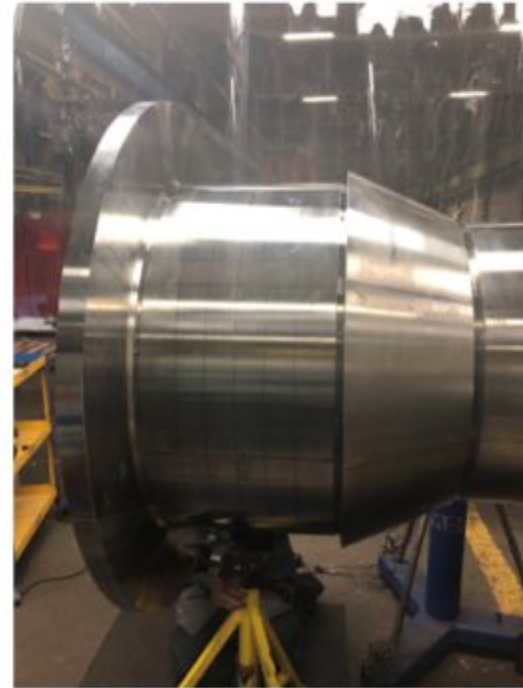
CSC fully tacked together

Inner and Outer

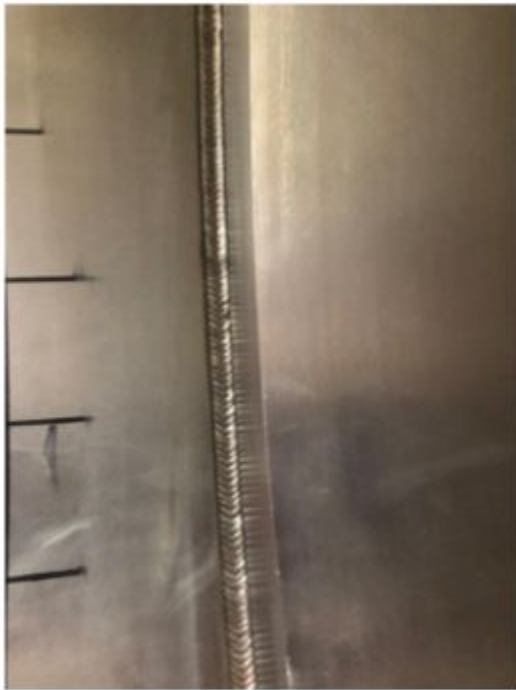
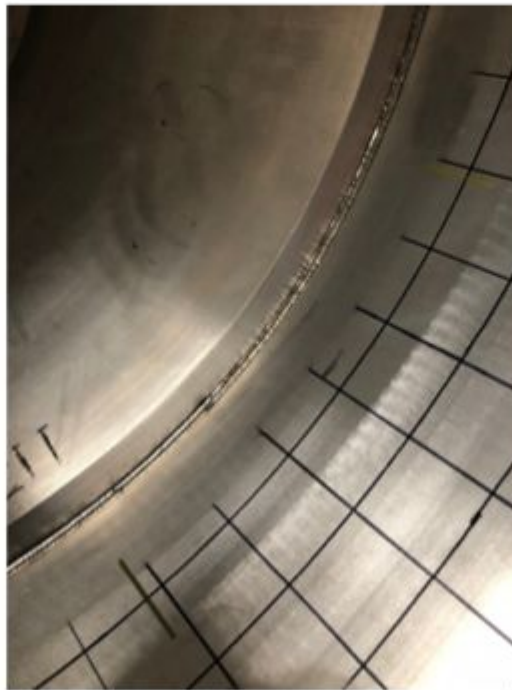
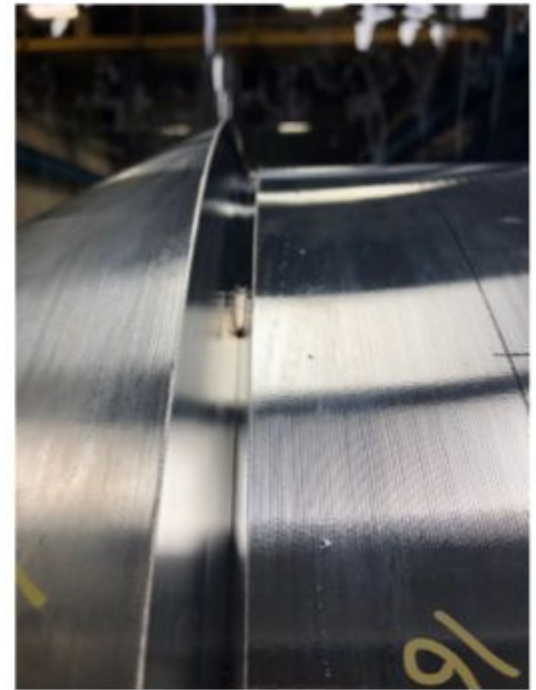
Welding Vertical Sleeve to Angled Section

ID welded first then OD background to smooth metal then welded

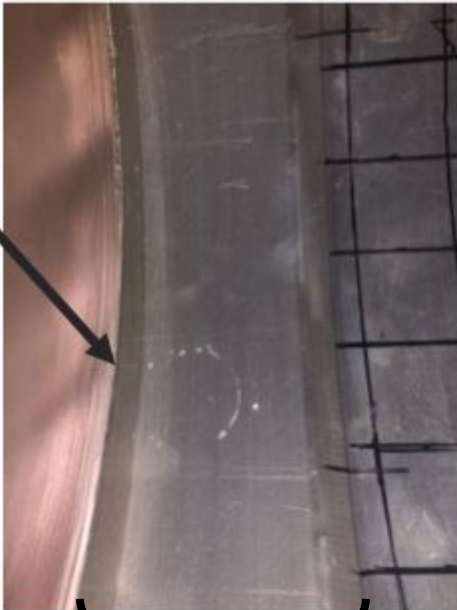
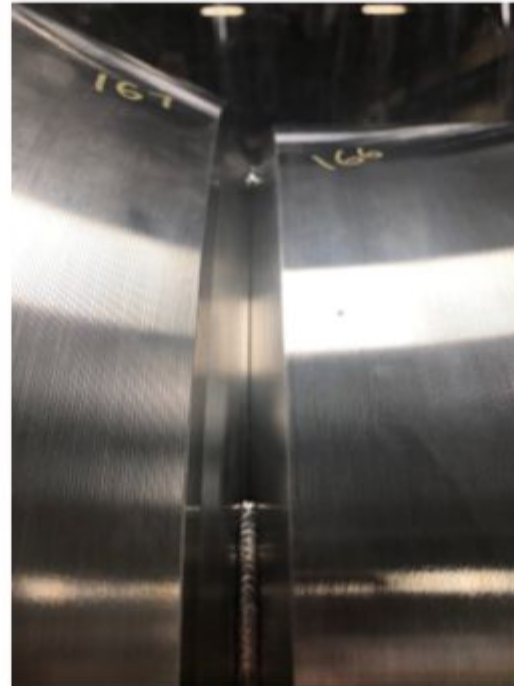
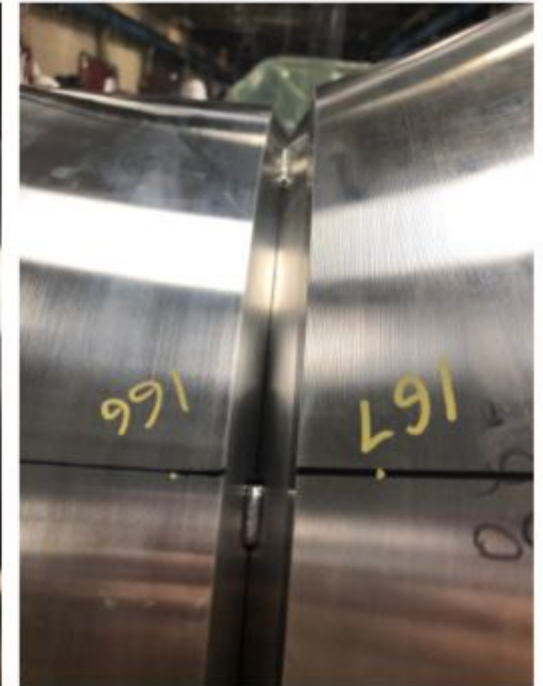
Angled Section to First Wall done from OD

ID

OD

All welding from OD

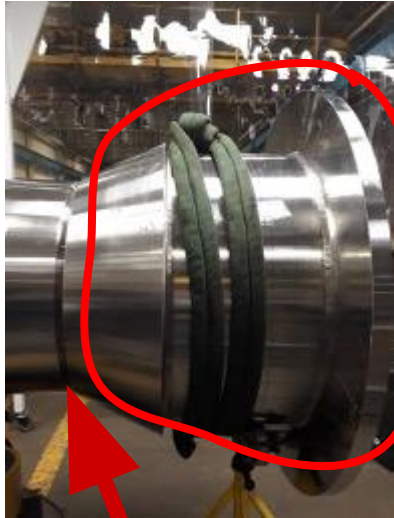
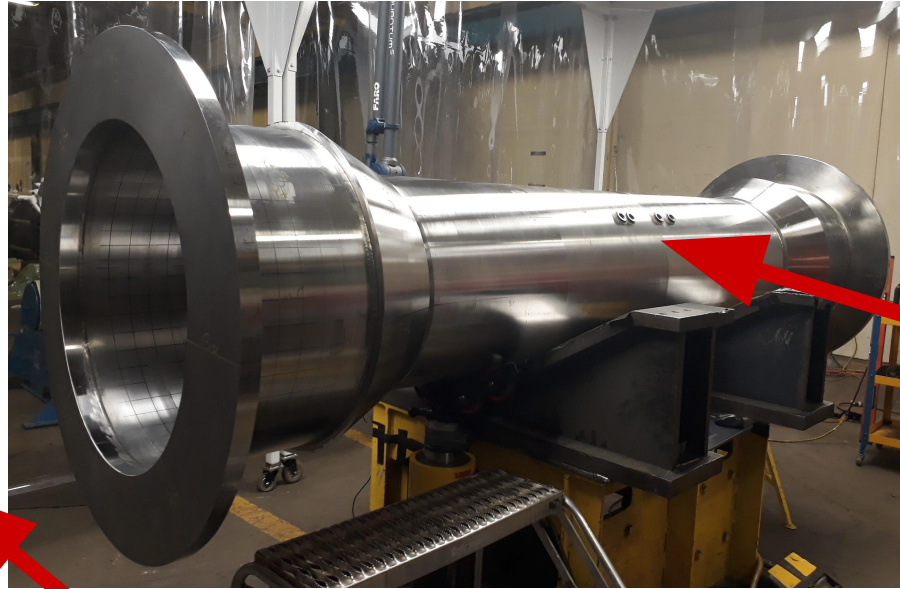
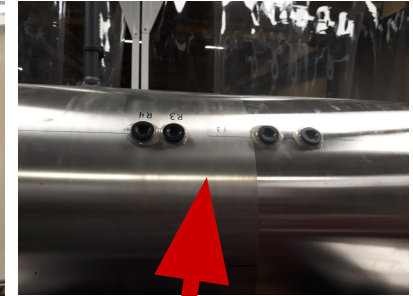
Welding of each end section to First Wall

Milled out after welding

Reference pucks
for FARO arm
measurements.

Tacks broken then end section
repositioned to accommodate
accumulative and predicted distortion.

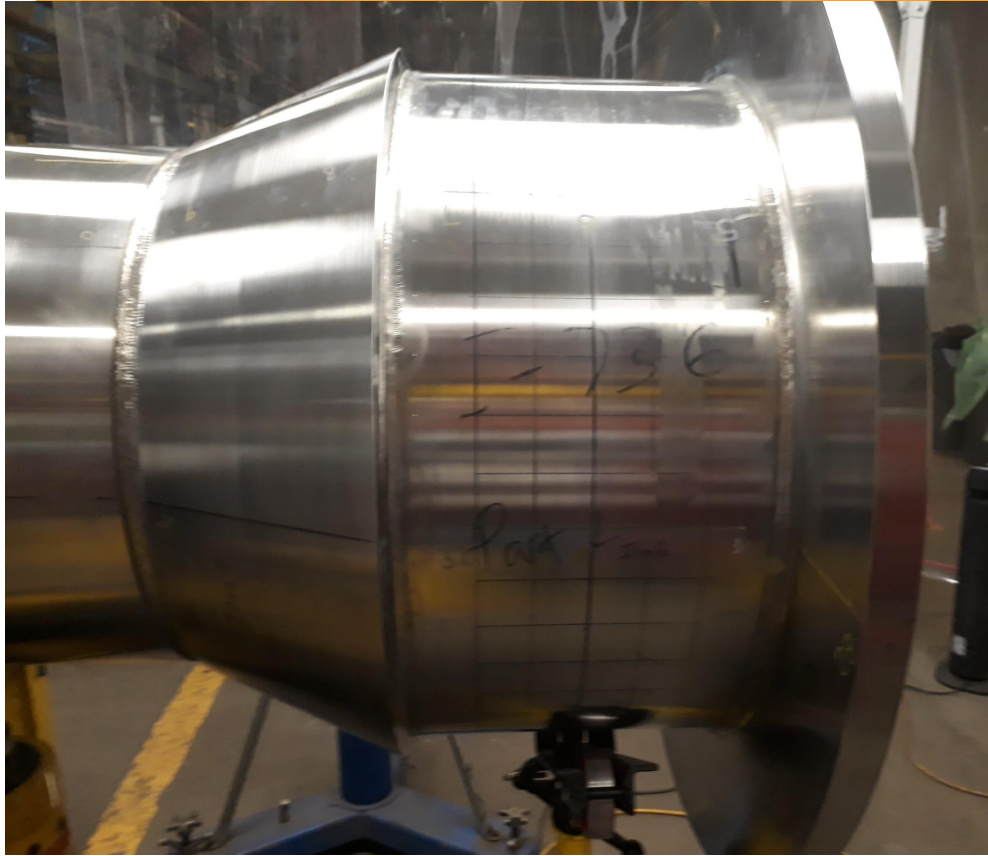
Completed Lower Section Weldment

First Wall Sleeve to
Angled Section Adapter to
CS Extension Sleeve to
Diverter Flange

Outside and inside surfaces
have extra material for final
machining.
