National Spherical Torus eXperiment Upgrade

NSTX-U Test Cell Shielding WBS 1.08.01.03

NSTX-U Recovery Project FDR – March 17-19, 2020

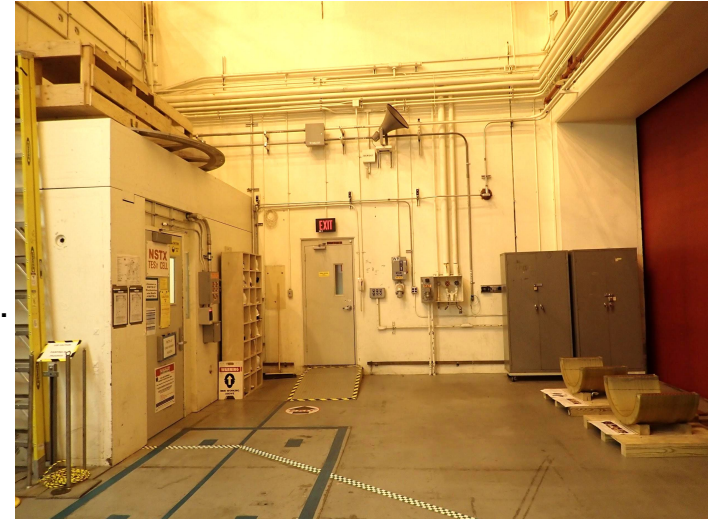
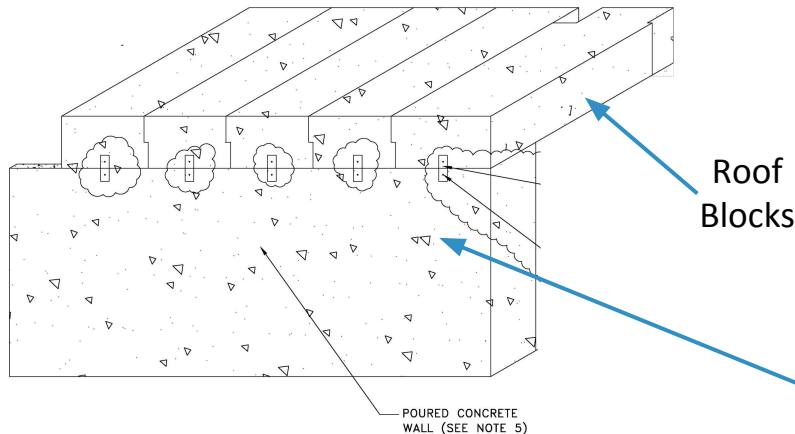
- The labyrinth walls will be poured in the field (per DWG# [D-PE213002](#)).
- The labyrinth roof blocks will be constructed per drawing [#E-AE2019](#).
- The roof concrete blocks have interlocking features at joints.
- The seams between existing wall and labyrinth roof will be sealed with concrete patching material.

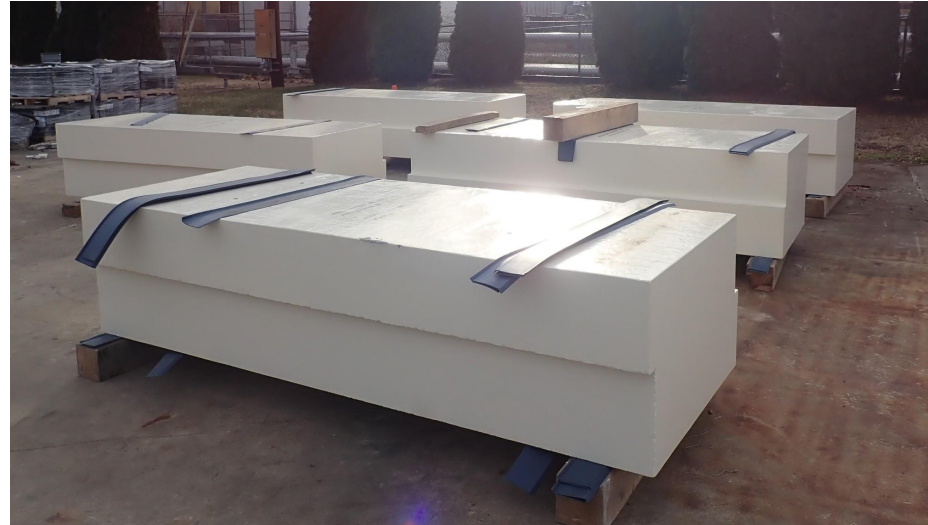
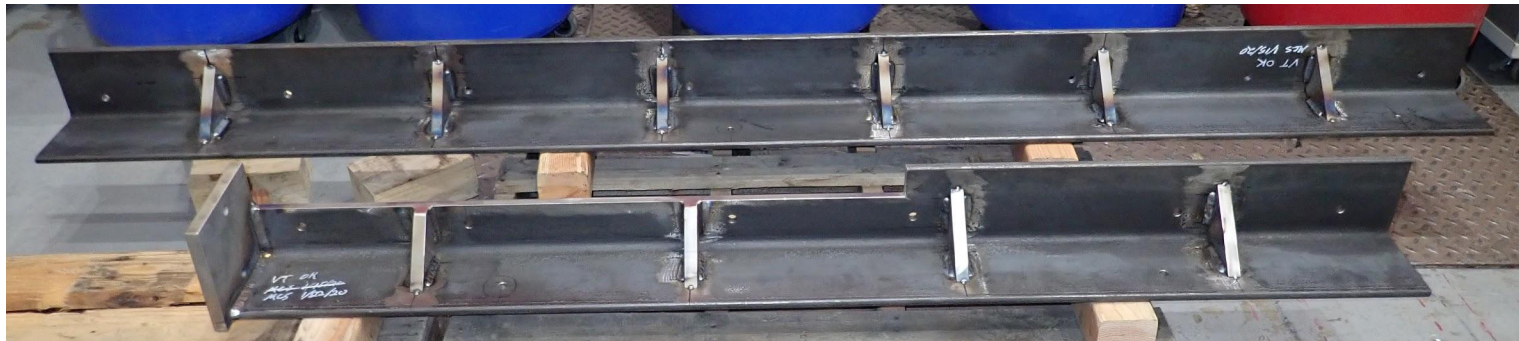
Labyrinth Roof Blocks & Supports

- The labyrinth roof blocks were constructed per drawing #[E-AE2019](#) by an external vendor.
- The roof concrete blocks have interlocking features at joints to eliminate shine through.
- Completed Roof Blocks delivered to PPPL from vendor.
- Roof Block support brackets have been fabricated and Installed.

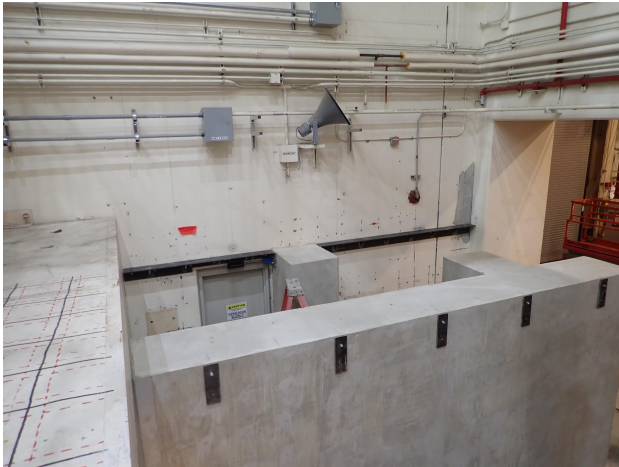
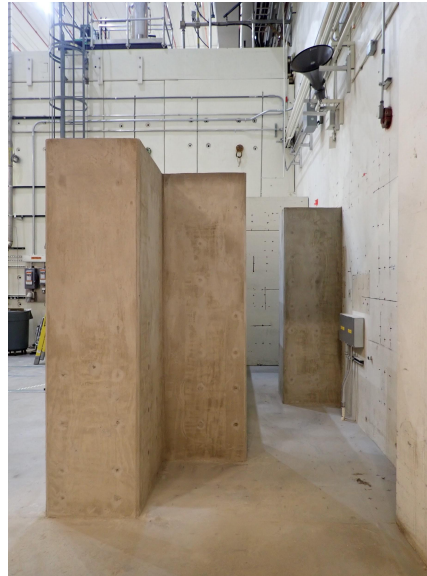
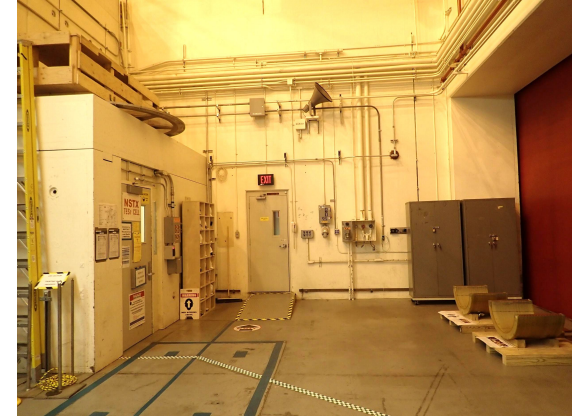
- The labyrinth walls were poured in the field (per DWG# [D-PE213002](#)).
 - Concrete was vibrated during pour to eliminate voids
- The seams between existing wall and labyrinth roof will be sealed with concrete patching material
- Gaps in existing labyrinth will be filled with neutron putty or grout

View from above

South High Bay prior to
labyrinth wall pours

View looking from the Neutral
Beam Building

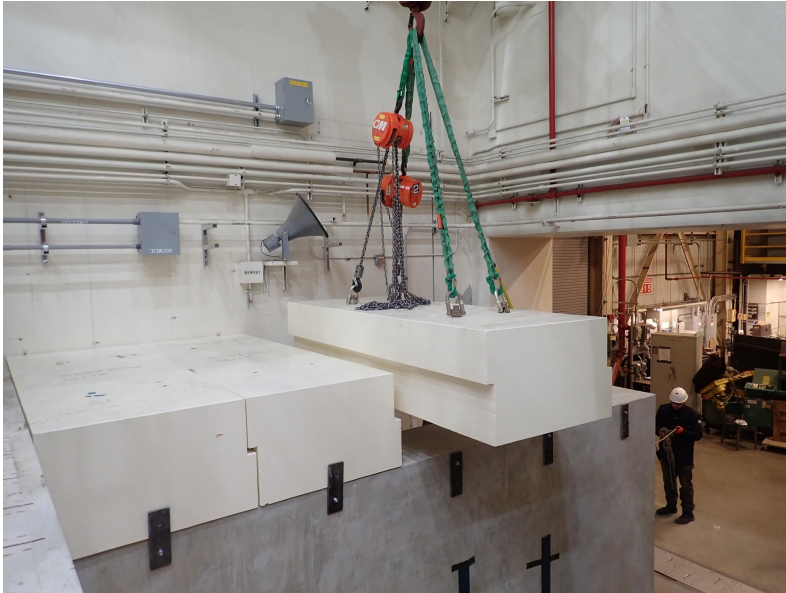
Installation of Labyrinth Roof Block

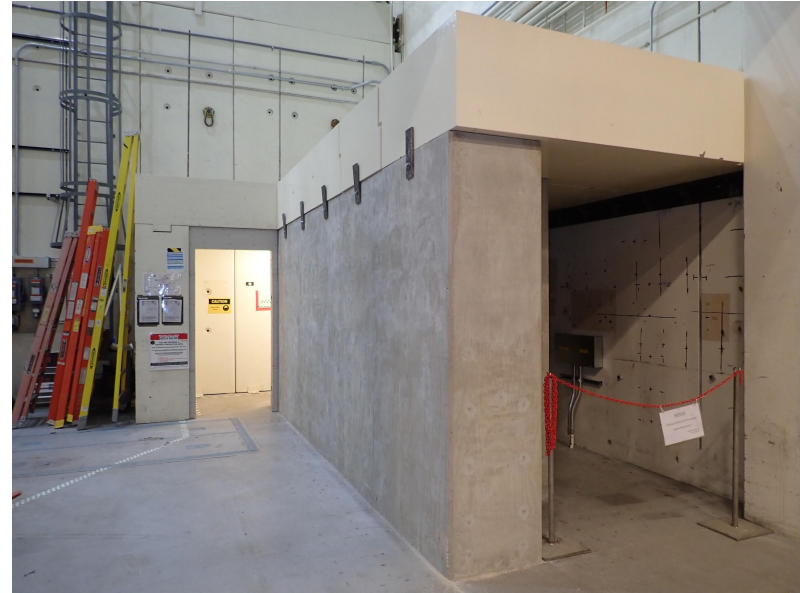
Installation of Block #3

All Five Blocks Installed

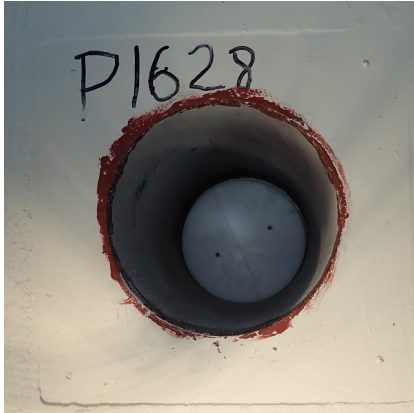
Circular Penetration Shielding

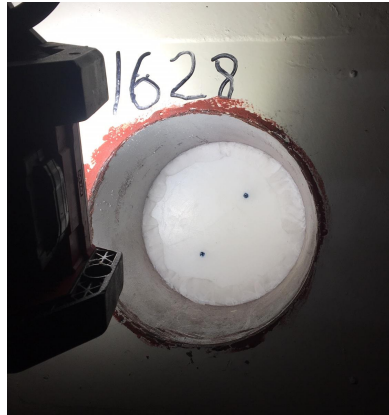
Installation of first Polly Disk

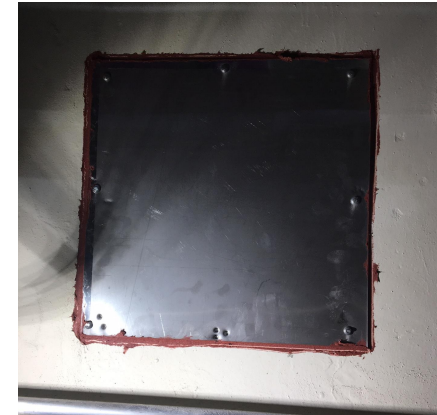
Installation of last Polly Disk

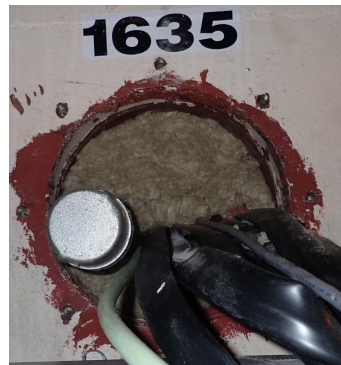
Installation of Neutron Putty

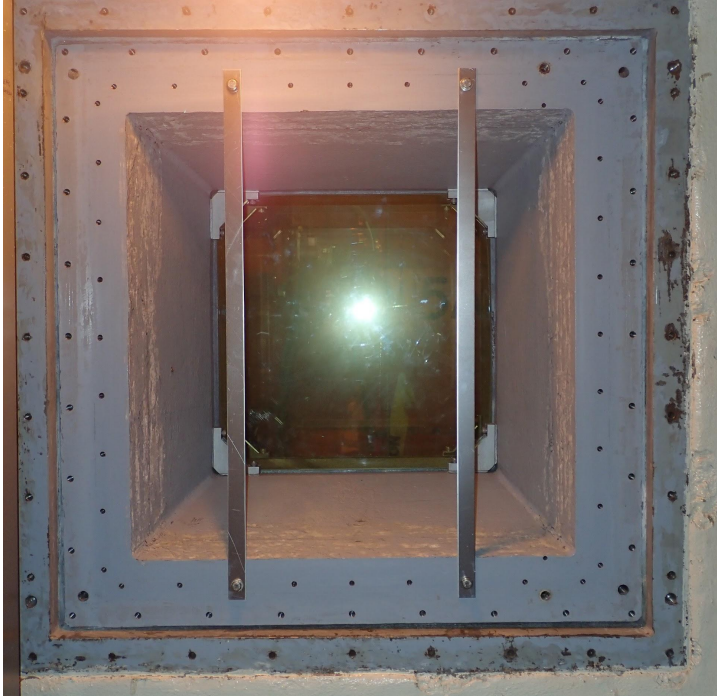
Window prior to Installation of Grout Plate

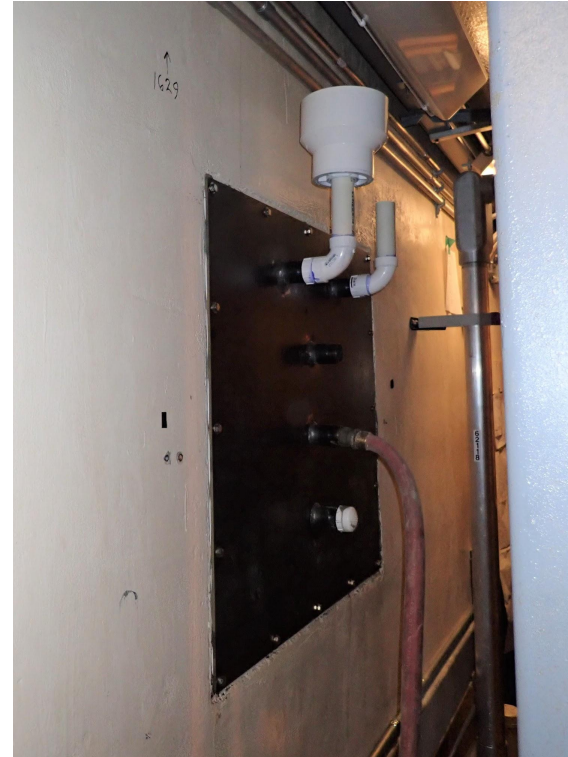
Grout being pumped into Window

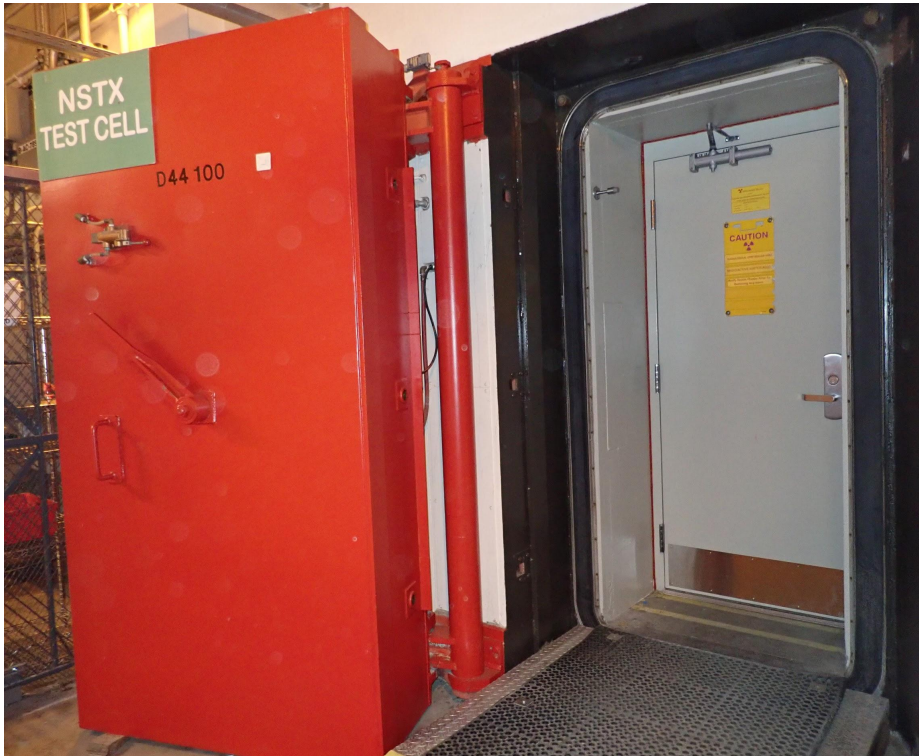
Shield Door (Battleship) Open

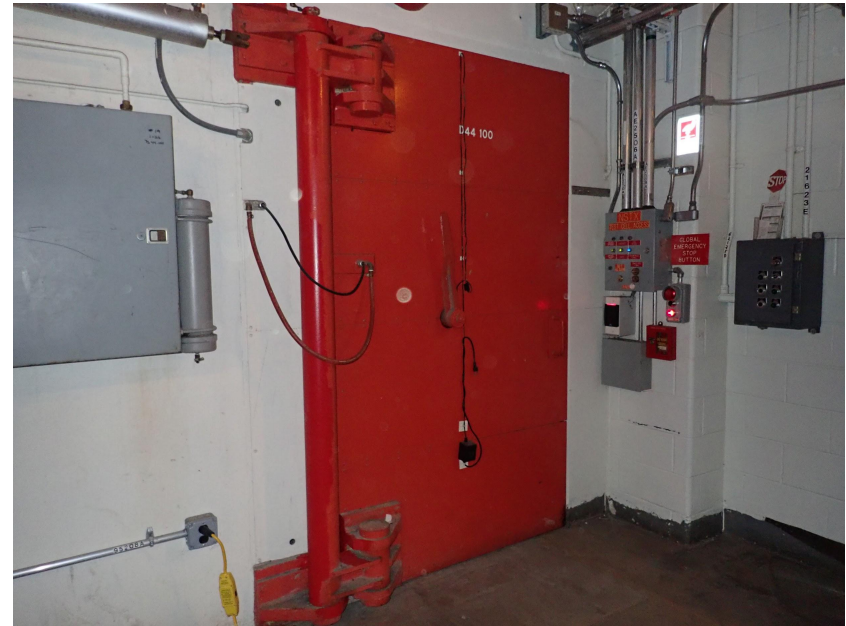
Shield Door (Battleship) Closed
