# National Spherical Torus eXperiment Upgrade

## Beam Emission Spectroscopy (BES) Shutter Repair WBS 1.04.01.07

NSTX-U Recovery Project FDR – March 17-19, 2020

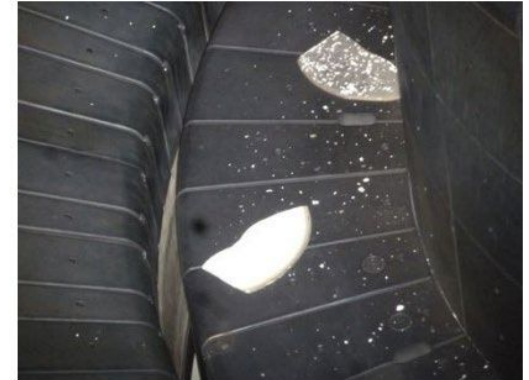
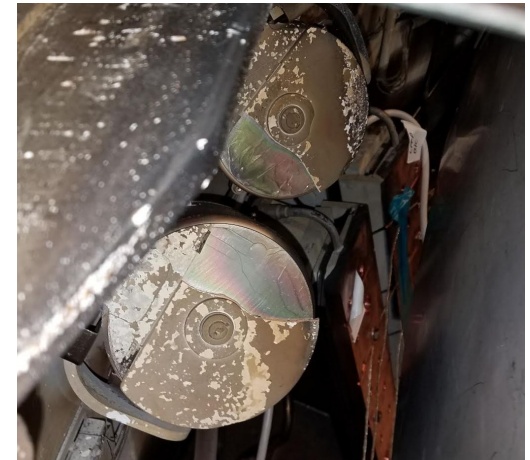
- Diagnostic installed in 2010 and operated successfully until shutter failure during 2016 run
- Fragments of boron nitride (BN) found on the lower inboard diverter in 2016
- Connections for shutter actuation reversed during installation and caused the shutters to slam closed

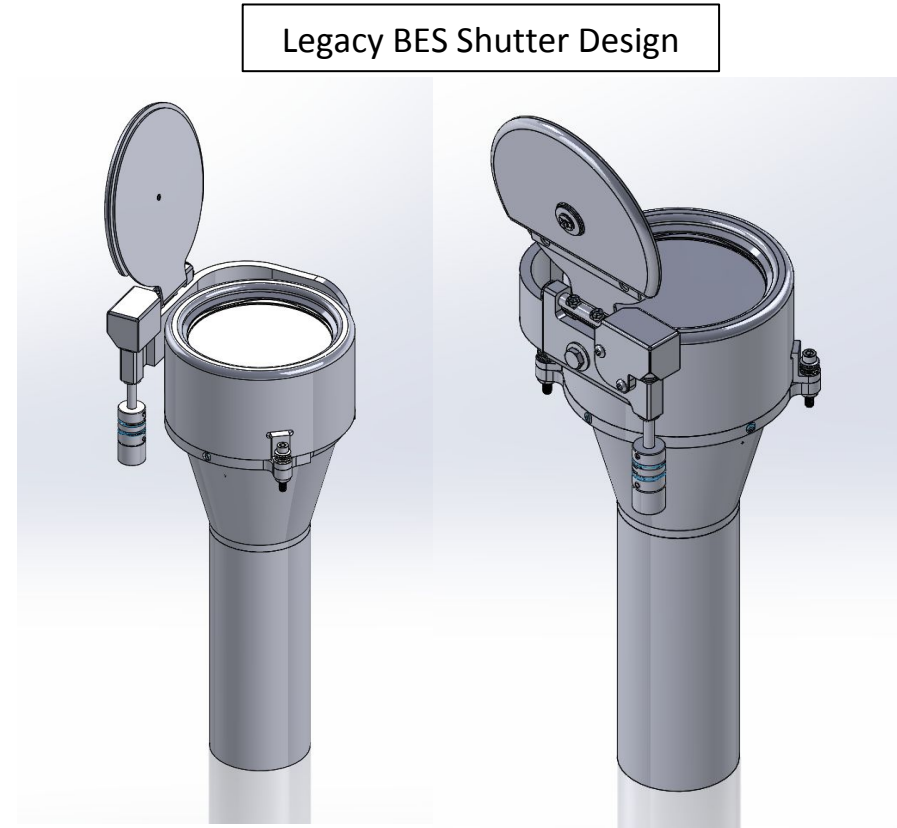
- Shutter OPEN requires significantly more air pressure to oppose gravity
- Excessive forces during shutter actuation if lines reversed
- Stress on BN is dependent on radius of central washer

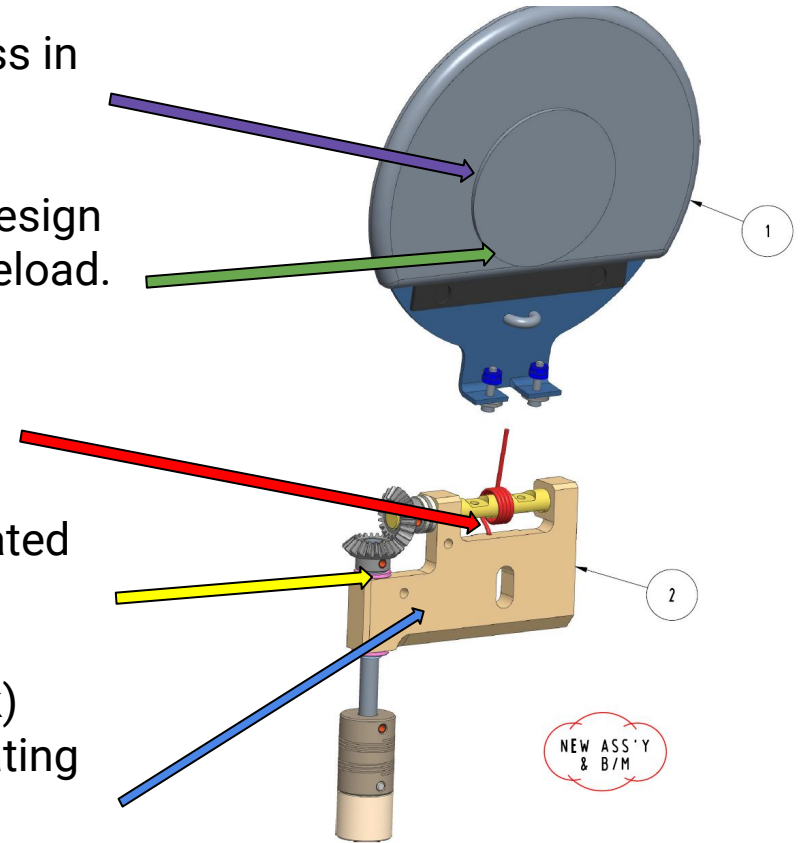
1. Implement a strongback to reduce stress in the boron nitride shutter covers.
2. Replace the existing Belleville washer design with wave springs for more accurate preload.
3. Implement a torsion spring to balance gravitational forces during actuation.
4. Replace zirconia shaft with ceramic coated 316 SS shaft for reliability.
5. Use shaft spacers (0.002" minimum thk) instead of snap rings for better gear mating (fewer friction losses).

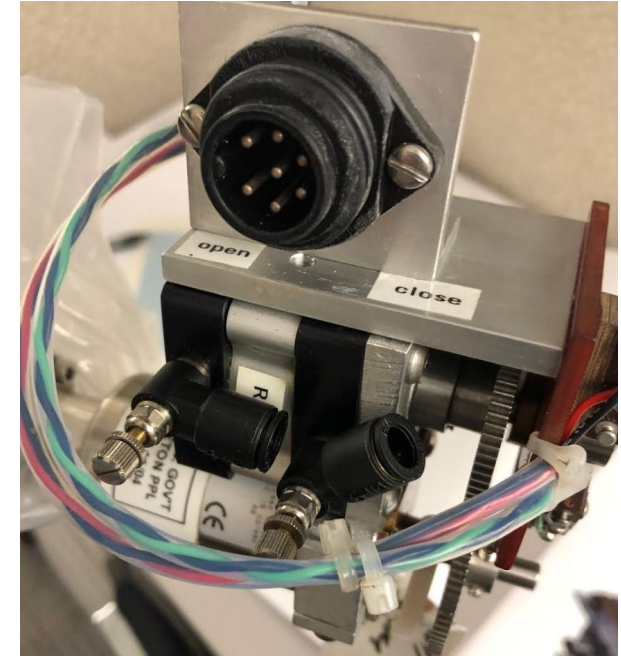
- Shutter material modifications are part-for-part replacements within previous design envelopes
- Open/close changes depending on shutter orientation. Inlet and outlet are labeled at time of assembly and testing
  - Implement adapters w/ different size threads  
-> open ¼" NPT, close ⅛" NPT
- Drawings revised after testing step to include shutter actuators & orientation
- Included in ECN for BES Shutter assem

Generic Labelled Shutter Actuator

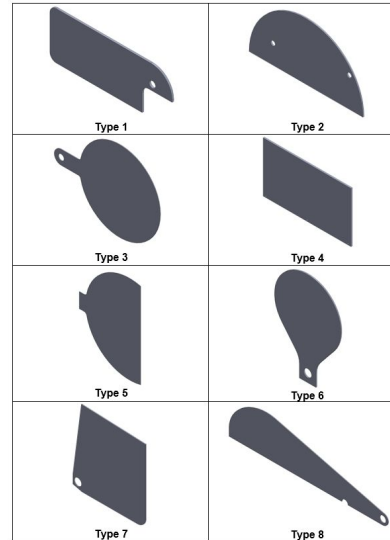
- EM analyses use worst case disruption loads from models near mid-plane duct region, **500 T/s**.
- 6/8 in-vessel shutter geometries meet SDC requirements
  - Type 3 and Type 7 require material change to Inconel 625
- Minimum shutter thickness:
  - **1/32"**

Figure 1. Eight variants of in-vessel shutter geometries.

Shutter Geometry	Peak EM Stress (MPa)	Peak Deflection (mm)	Comment
Type 1 (304 SS)	7 (1 ksi)	0.01 (0.0004 in)	PASS
Type 2 (304 SS)	4 (0.6 ksi)	0.005 (0.0002 in)	PASS
Type 3 (304 SS)	400 (58 ksi)	4.0 (0.16 in)	FAIL
Type 4 (304 SS)	85 (12 ksi)	0.2 (0.008 in)	PASS
Type 5 (Inconel 625)	300 (43 ksi)	6.0 (0.24 in)	PASS
Type 6 (304 SS)	75 (11 ksi)	0.3 (0.01 in)	PASS
Type 7 (304 SS)	300 (43 ksi)	7.0 (0.28 in)	FAIL
Type 8 (304 SS)	50 (7.2 ksi)	0.2 (0.008 in)	PASS

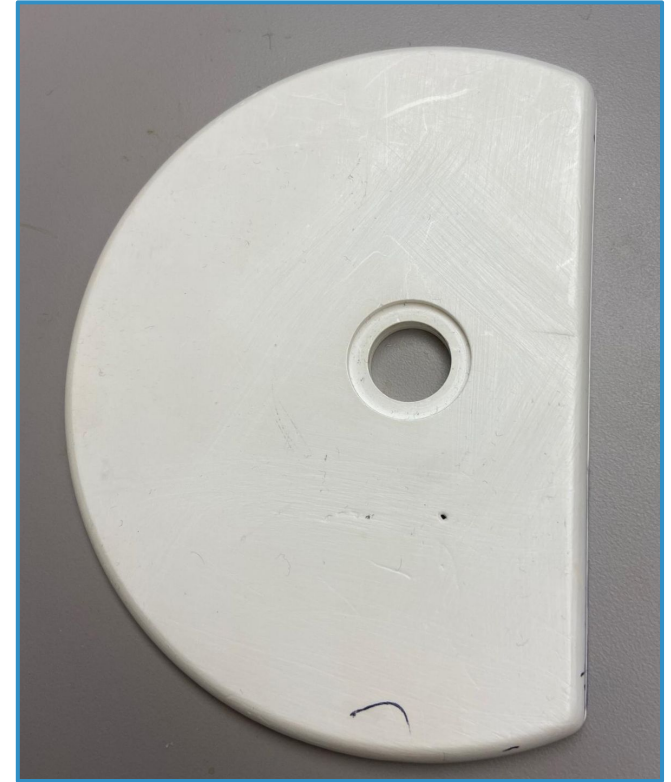
Boron Nitride Grade AX05

- Boron nitride grade AX05 and Inconel 625 are widely available
- Redesigned shutter components will be manufactured in-house prior to installation
- No in-vessel components will be removed for modification.
  - All newly manufactured parts
- Ceramic coating technical specification has been written and vendor has been qualified
