# National Spherical Torus eXperiment Upgrade

## Machine Core Structures WBS 1.01.02.01

NSTX-U Recovery Project FDR – March 17-19, 2020

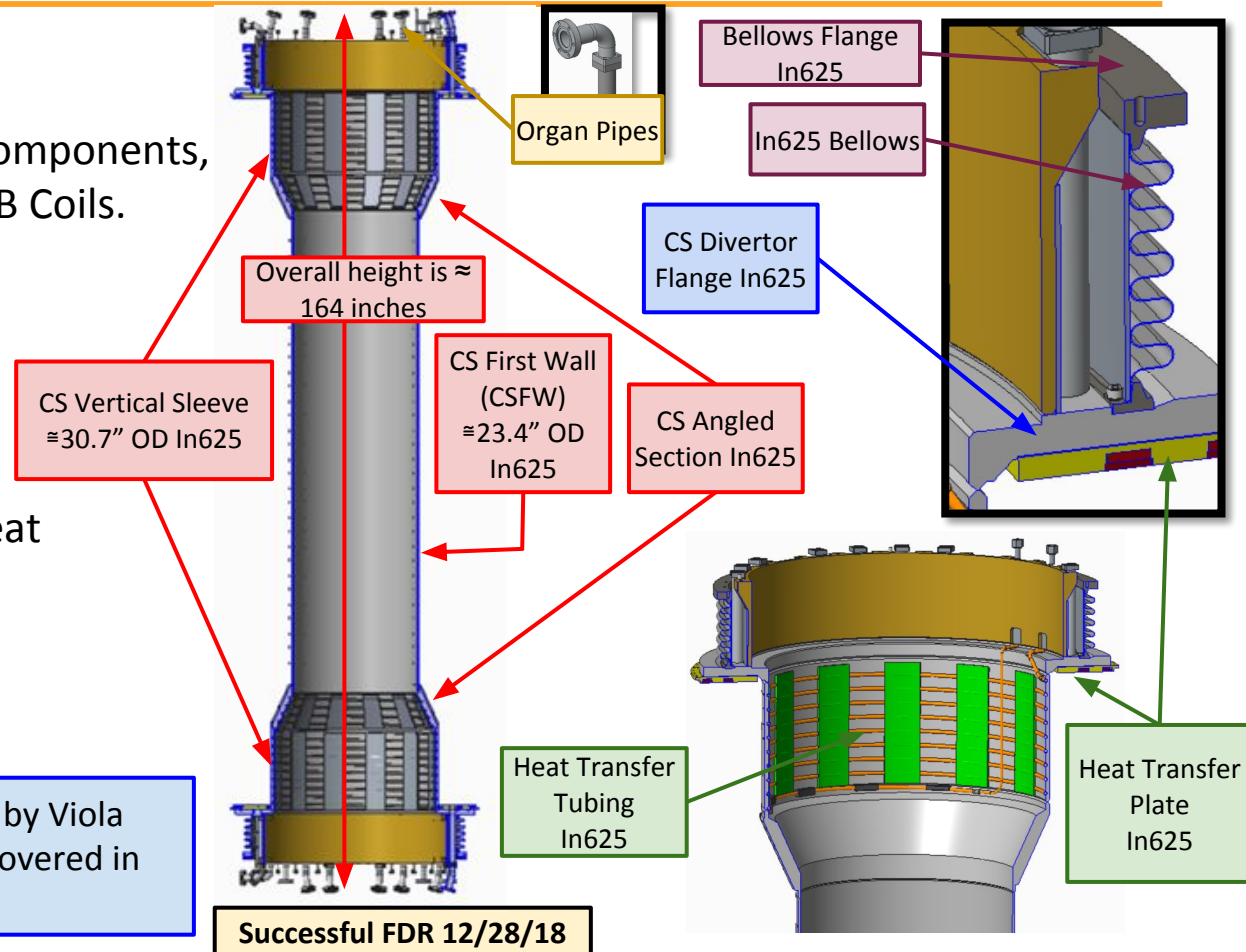
# CenterStack Casing - Scope

- CS Casing provides:
  - primary vacuum interface,
  - support for plasma facing components,
  - Support for Upper PF-1A & B Coils.
- Weldment made from In625 and 316SS.
- Casing fabrication contract includes the full weldment, and installation of Heat Transfer Tubing (HTT) and Heat Transfer Plate (HTP)

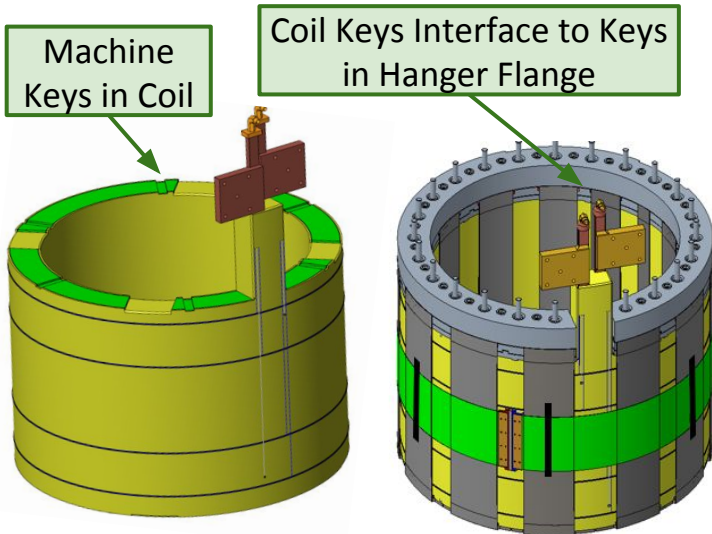
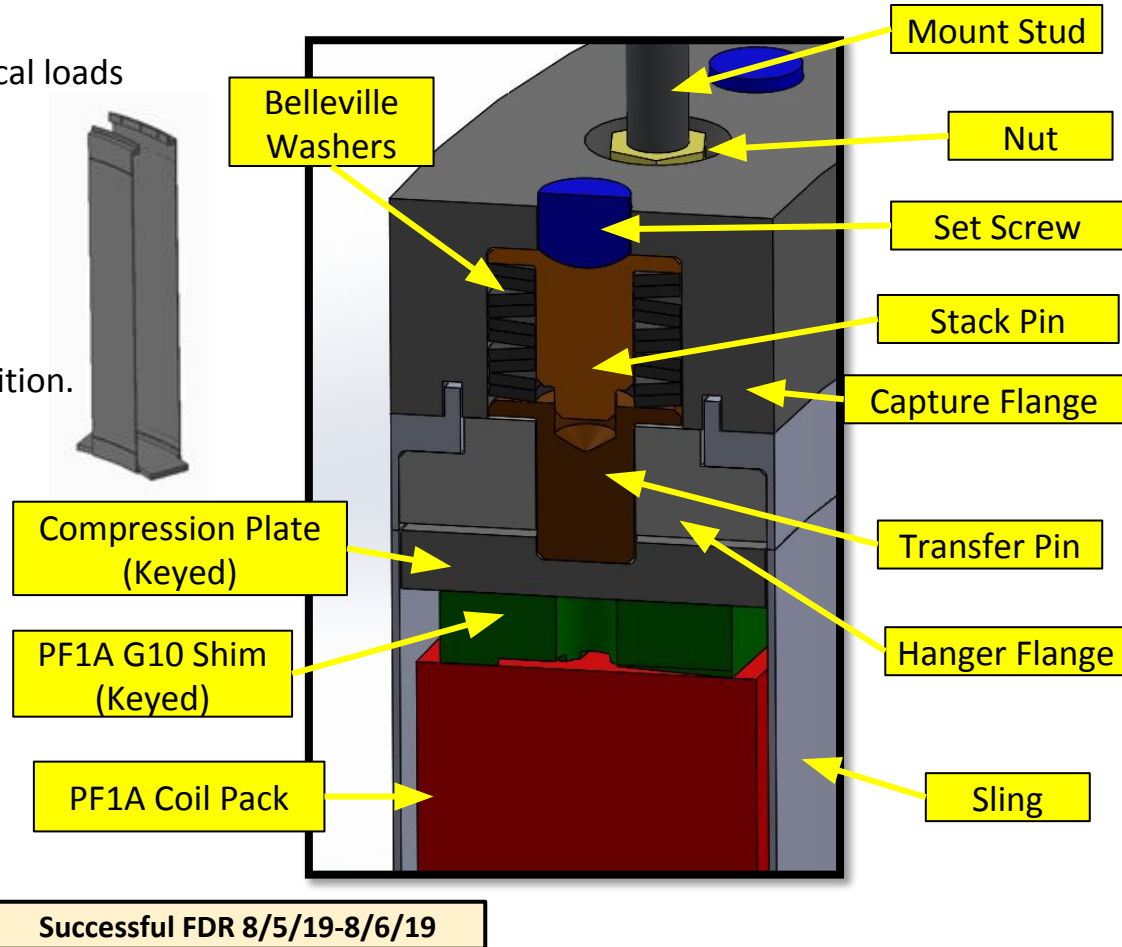
# PF-1a & -1b Sling Supports - Scope

- PF-1a and PF-1b coil supports:
  - Support against upward/downward vertical loads
  - Support against side-loads and moments
  - Provide significant vertical pre-load
    - mitigates coil thermal stresses
- Solution –
  - Support coils in In718 slings
  - Belleville stack used to provide pre-load
  - Use keyed interfaces to maintain coil position.

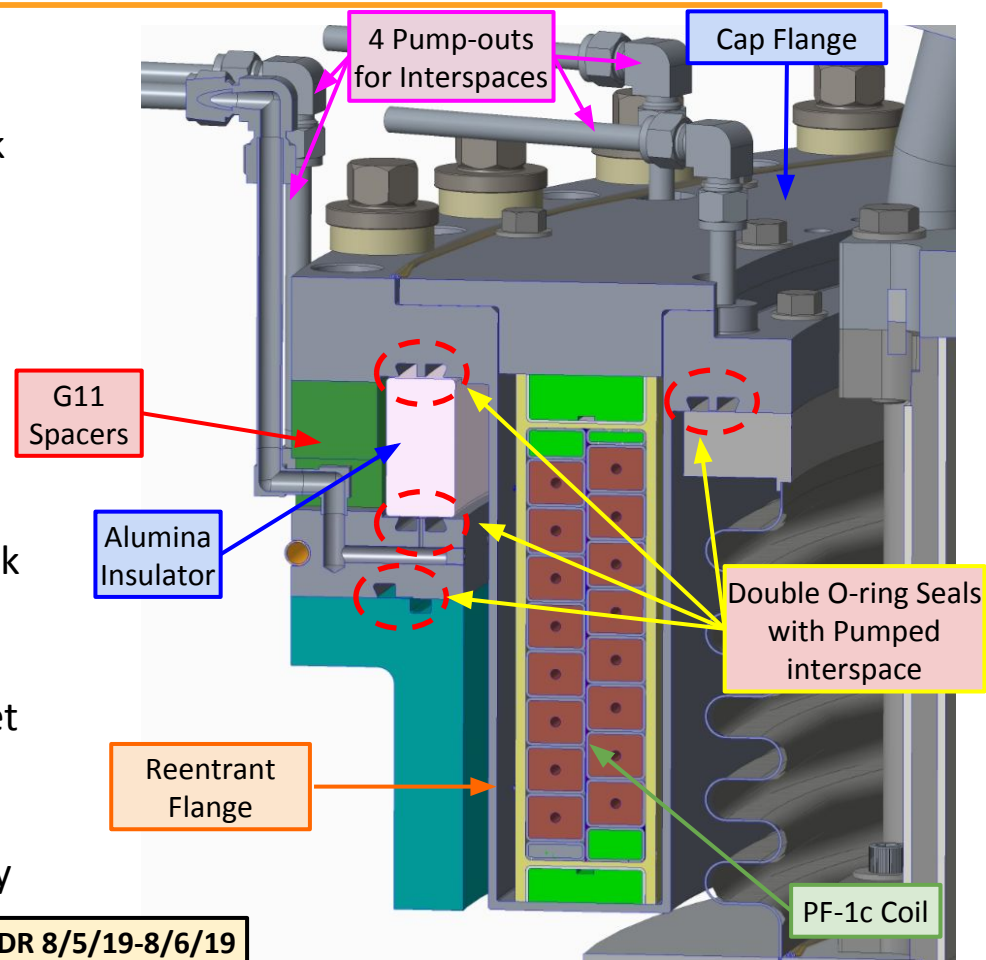
# PF-1c Supports and Ceramic Break - Scope

- PF-1C contained in a reentrant In625 housing
  - Made from In625
  - Double O-ring interfaces to ceramic break and bellows flange
- Flange cap contains keys to allow coil radial expansion & maintains coil position.
- Double O-rings on all vacuum interfaces
  - dovetail grooves trap O-rings during component assembly
  - Two pump-out ports for each interspace.
- Bolts have sealing feature preventing water leak ingress compromising the ceramic break standoff.
- Ceramic break floats between O-rings, space set by G-11 spacer
  - Cooling water on ceramic break assembly
  - Note: No ceramic break in lower assembly

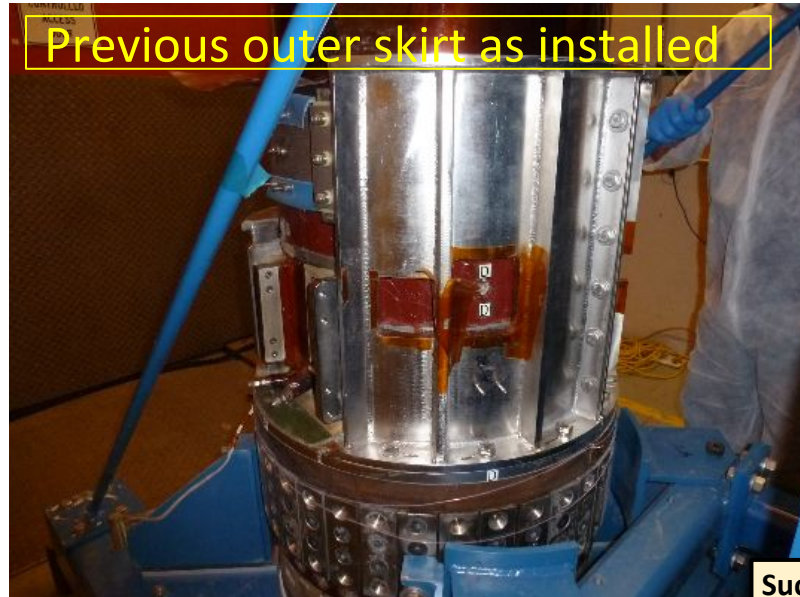
Previous outer skirt as installed

*The Outer Skirt is a 4 part weldment made from In625 with G7 dielectric breaks between each section. The sections are bolted together with hardware + dielectric bushings.*

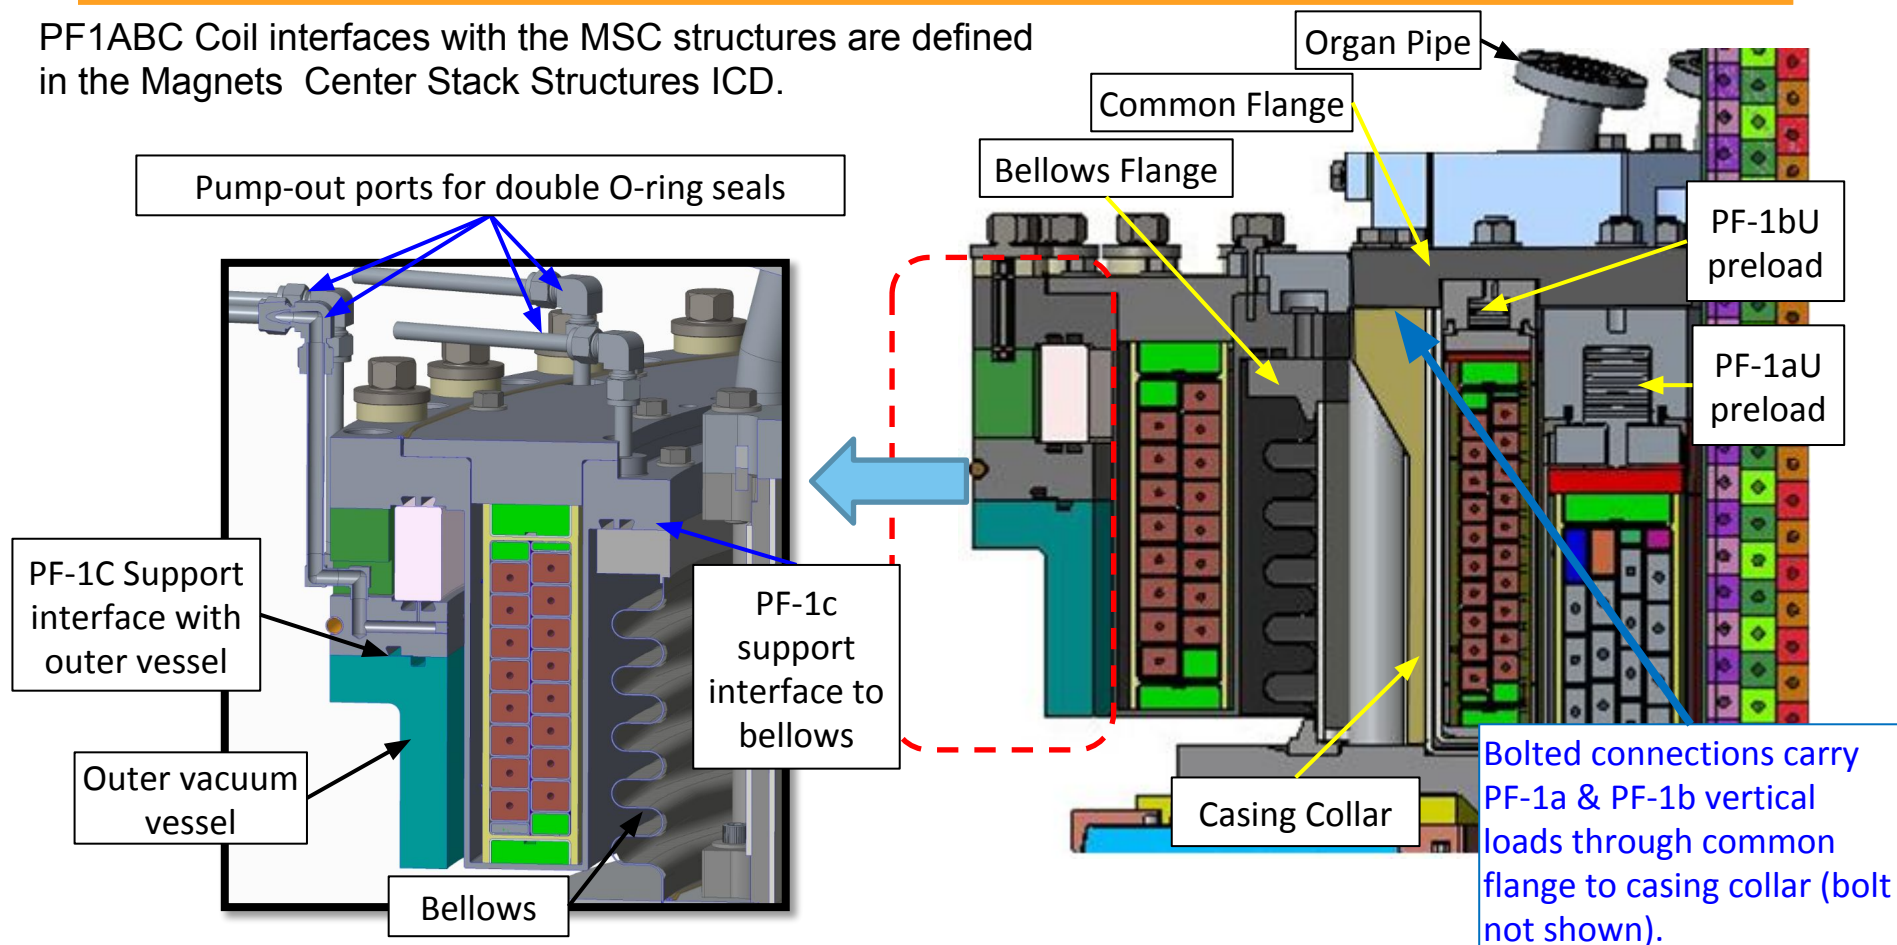
PF1ABC Coil interfaces with the MSC structures are defined in the Magnets Center Stack Structures ICD.

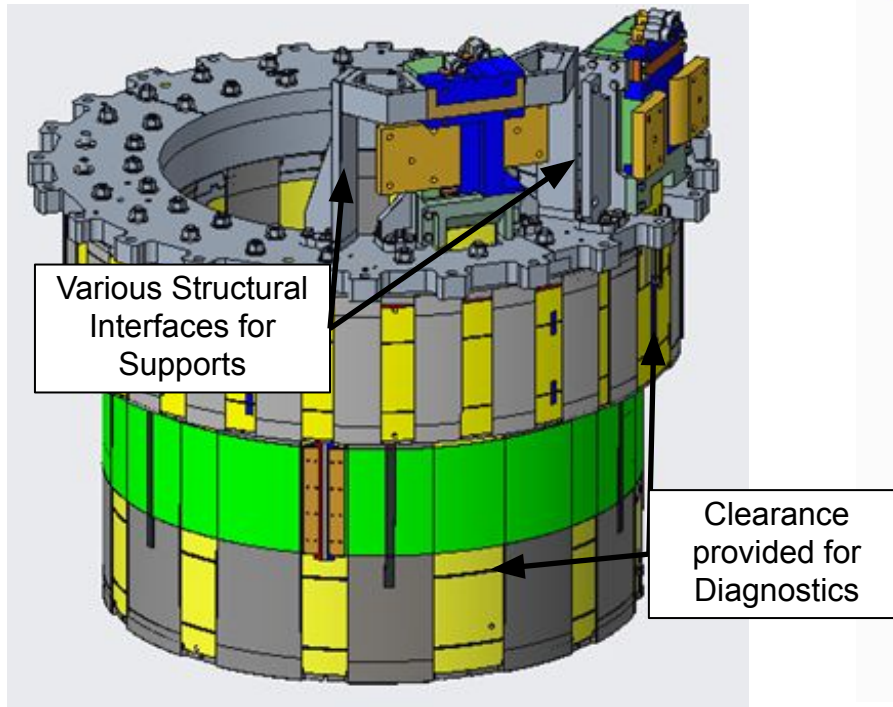
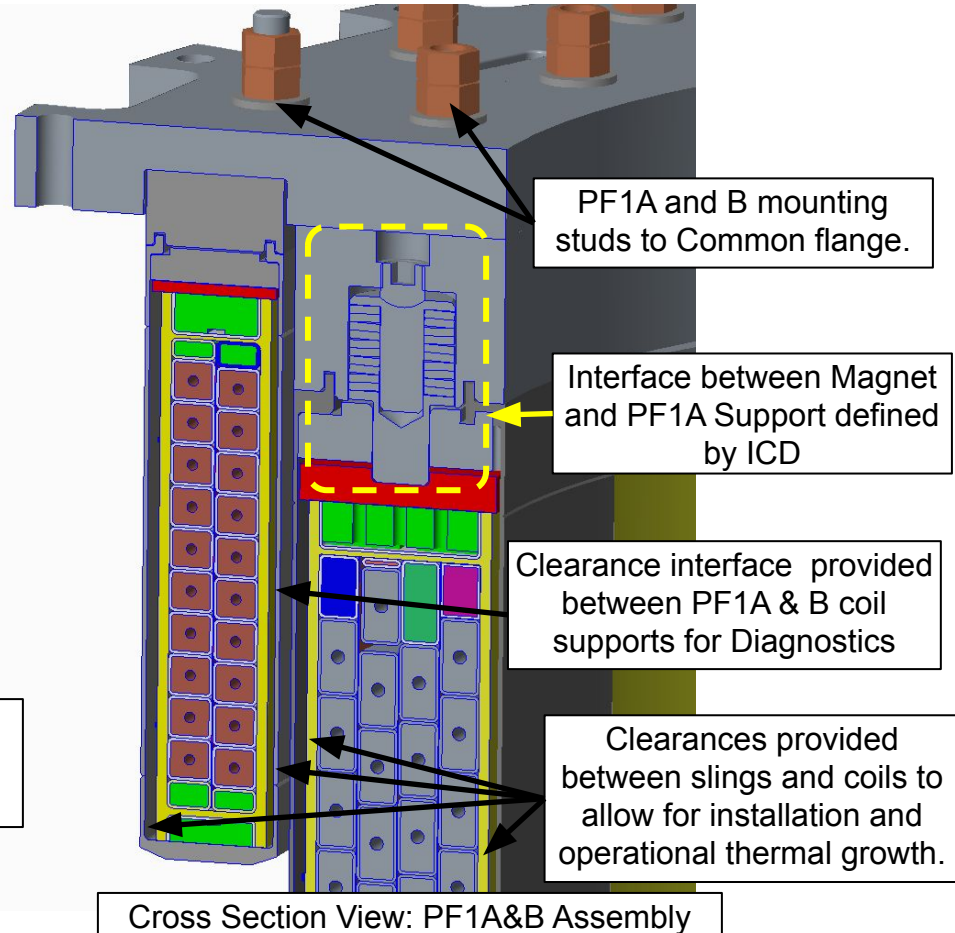
## PF1AB Coils in Combined Assembly

Interfaces with Coils (contact surfaces) and Leads, Flags (clearances)

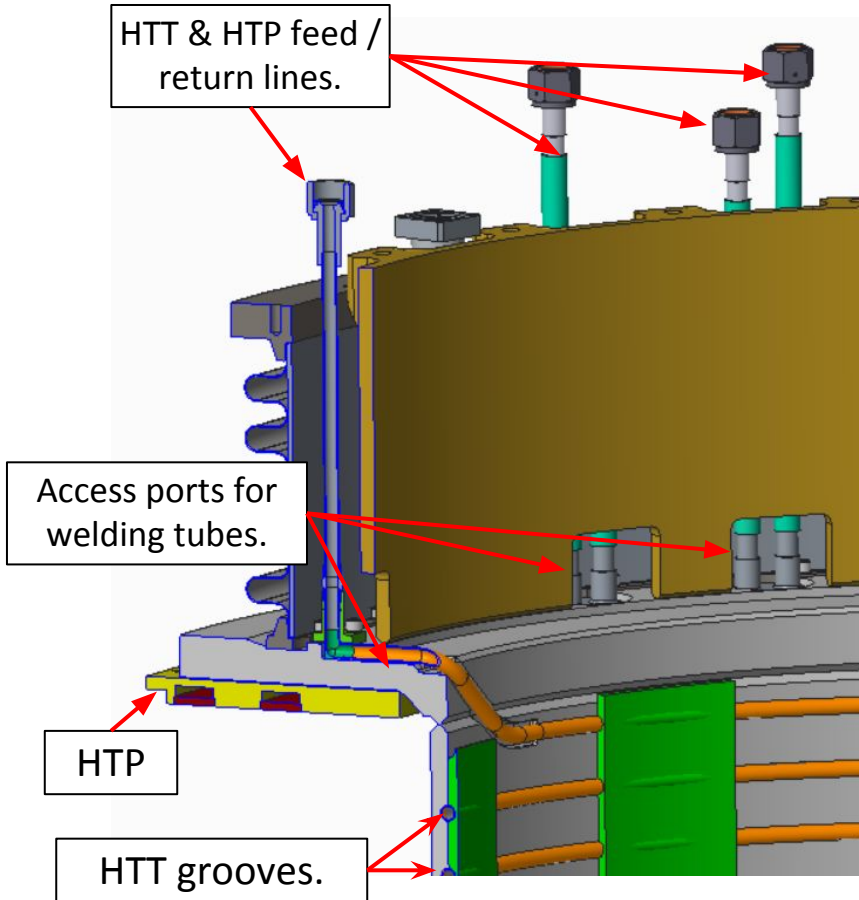
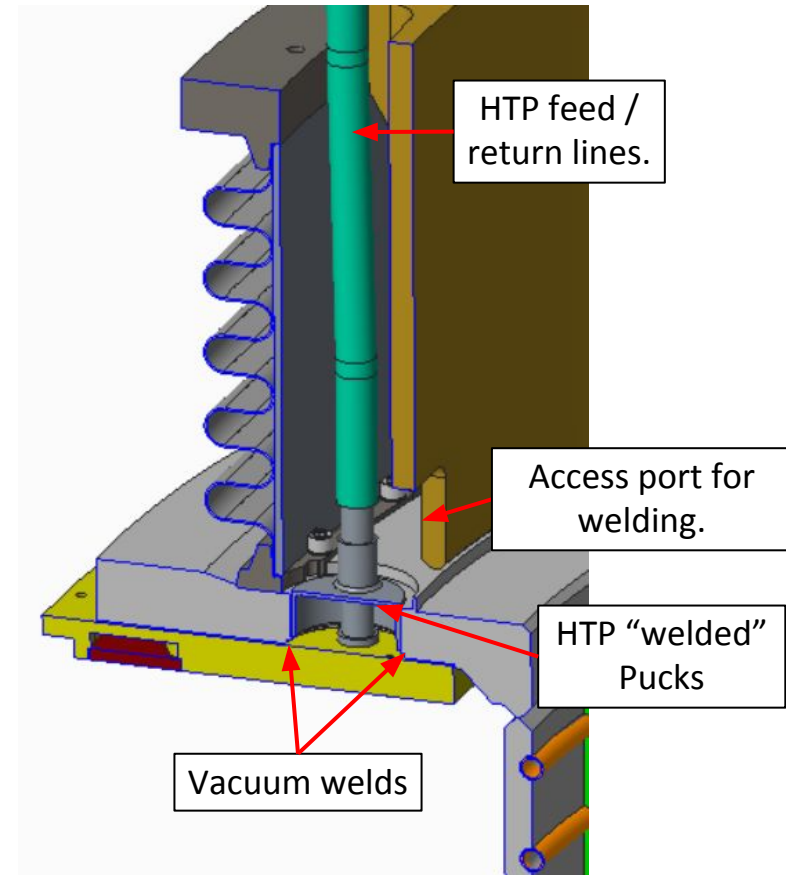
# CenterStack Case Interfaces with Heat Transfer Plate and Heat Transfer Tube Fittings are Integrated into the Design

Clearance ensured between feed / return tubes and adjacent CSCA components.

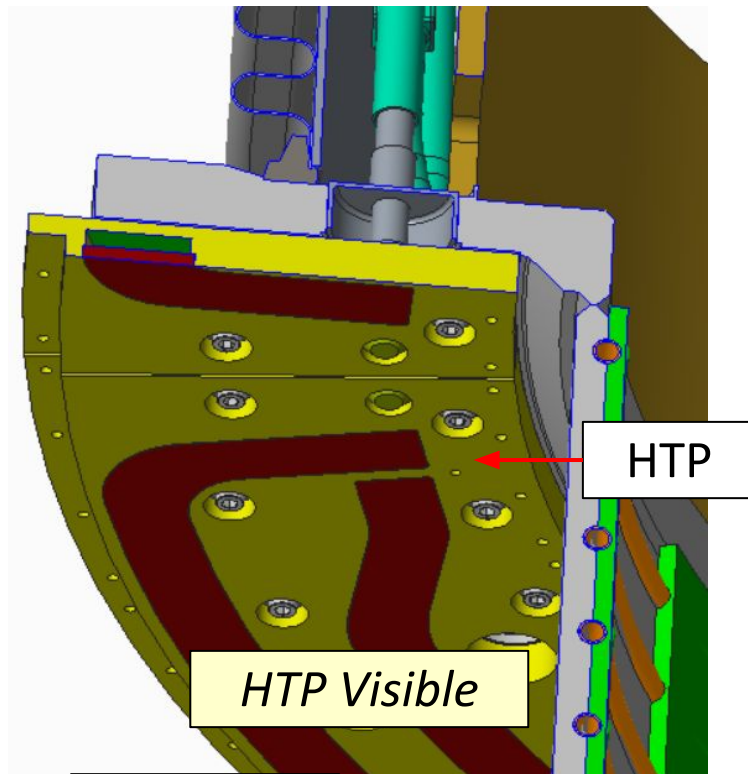
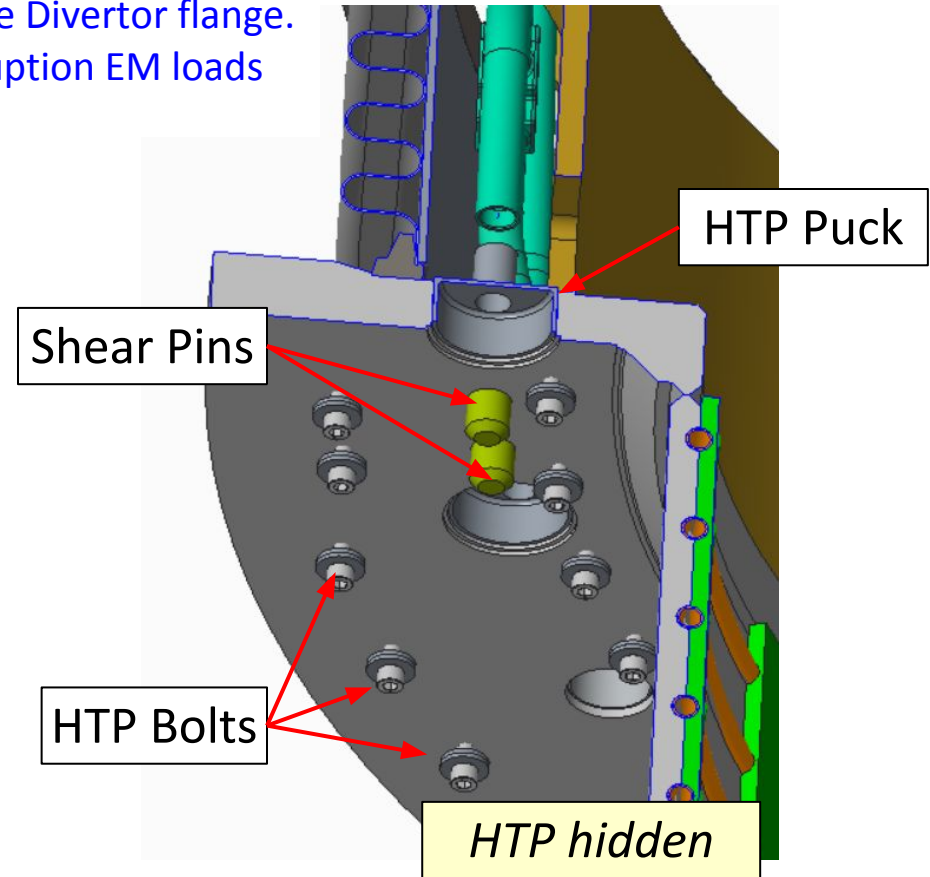
# CenterStack Case Interfaces with Heat Transfer Plate and Heat Transfer Tube Fittings are Integrated into the Design

HTP bolt, shear pin, and puck holes machined into the Divertor flange.  
Provide alignment capability, restraint against disruption EM loads

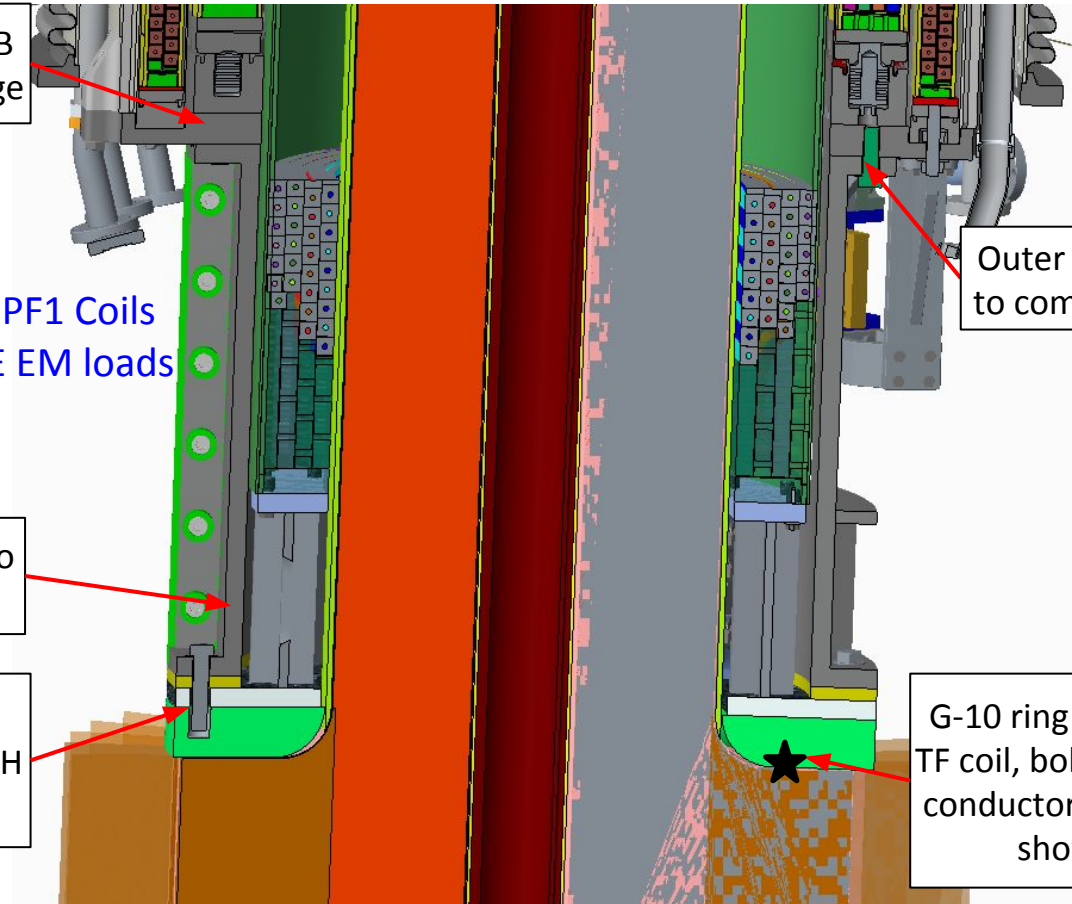
Outer skirt bolted  
through flange of OH  
skirt to G-10 Ring

G-10 ring at base of  
TF coil, bolted into TF  
conductors (bolt not  
shown).

Interfaces support the CSC loads:

- Static vertical: PF coil interactions
- Static side loads: Error field effect PF1 Coils
- Dynamic vertical: Disruption / VDE EM loads
- Dynamic side loads: CS halo
- Dynamic Seismic loads
