# National Spherical Torus eXperiment Upgrade

## Bus Work WBS 1.01.03.02

NSTX-U Recovery Project FDR – March 17-19, 2020

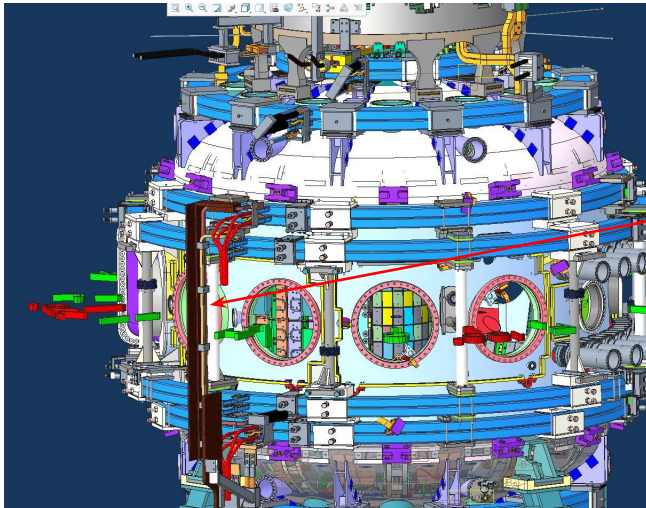
PF4 Bus

- o The PF4 hard BUS and flexible cable supports
- o The Inner PF1 coil support, hard BUS and hard/flex BUS support
- o The center stack casing bakeout BUS and BUS support

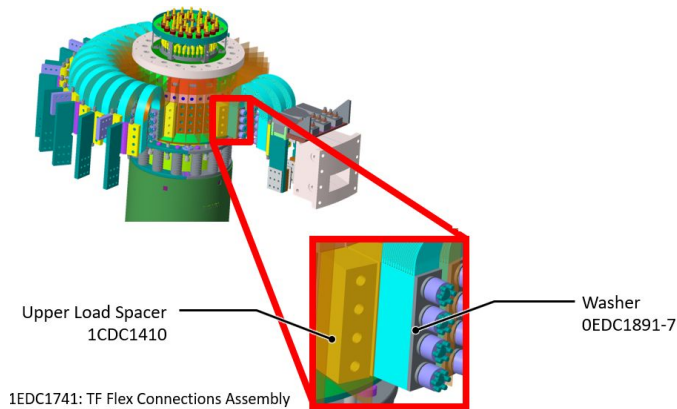
Inner TF bundle extension

- o Inner and outer TF bundle extension field modification
- o OH BUS assembly field modification
- o PF1B water cooled flex power supply cable design and installation

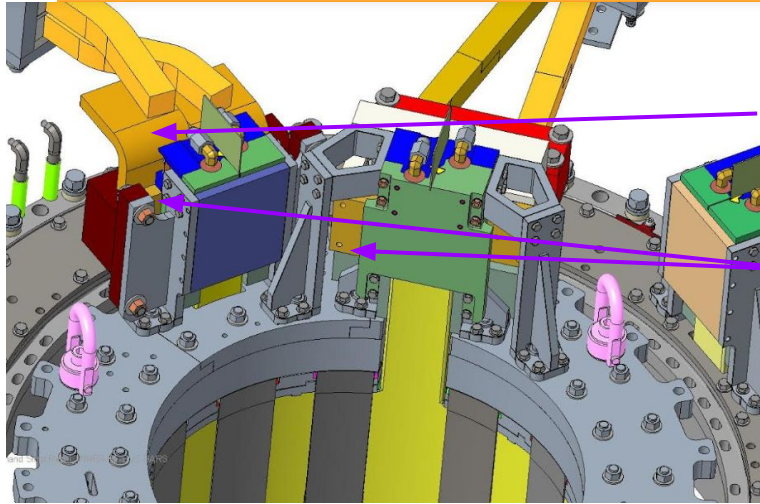
Hard bus flag

Coil flags

Helium tubing  
in-between hard  
BUS

- Coil and BUS are bolted together through coil flag and BUS flag
- BUS routine is based on the space available inside umbrella
- Hard BUS is supported by stainless steel brackets that are attached to umbrella or PF3 supporting structure

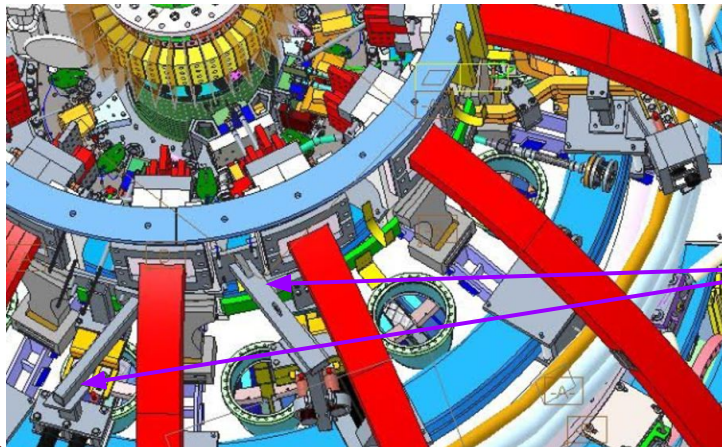
Hard bus support  
attached to  
umbrella

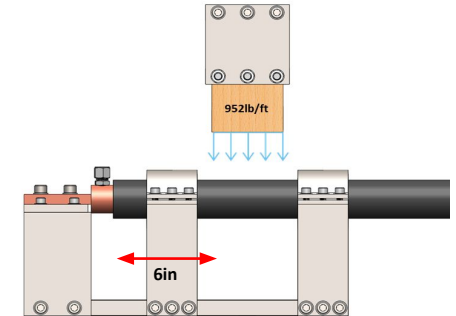
- Cable Pressurized to 120 PSIG
  - Survive without Leak
- 952 lb/ft Load
- Time/Cycle: 2sec
- Frequency: 0.5Hz
- 100,000 Total Cycles (NSTX-U Pulse Spec: 20,000)

Fixture on the 10kip MTS Machine with 4.25in Wood Saddle applying distributed load.

Cable	Young's Modulus	Shear Modulus	100,000 Cycles	120PSIG	Untested Resistance	Tested Resistance
PF1-A/C	12.5ksi	4.4ksi	Survived 50,000 Half load / 50,000 Full Load	No Pressure Loss	162 $\mu\Omega$	162 $\mu\Omega$
PF1B	7.21ksi	2.5ksi	Survived 50,000 Half load / 50,000 Full Load	No Pressure Loss	24 $\mu\Omega$	24 $\mu\Omega$
