NSTX Armor High Heat Flux (HHF) Tests

performed September 1998

Richard Nygren, Sandia National Laboratories

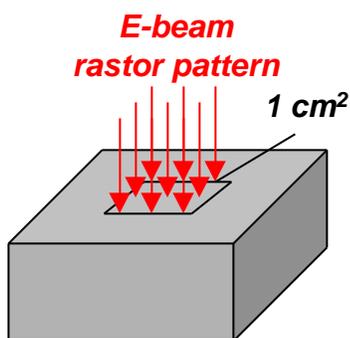
*Result: no apparent damage for exposures to 120 MW/m² for 1.5 s.
We know that CFCs are tough materials.*

<u>ID</u>	<u>Energy</u>	<u>Wt. loss</u>
A	377 kJ	0.0018 g. (<i>Low</i>)
B	494	0.0063
C	356	0.0066
D	285	0.0095
E	271	0.0027 (<i>face, n</i>)

<u>case</u>	<u>heat flux</u>	<u>comment</u>
1-6	5-35 MW/m ²	All samples OK, all shots 1.5 s
7-9	50-140	Short shots (P,T trips), calorimetry
9 rerun	100	All OK, New TC, refocus beam
10	120	All OK
11	60	Longer shots, >2 s until T trip ends
