# Forensic Analysis of Faulted NSTX-U Inner Poloidal Field Coil

**Abstract**—The failure of the NSTX-U PF1A upper coil suspended plasma operations during the project’s first operational campaign after commissioning. Initial nondestructive testing and examination of the failed coil was followed by extensive nondestructive radiography. Destructive testing facilitated visual borescope/videoscope inspection through the cooling path, vacuum testing, and electrical testing of every conductor segment. One conductor cooling path visually evidenced a void through the sidewall of the cooling path in a layer-to-layer region. The identified void in the conductor cooling path was not proximal to a braze or joggle. Electrical testing indicated that the voided conductor segment was a member of a group of 14 conductor segments that evidenced low-resistance connectivity. Four braze joints and two lead segments were subjected to 400-lbf/in<sup>2</sup> hydrostatic pressure testing followed by helium leak testing and evidenced that there were no detectable leaks in the tested cooling path segments. The faulted region was proximal to the center of the coil pack and evidenced historical electrical pitt

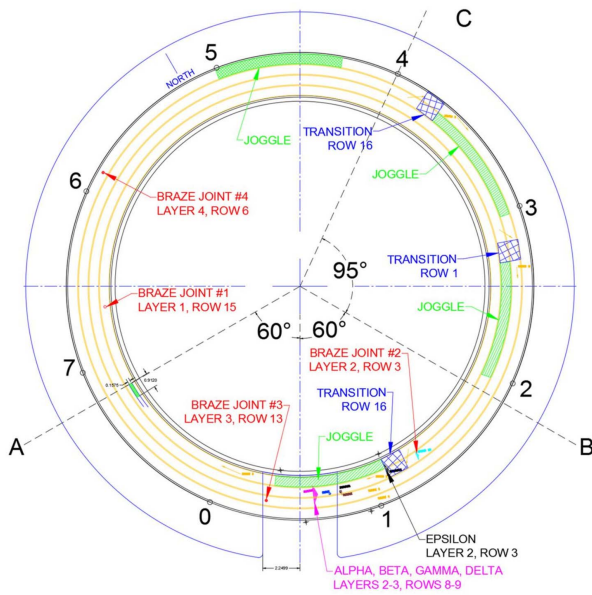
The completed radiographic study was used to select locations to segment the coil for destructive evaluation. The features observed in the radiographic study allowed the investigation team to minimize the risk of compromising anomalies and critical areas such as brazes, joggles, and leads.

Fig. 8. Identified sectioning cuts “A, B, and C.”
