NSTX TF JOINT RE-DESIGN

C. Neumeyer

20th IEEE/NPSS Symposium on Fusion Engineering

October 14-17, 2003

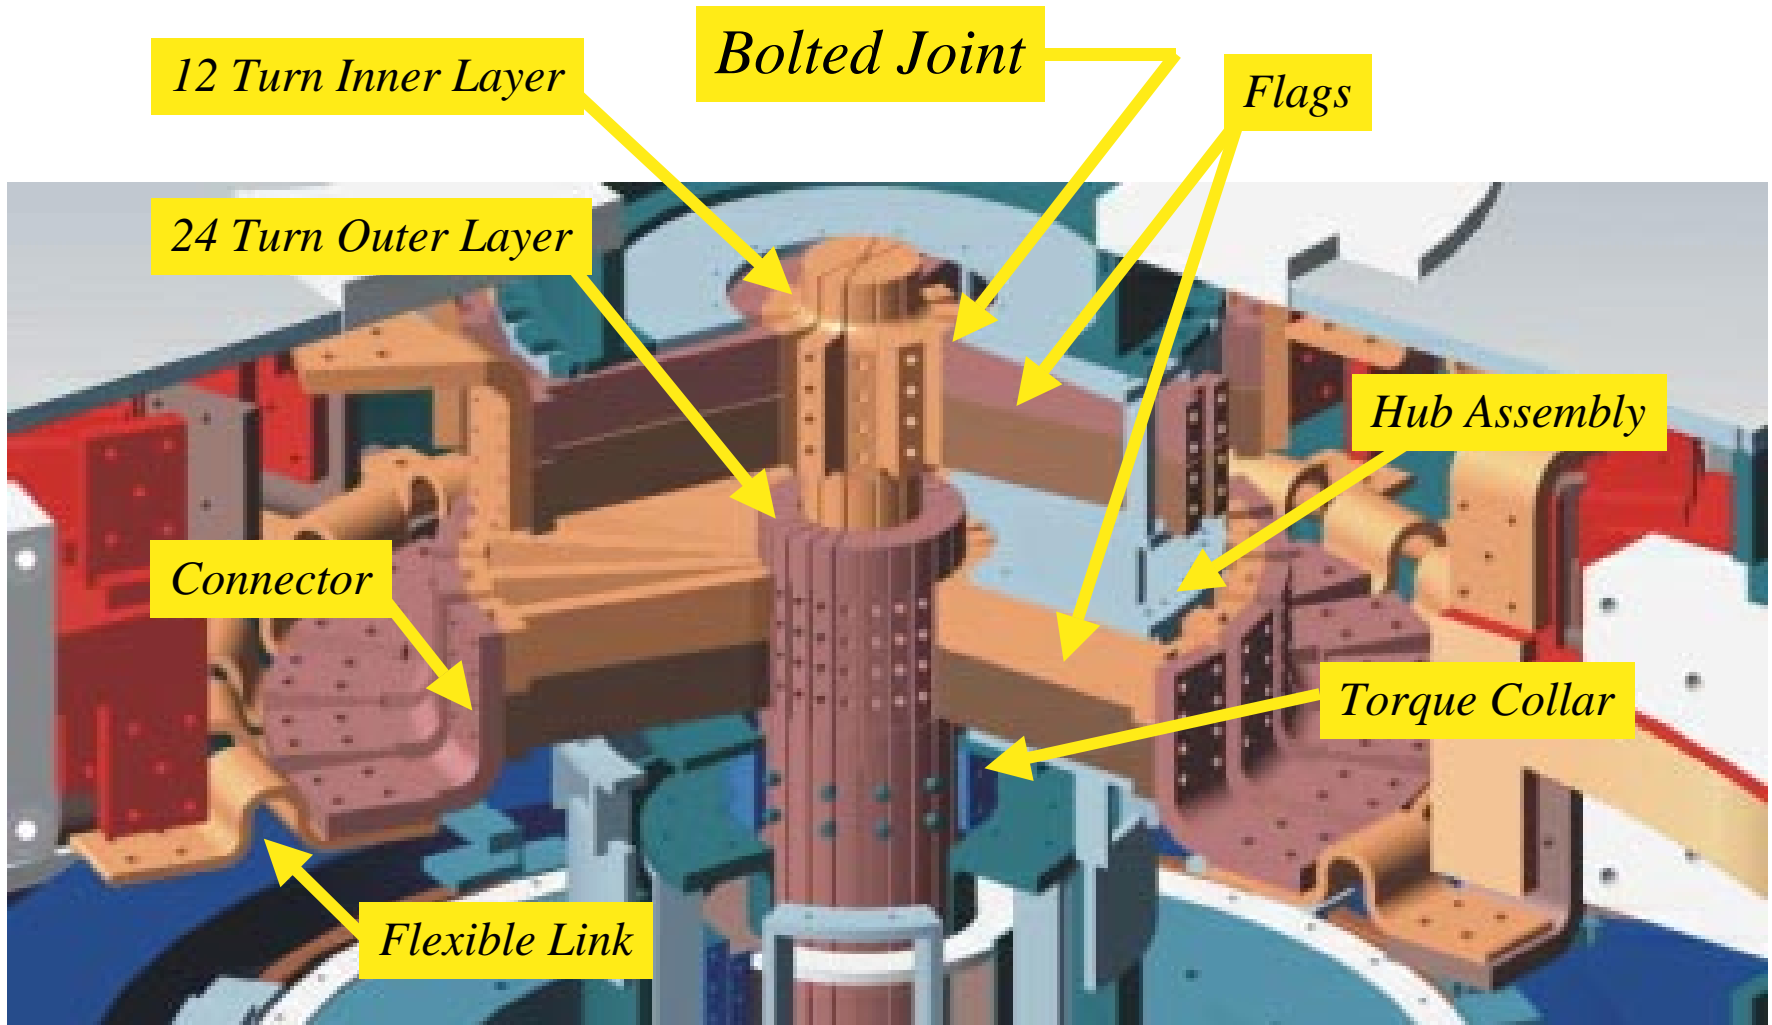
ORIGINAL TF JOINT ELEMENTS

Note: Original Design Shown

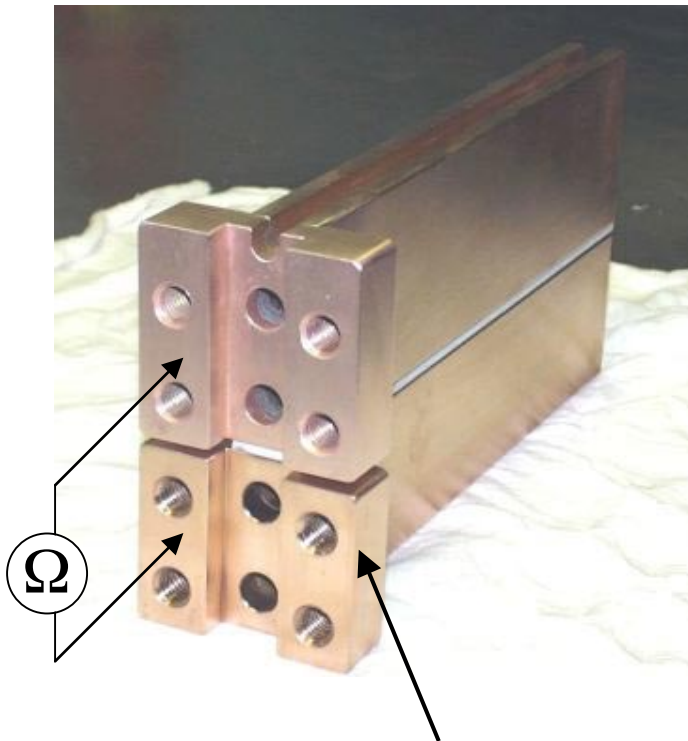
FLAGS, SHIMS, WEDGES

Original Split Flag

Original Wedges and Shims

Split flag to facilitate joint resistance measurement
