# PF-1aU Summary

Stefan Gerhardt

NSTX-U Team Meeting  
PPPL, MBG Auditorium  
7/29/2016

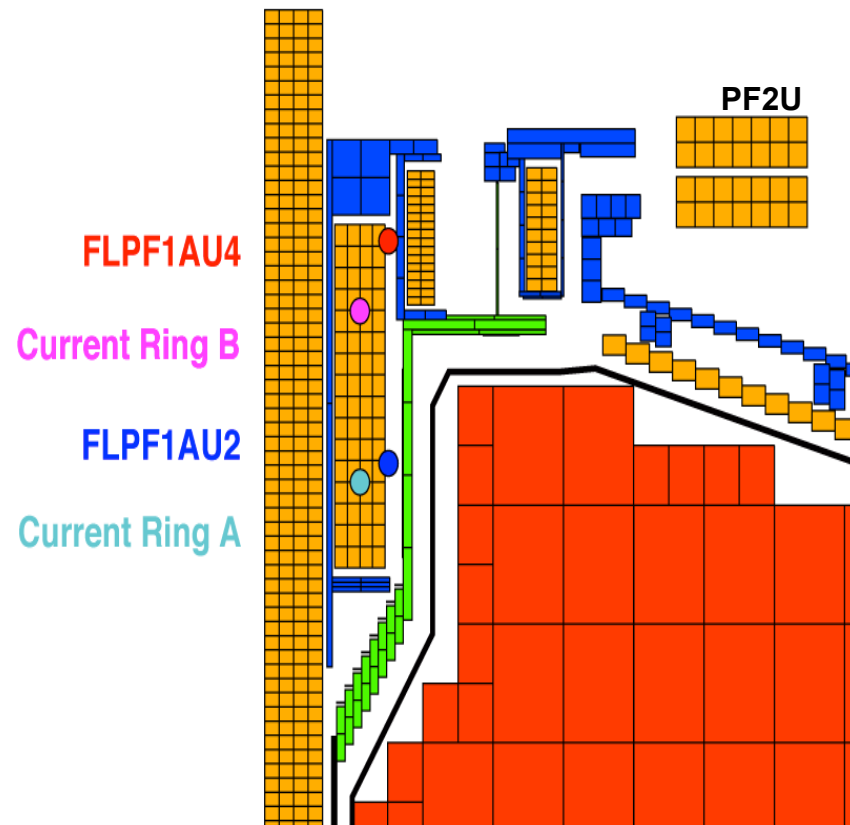
# Use Two Model 'Current Rings' in PF1aU to Estimate Current Transients

- The fluxes are measured at FLPF1AU4 and FLPF1AU2
- The difference between the fluxes measured during recommissioning in July and during reference shots in December can be used to infer circulating currents in the compromised PF1aU coil
- Model the circulating currents in PF1aU with two current rings (A & B)
- Compute the mutual inductance matrix and invert to find the currents that produce the measured flux differences
- Identical analysis on the bottom coil and loops

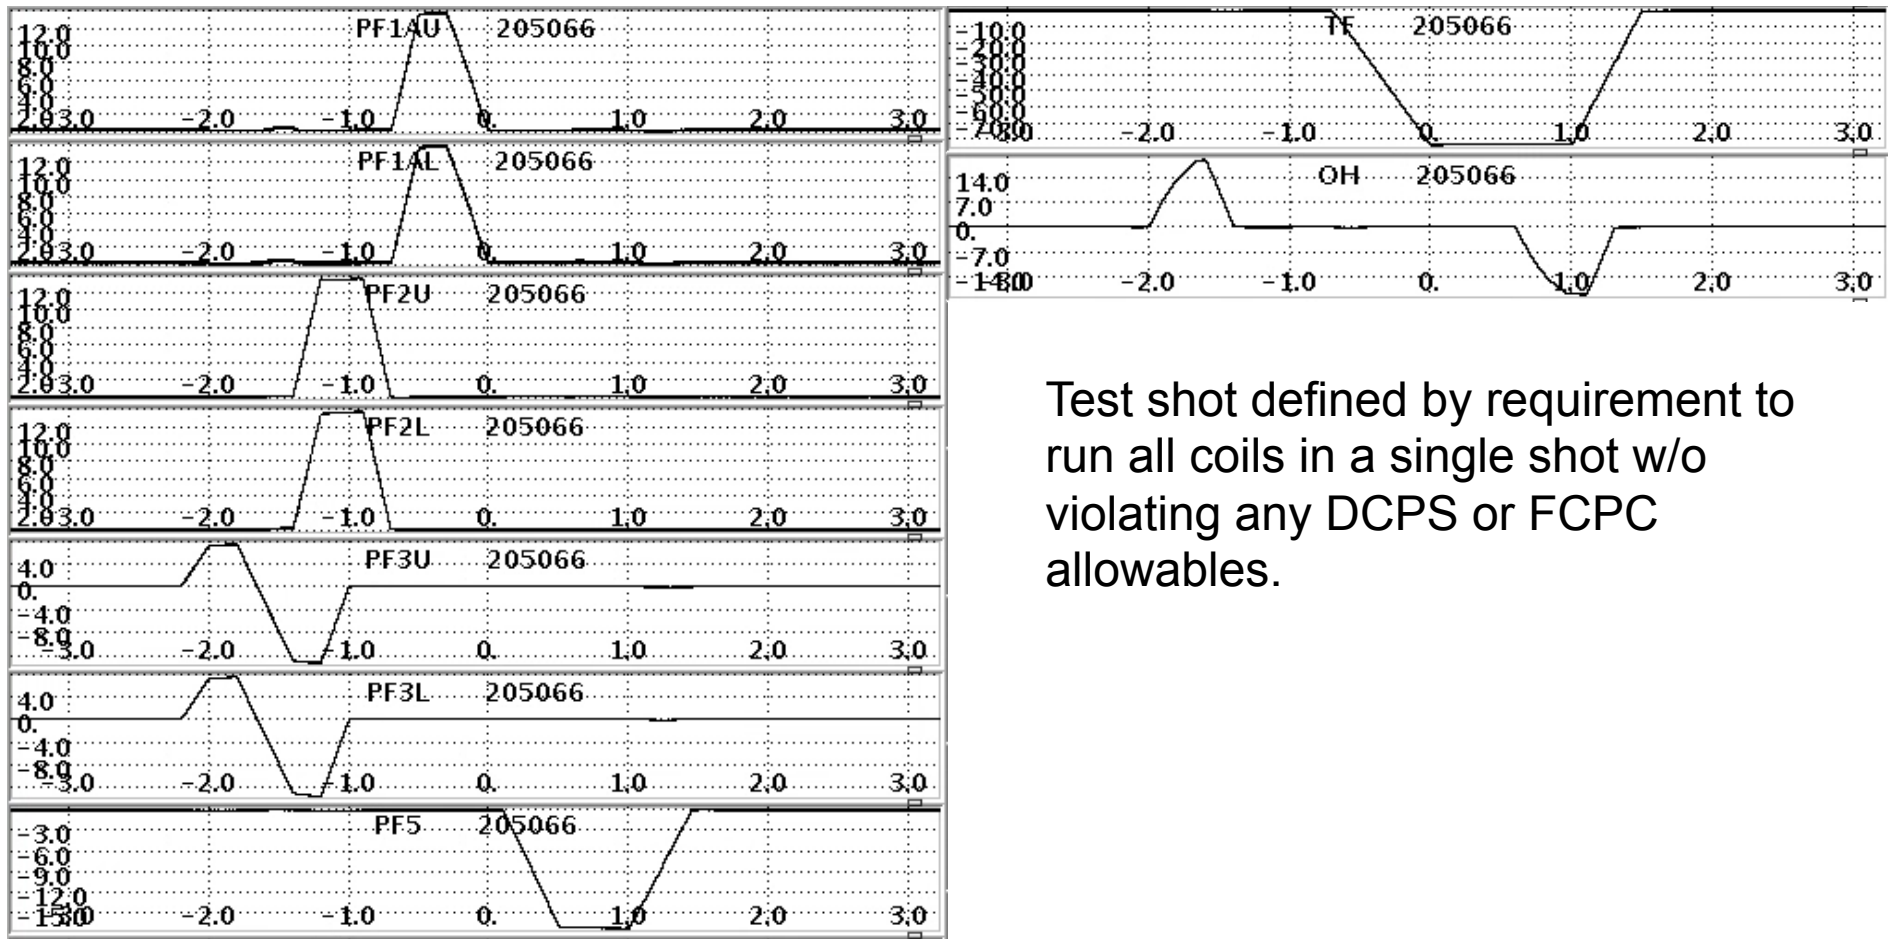
# Test Shots Have Coils Coming and Going at Various Times

Test shot defined by requirement to run all coils in a single shot w/o violating any DCPS or FCPC allowables.

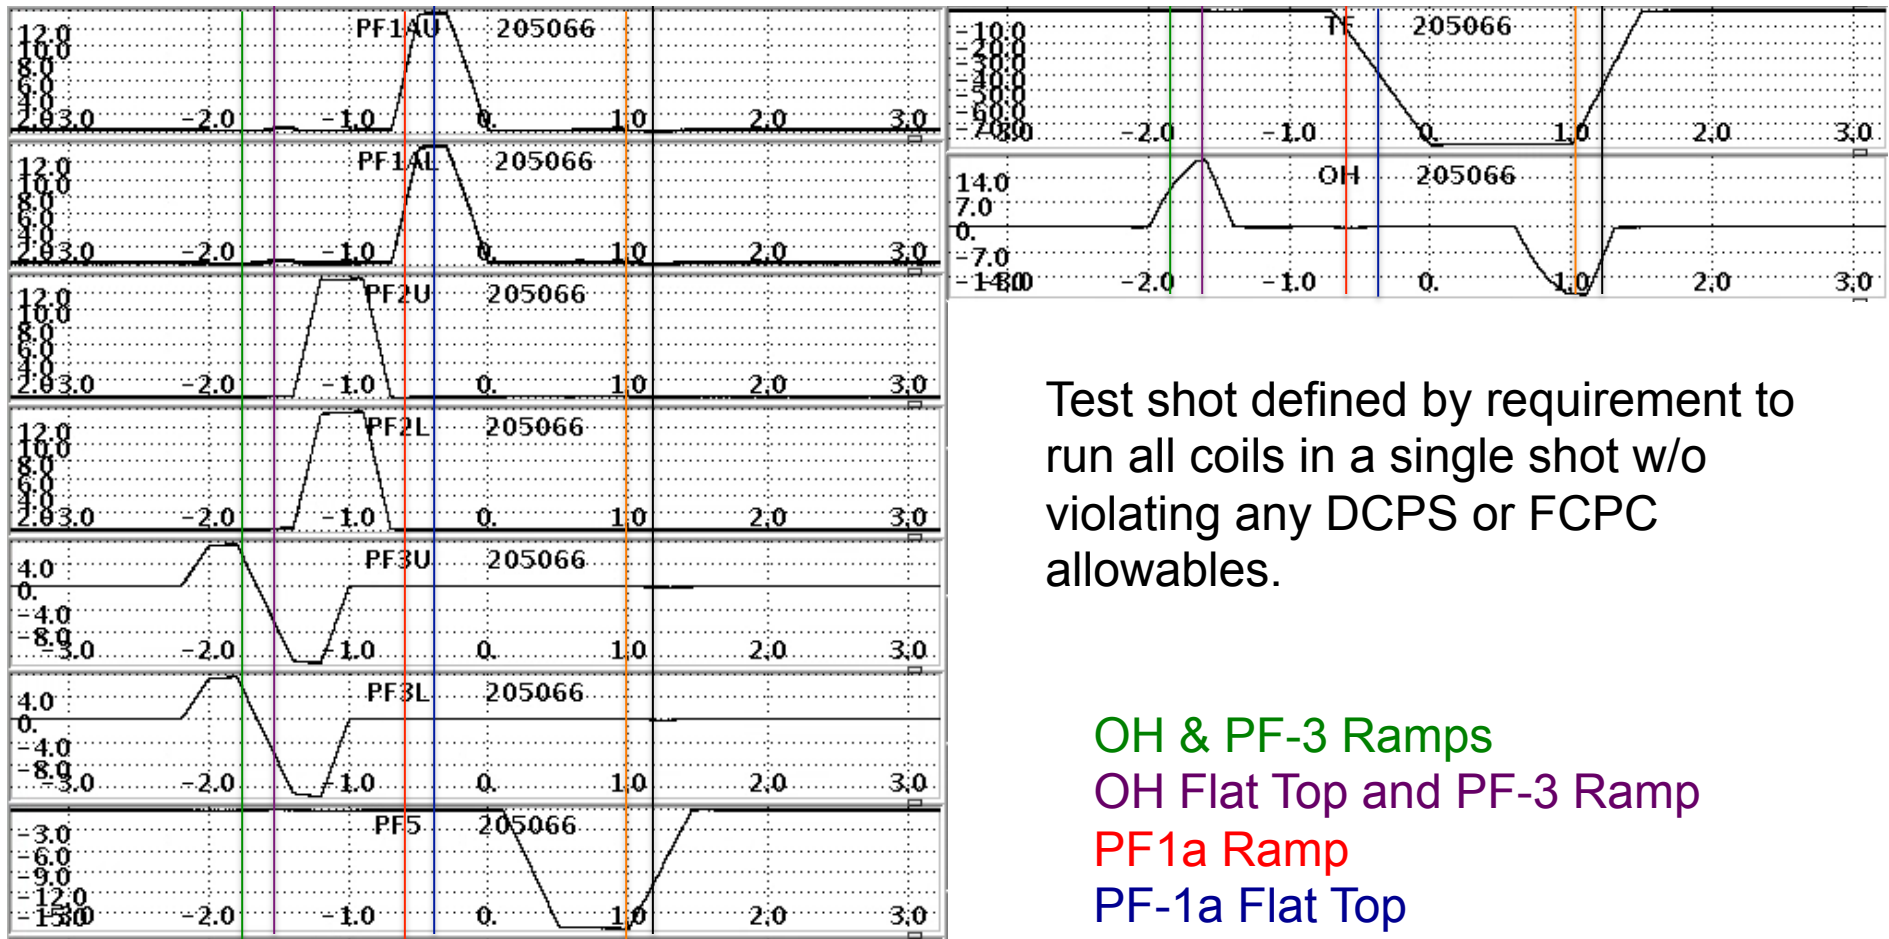
# Test Shots Have Coils Coming and Going at Various Times

Test shot defined by requirement to run all coils in a single shot w/o violating any DCPS or FCPC allowables.
