National Spherical Torus eXperiment Upgrade

Project Status

TB Bundle - Recent Activities

Overview - 2/2: Recent

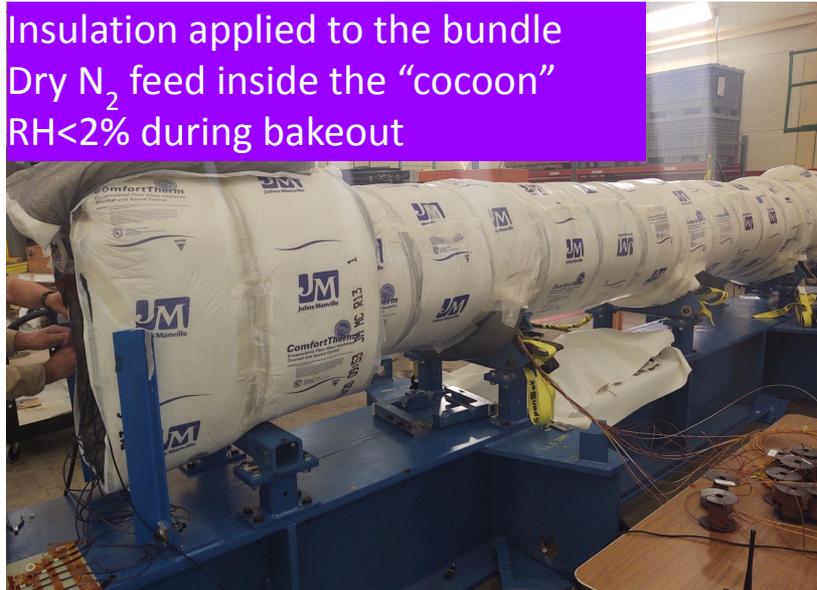
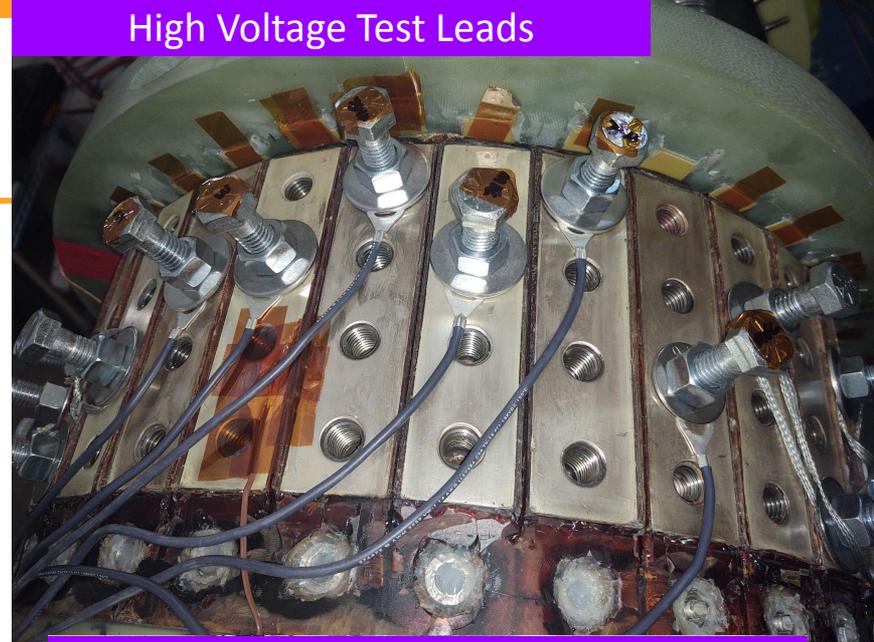
Bakeout Preparation

Insulation applied to the bundle
Dry N₂ feed inside the “cocoon”
RH < 2% during bakeout

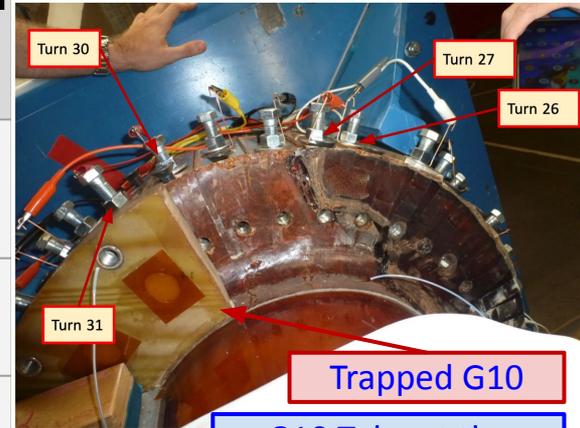
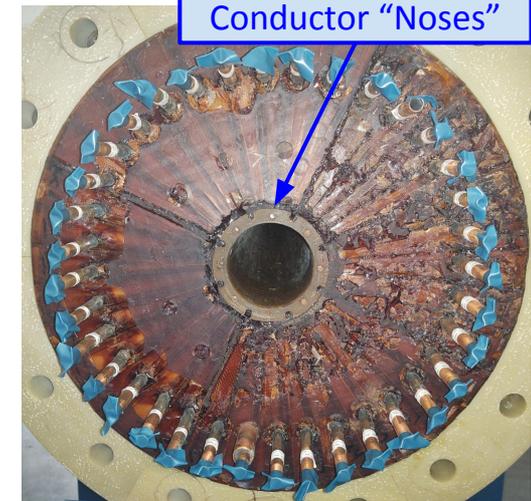
Potential Location or Source of Problem	Action	Action included in present schedule
Contamination in cracked or patched resin on the midplane side of the flags	Carefully remove the “neat resin” <i>...ongoing...see next slide...</i>	Yes
Bundle ends, amongst water tubes	Excavate resin/glass around tubes, repair	Yes
Contamination under trapped portion of G10 ring	Remove trapped G10 ring half, either by cutting it away or by sliding the OH coil	Planning: Yes Work: No
Water trapped “deep” in the bundle	Vacuum bakeout - developing an idea for a method to do this at PPPL	Planning: Yes Work: No
Contamination or insulation degradation at the noses of the conductor	“Excavate” the G10 ring in the core of the bundle	Planning: Yes Work: No

Evaluating whether these issues may be traceable to manufacturing, i.e. RTV use, kapton tape, etc.

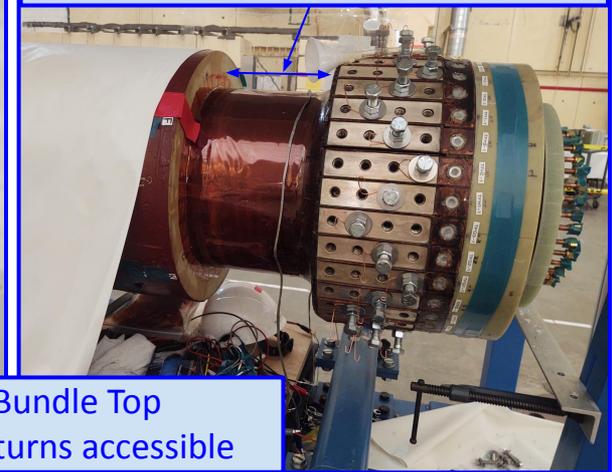
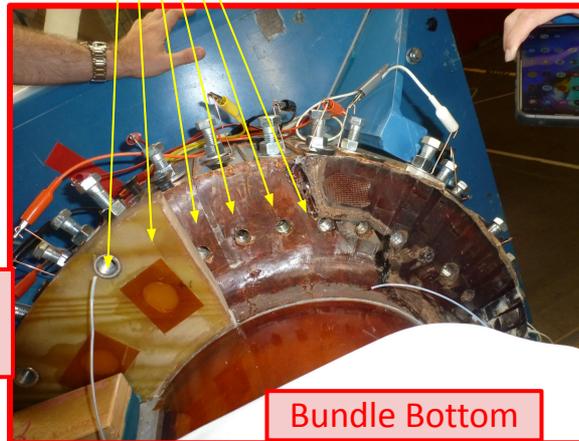
Pre-load applied by a Belleville washer assembly in this gap at top

- Resin w/o glass is inherently brittle (resin rich)
- Cracks may have contamination.
- Network of cracks can allow non-adjacent turns to communicate
- Carefully sand down the cracked and extremely resin rich areas, down to the turn insulation - removal of contamination and provide a uniform bearing surface when restored.
