Overview XP 455

Error-field studies using tearing modes and mode control coils

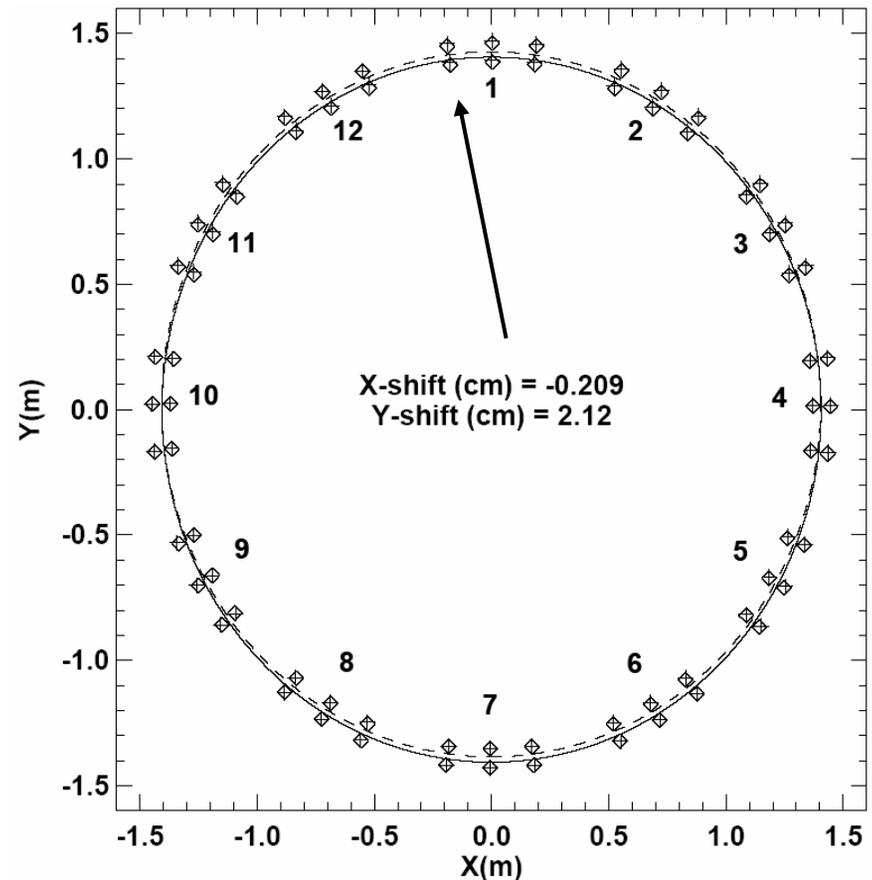
Primary passive plates
apparently lie on circle
shifted from machine centerline

Also affects interpretation
of signals from B_R & B_P sensors
mounted on passive plates

- Locking much less of an issue since PF5 circularization
 - But, TMs still often lock to a few preferred locations
- Only PF5 has been measured and “circularized” – other PFs may have issues
- Another possible source is shift in vessel & plates relative to machine centerline

Need to re-measure plate
centering during the next outage

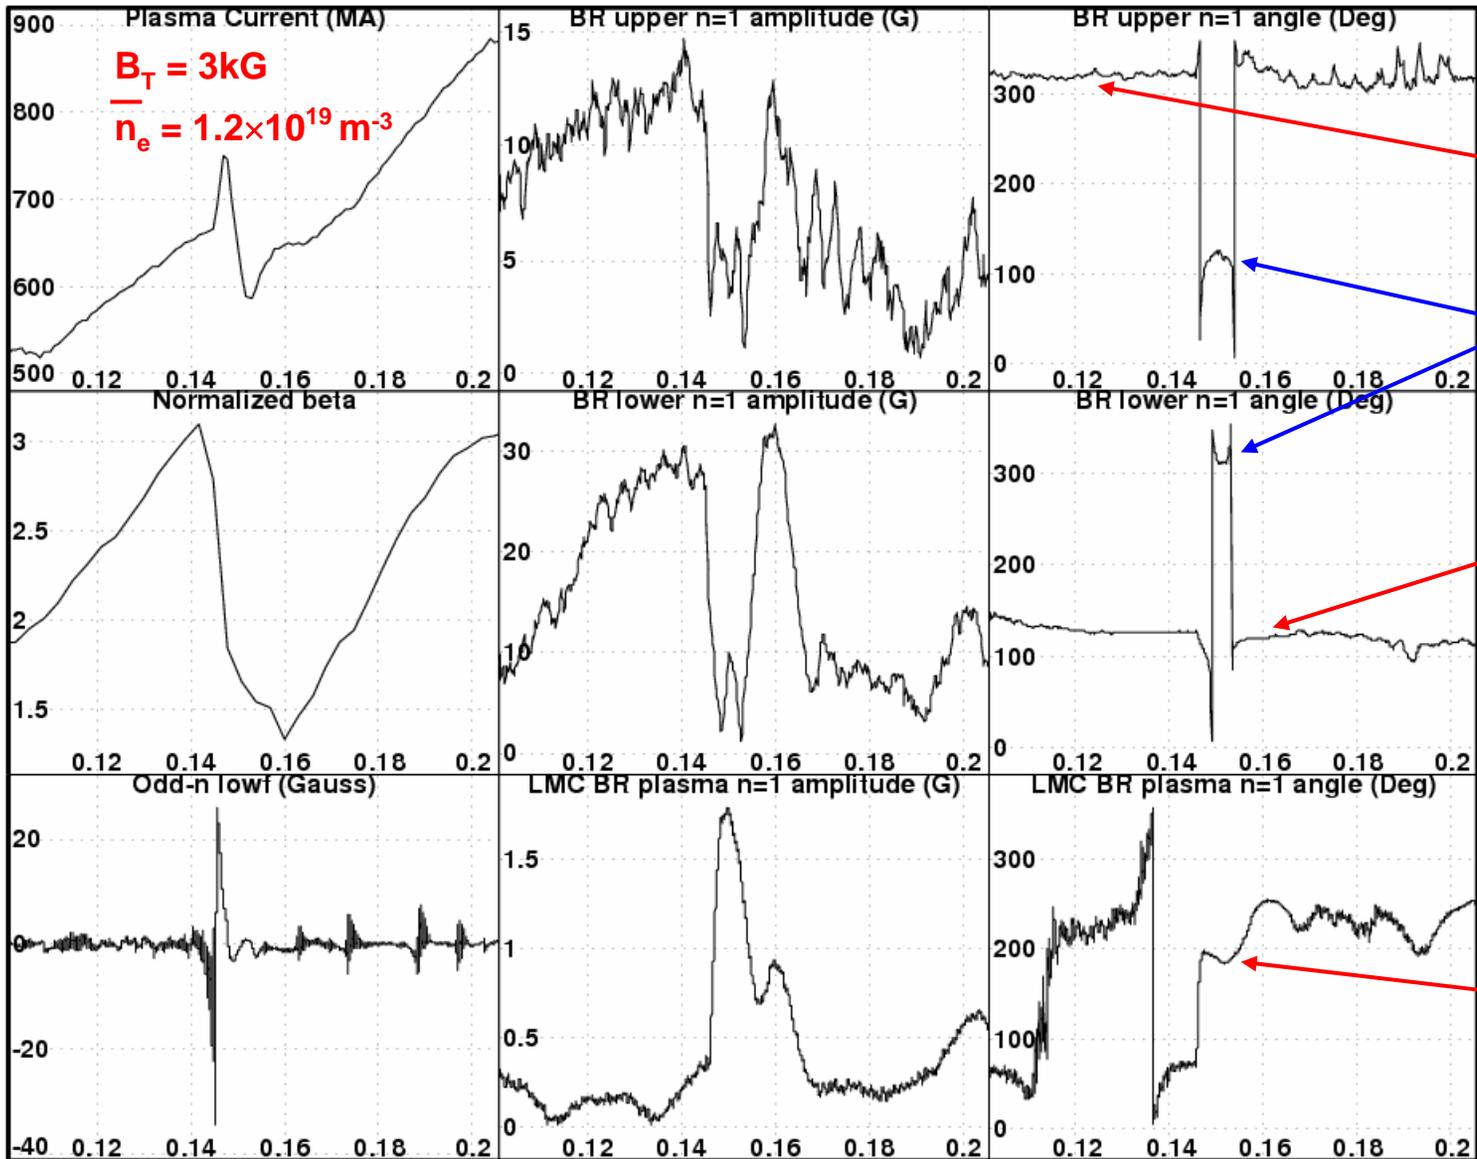
NSTX RWM/EF BR n=1 Modes 113266

Data suggests island locked with O-point near $Z=0$, $\phi_{\text{ENG}} \approx 130^\circ \Rightarrow$ apply B_R at $\phi_{\text{ENG}} \approx 240^\circ$ (H/I)

Part 1 - low- n_e locking during I_p ramp

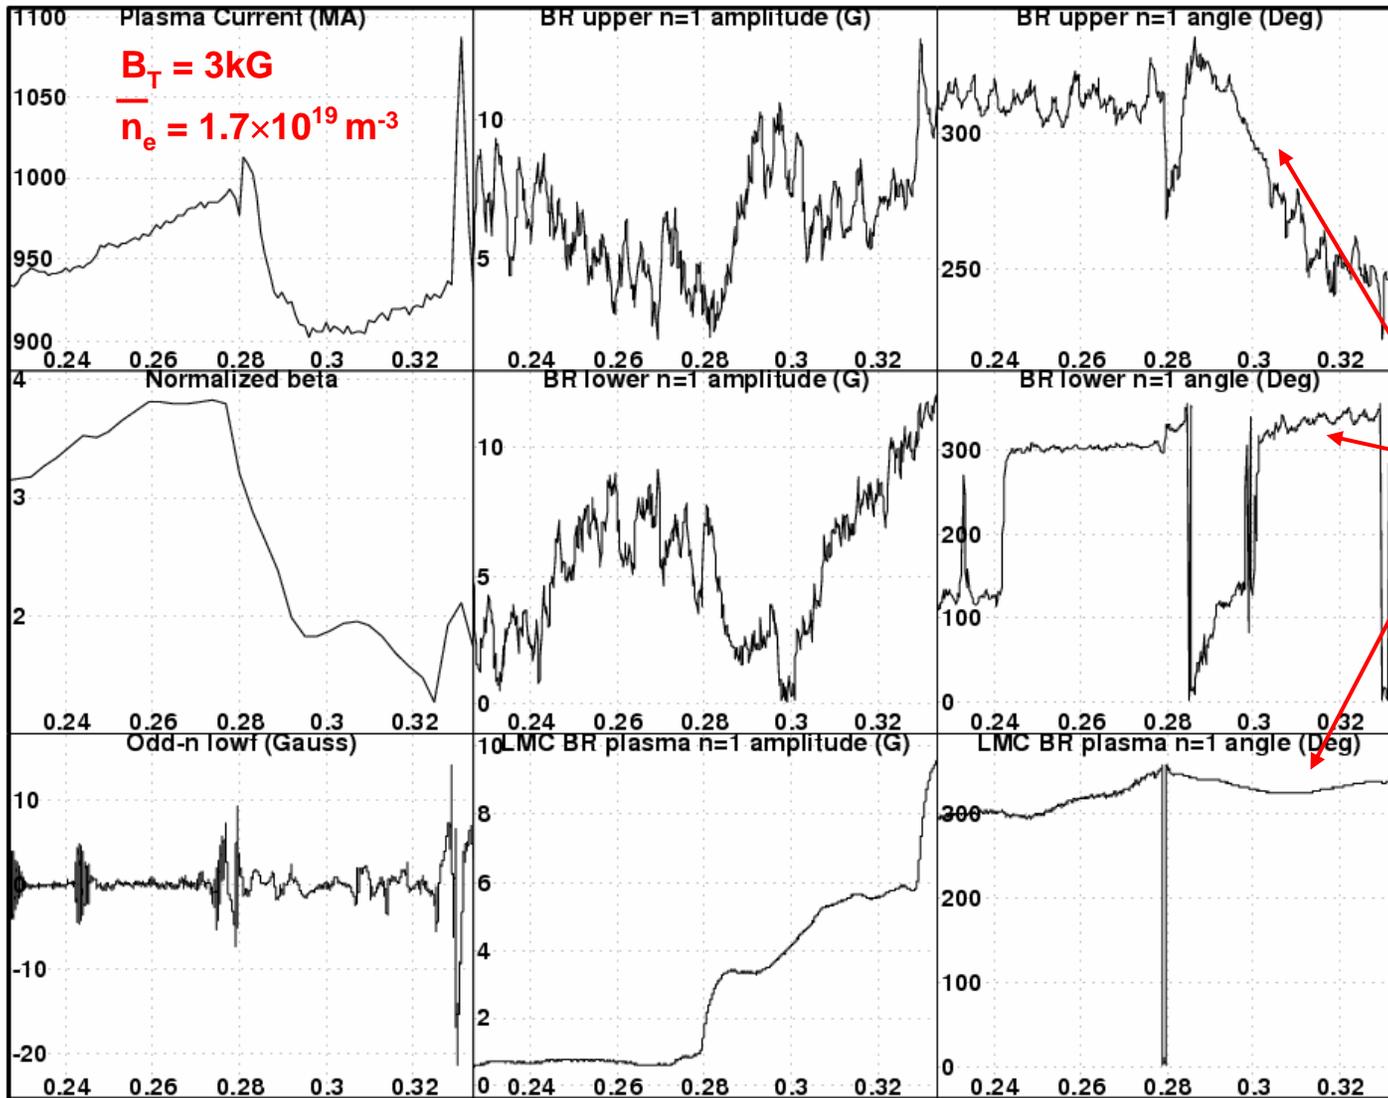
NSTX RWM/EF BR n=1 Modes 113266

Toroidal angles similar...

Different helicity mode - 1/1?

Not clear applied field can match helicity...

Part 2 - low- n_e locking during I_p flat-top

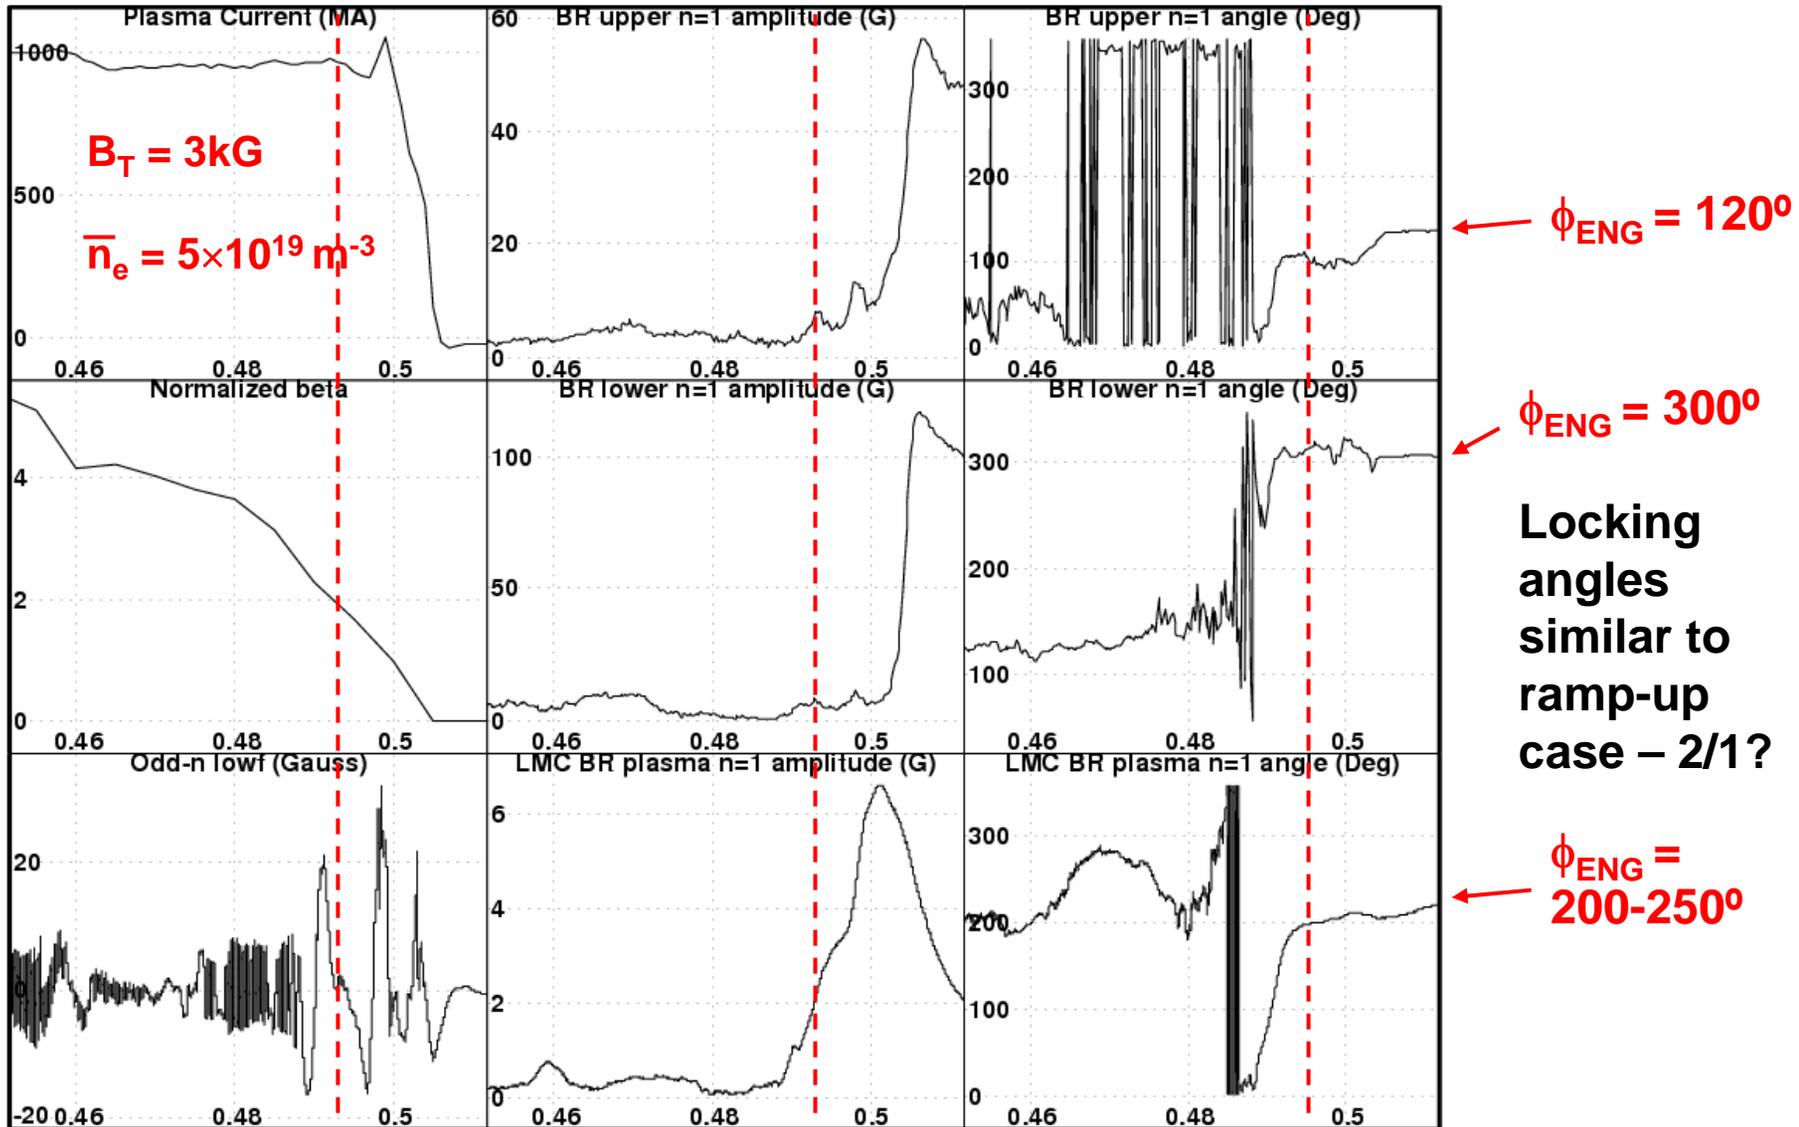
NSTX RWM/EF BR n=1 Modes 113265

Part 3 - higher- n_e rotating mode during I_p flat-top
