**1st NIFS-CRC International Symposium and 1st Korea-Japan Workshop
on Edge Plasma and Surface Component Interactions in Steady State
Magnetic Fusion Devices, NIFS, Gifu, 2007.05.20-22**

Damage Structure of Tungsten under He Particle Loading

Naoaki Yoshida

**Research Institute for Applied Mechanics,
Kyushu University, Japan**

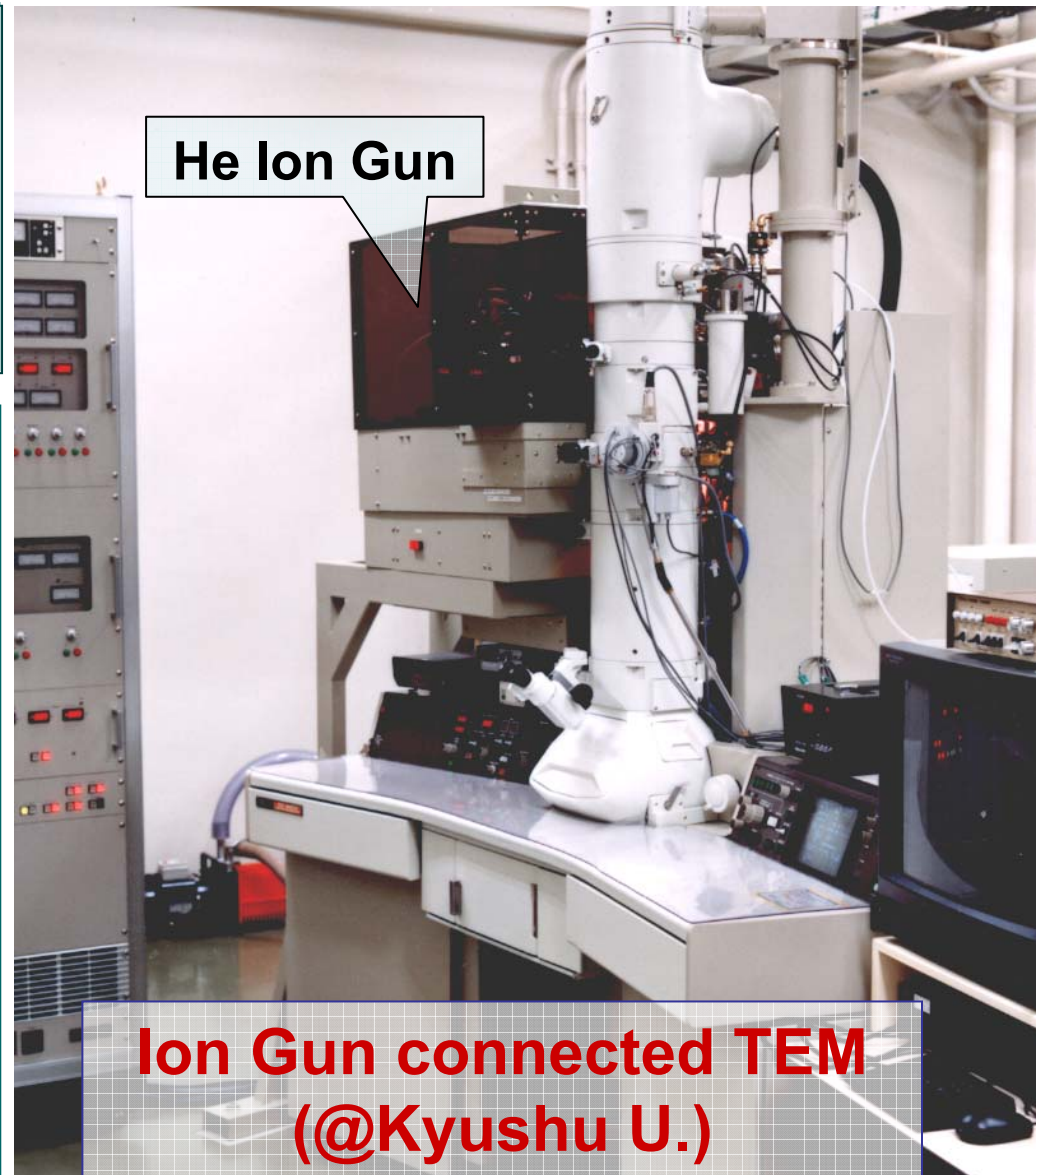
In situ Obs. of Dynamical Damage Proc.

Ion Injector

- Acc. Energy: 0.1 ~ 10 keV
- Ion Species: H, D, He
- Ion Current (on the specimen):
 $2 \mu\text{A}$ (@0.2keV)
- Record: films, video

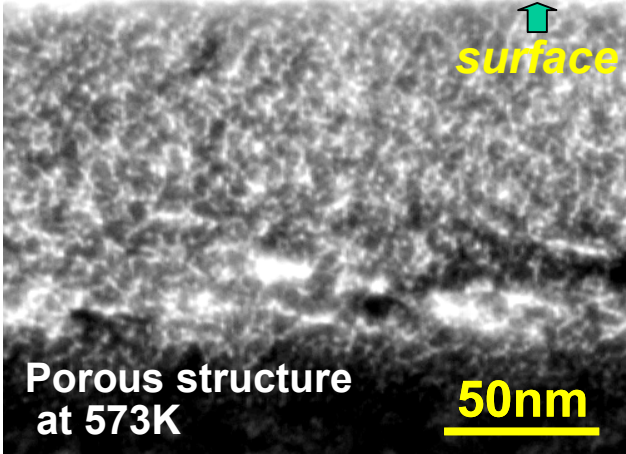
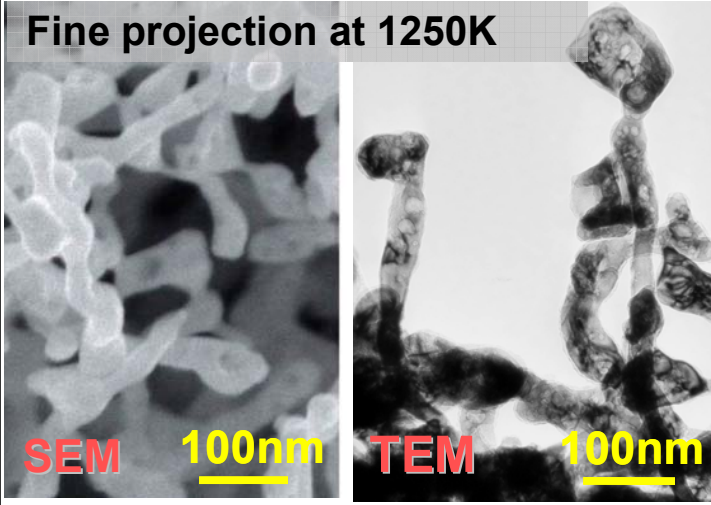
<p>Porous structure at 573K 50nm</p>	<p>Fine projection at 1250K</p>

<p>SEM 100nm TEM 100nm</p>

Behavior of He bubbles determines these variety of microstructures and resulting optical properties.

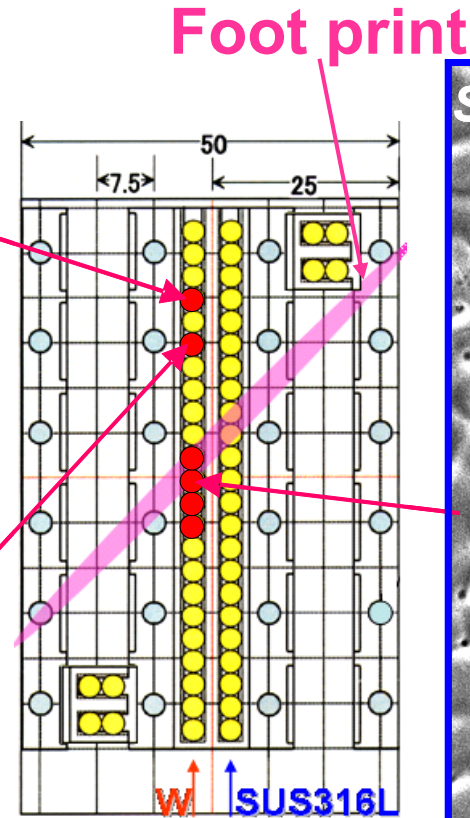
He Plasma Irradiation Damage of W at Divertor Position in LHD

Discharge time = 1 s

He bubbles Blisters

Grooves, cracks

- These are damage at erosion dominant area.
- We should know the phenomena at deposition dominant area.

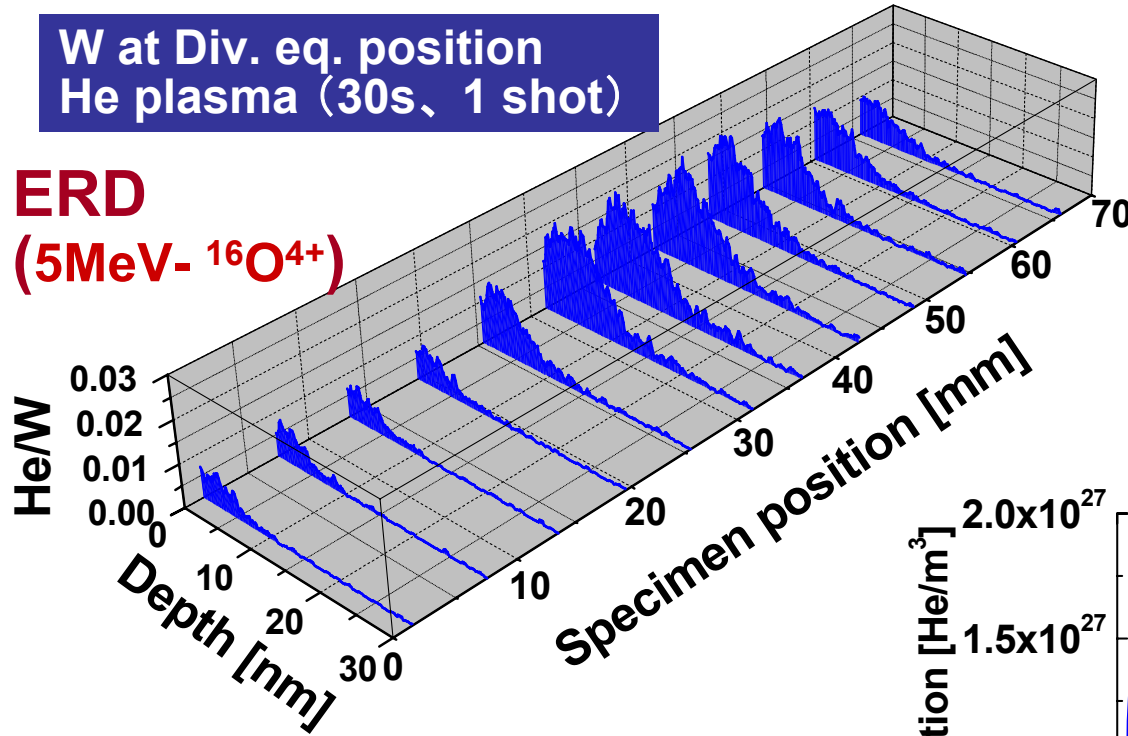
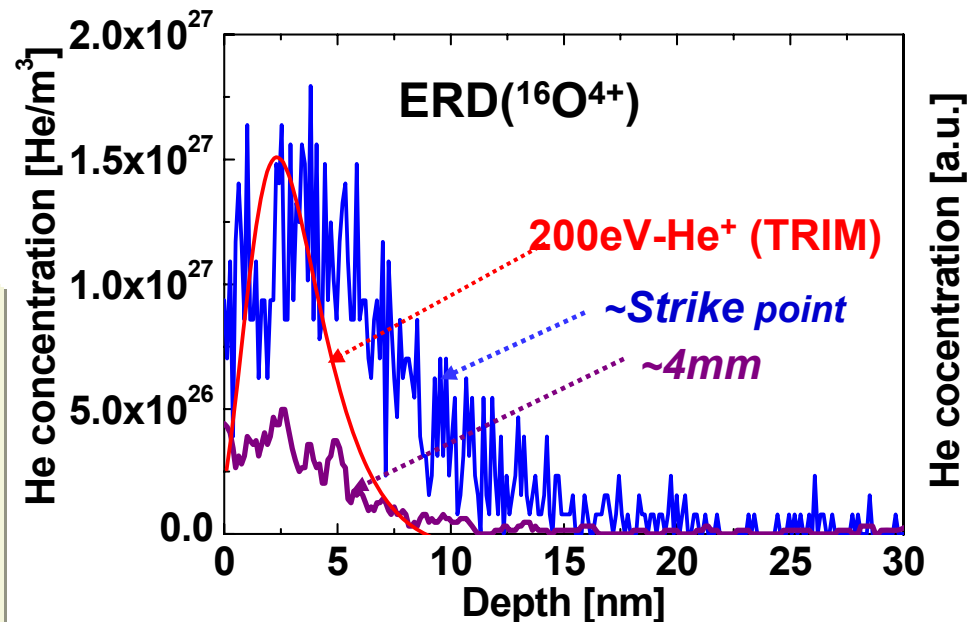
Depth Distribution of He in W at Divertor Equivalent Position

W at Div. eq. position
He plasma (30s, 1 shot)

ERD
(5MeV- $^{16}\text{O}^{4+}$)

Parameters of core plasma

Electron density (n_e)	Ion temp. (T_i)	Input power
$1.3 \times 10^{19} \text{ m}^{-3}$	1.6 keV	0.5 MW

Peak of He: ~3nm

- ⇒ He ion energy $\geq 200\text{eV}$
- ⇒ accelerated by sheath potential

(T_i, T_e at divertor region = 20~50eV)

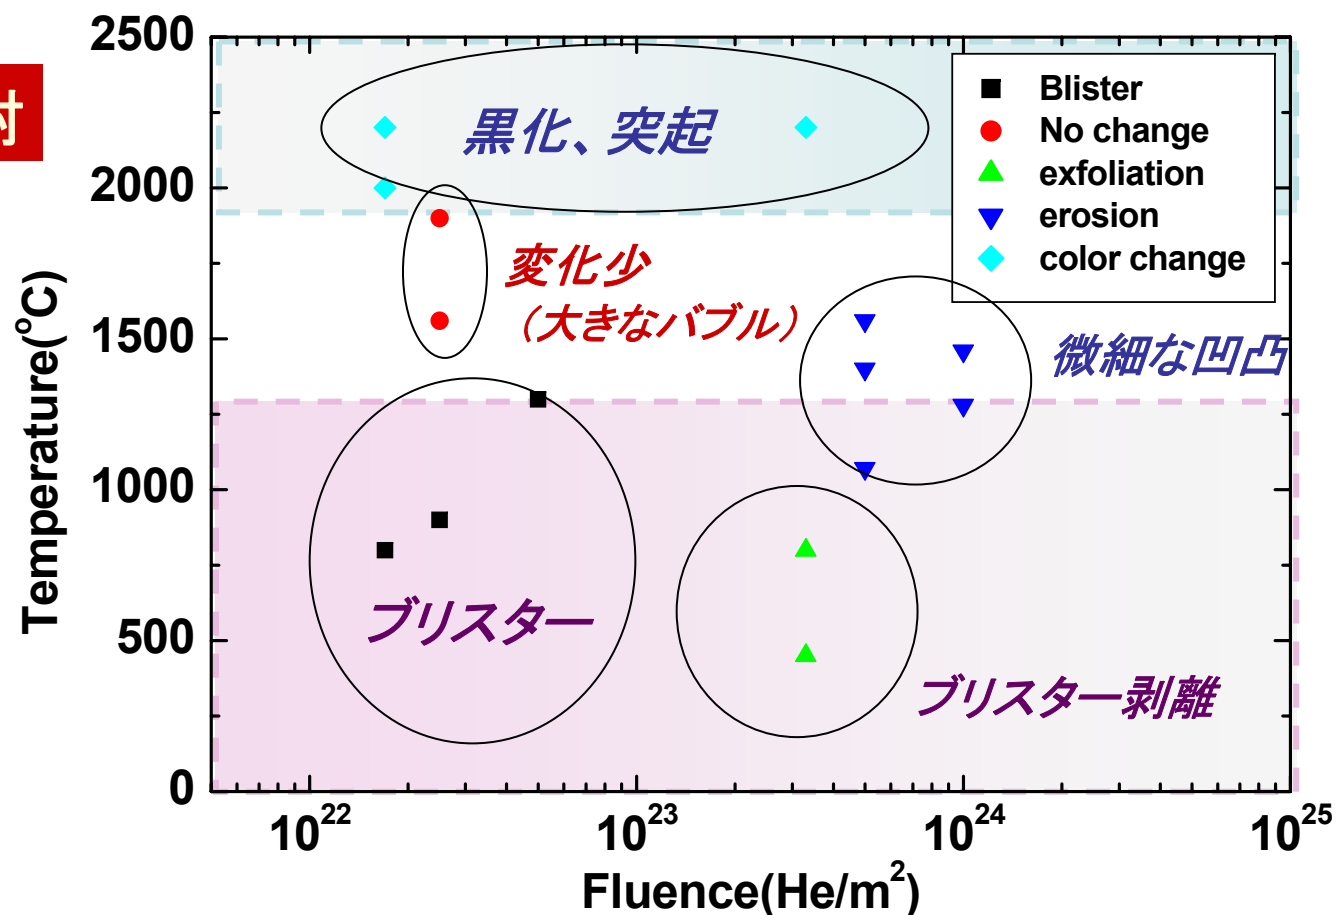
表面形状の照射量／最高到達温度依存性

パルス照射

- Heのバブルへの極めて強いトラップ、バブルの熱的移動によって低温から極めて高温まで様々な表面形態が出現。
- ヘリウム照射特有の現象。

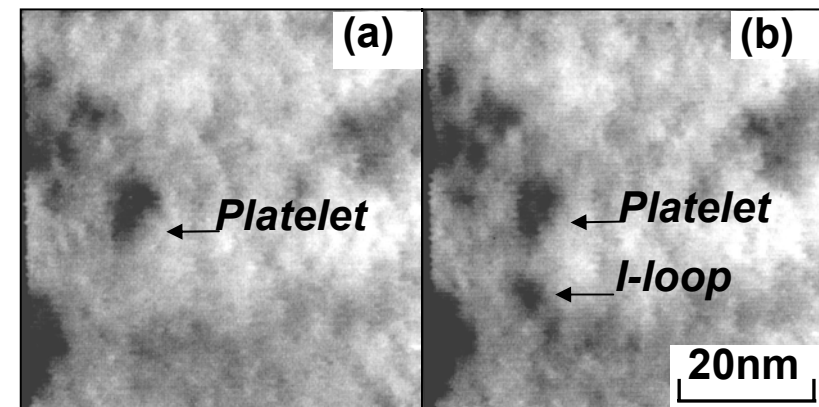
sub- E_d Heイオンによる損傷(低照射域)

W、0.25keV He⁺ イオン、 室温照射

(原子はじき出し損傷を起こすための閾イオンエネルギー ($E_d = 0.4\text{keV}$) 以下の照射)

- まず、板状He集合体が作られ、パンチアウトによる I-型転位ループの形成
