R(17-3): Identification, mitigation, and correction of intrinsic error field sources

Research Milestone Status Meeting
May 25, 2017

Milestone and Recovery Project charges

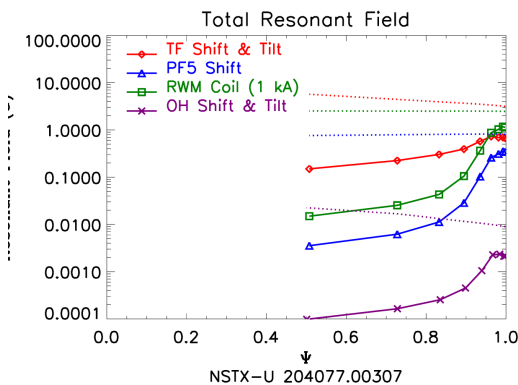
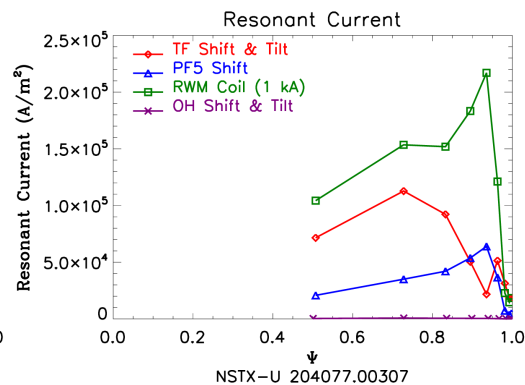
Modeling results → 2 mm tolerance

- Metrology → coil shape models
 - Feed to IPEC & M3D-C1
- Resonant fields and currents:
 - TF error field is dominant
 - TF EF phase not constant
 - Difficult to correct
- Neoclassical toroidal viscosity:
 - RWM coils are poorly matched to TF NTV spectrum
- Tolerance of 2 mm:
 - Resonant fields below locking threshold without EFC
 - Reduces TF NTV by 10×

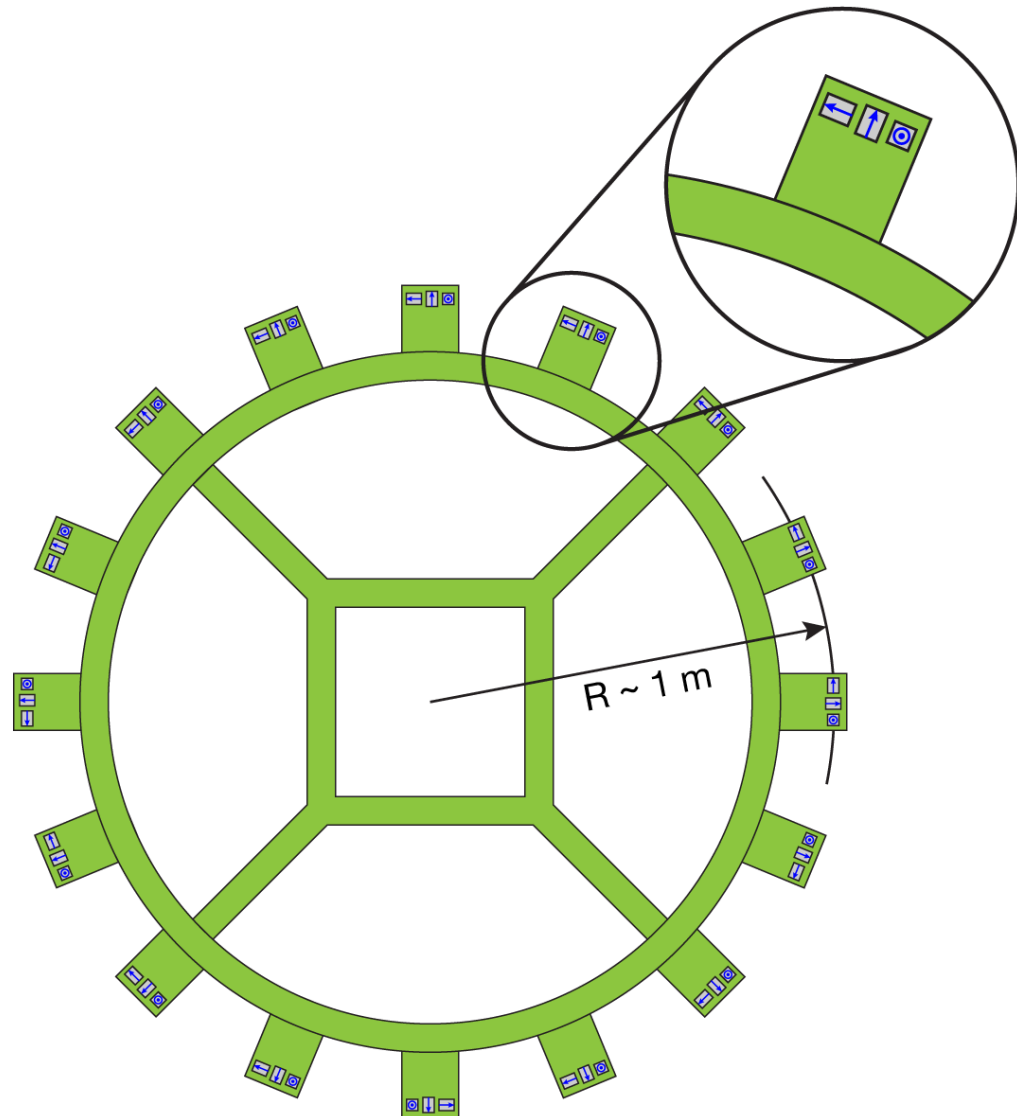
In-vessel magnetic measurements

- Deploy in-vessel magnetics rig during possible coil validation testing of outer PF coils:
 - Directly measure error fields from each coil (DC, AC)
- Tentative specifications:
 - 48 sensors ($16 \times 3 B_Z, B_R, B_T$)
 - Difference opposing sensors
 - Requires 24 new integrators
 - Calibrate each set of sensors on bench with Helmholtz coils
 - Position with ROMER arm
 - Move rig vertically in vessel
→ multiple horizontal planes
