## NSTX Mission Elements

## NSTX Facility Overview To Support NSTX Mission Elements and Upgrades

## Upgrade Substantial Increases $B_T$ , $I_p$ , $\tau_{pulse}$ , $P_{NBI}$ Higher $B_T$ and $I_p$ narrows gaps to Fusion Neutron Science Facility

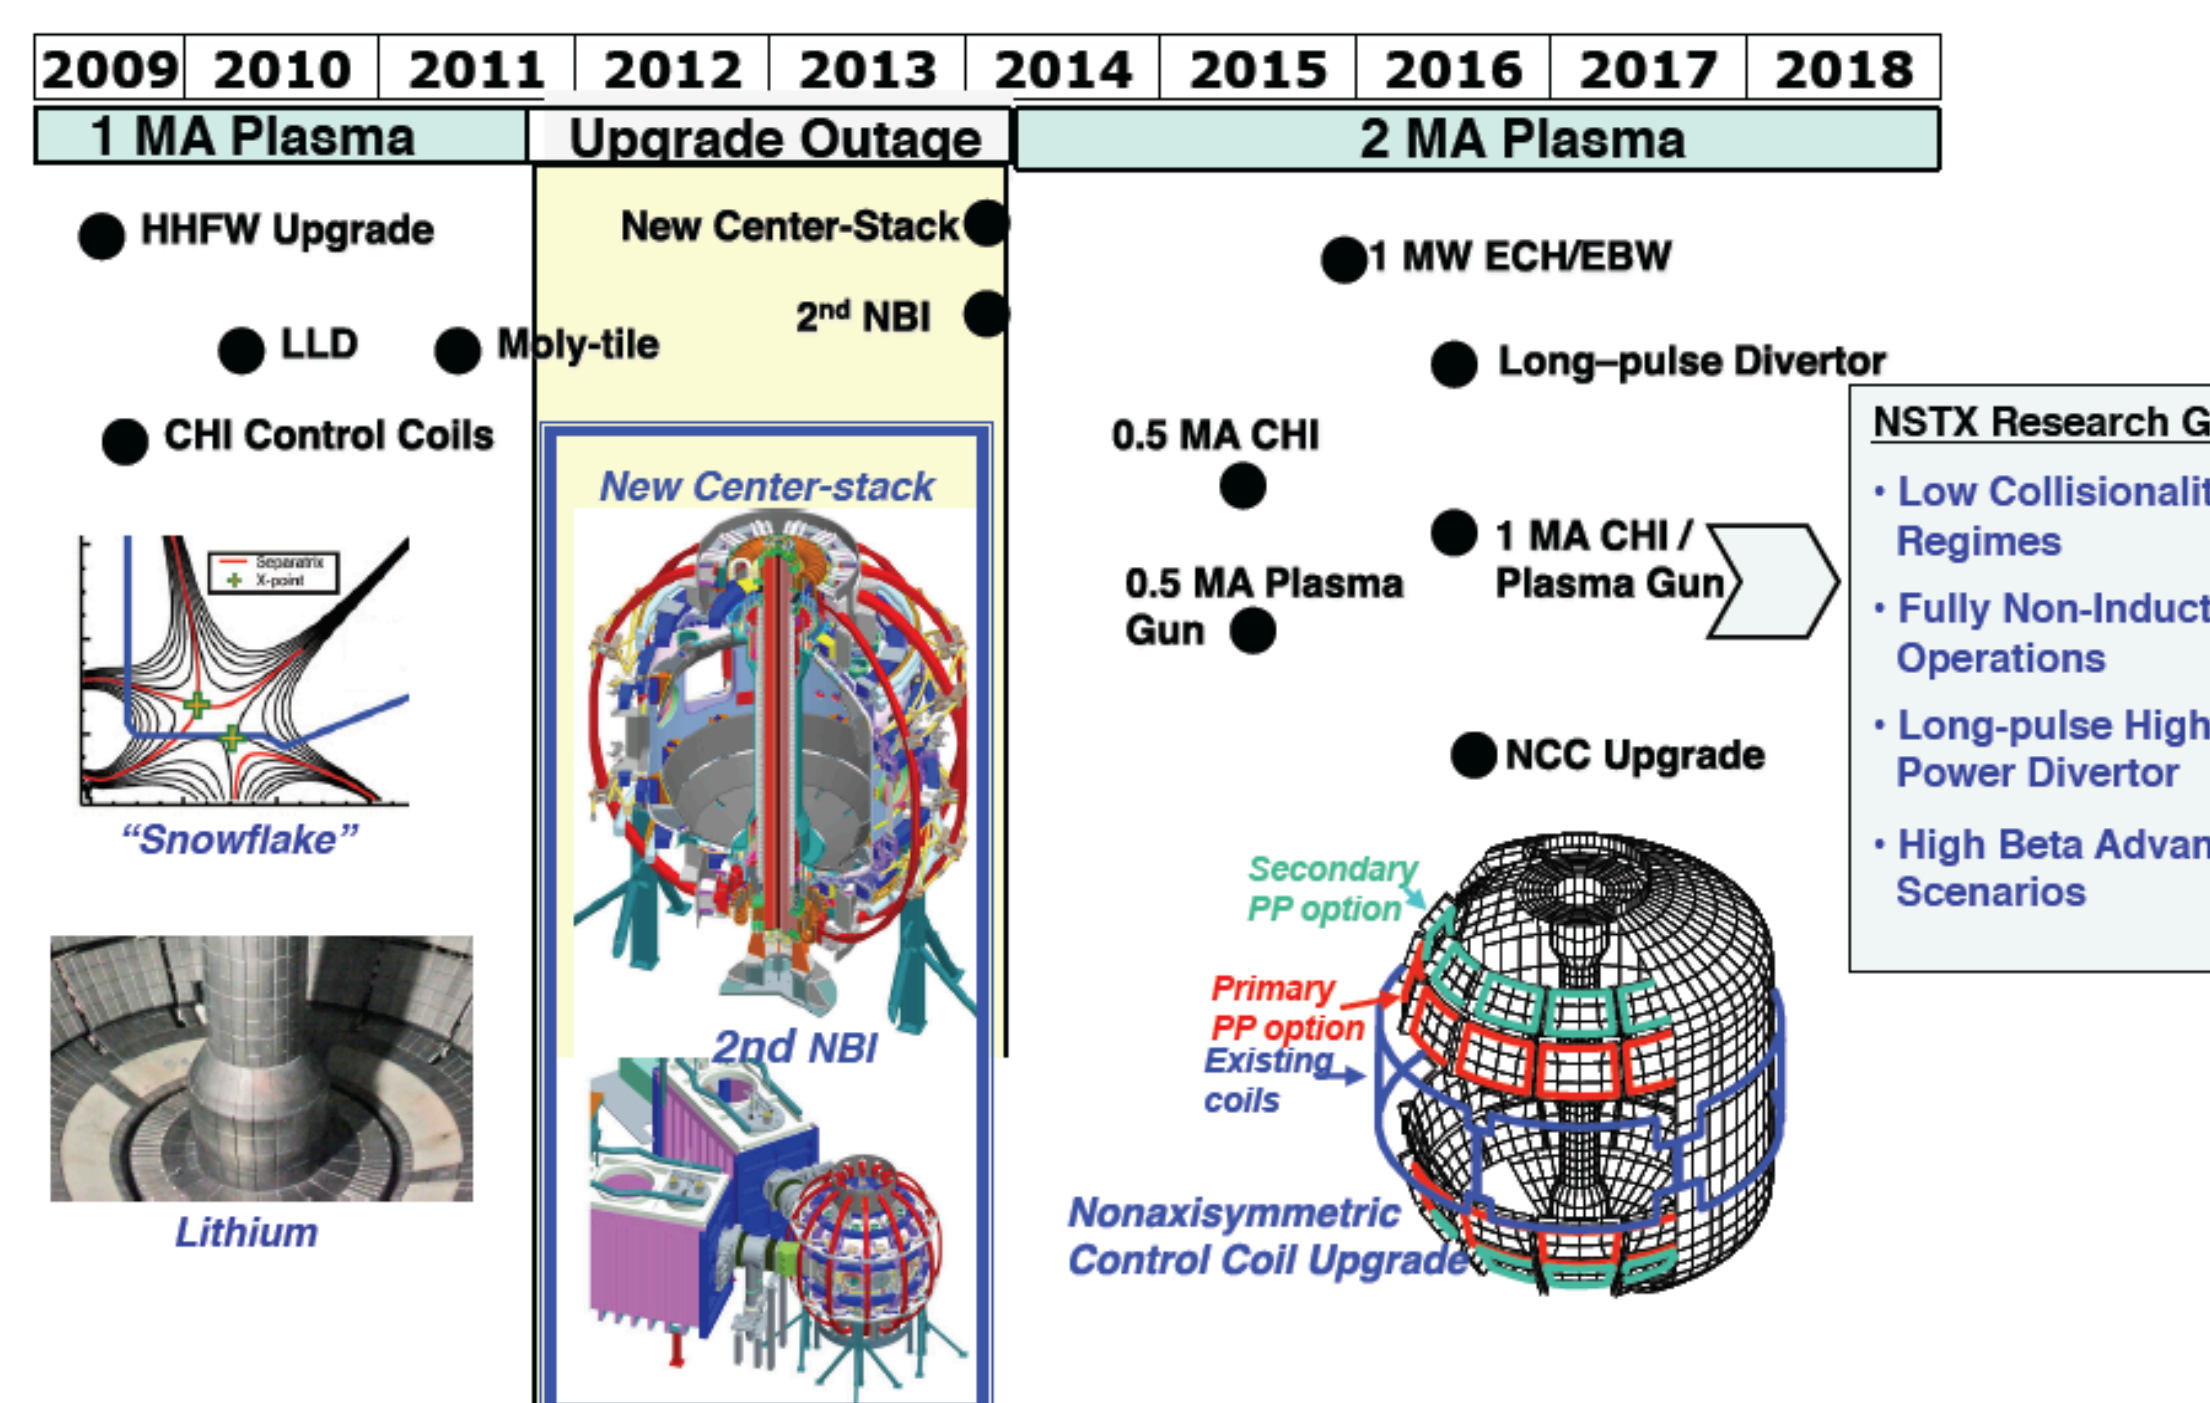
## NSTX Upgrade Outage Started Due to TF Fault, Upgrade was Accelerated by ~6 Months

## NSTX TF Fault Occurred on July 20, 2011 TF Bundle Operated for 7+ years for 20,000 shots

- TF bundle short occurred ~ 2 feet from the bottom in a relatively low mechanical stress area.
- TF bundle dissection and analyses showed no sign of fatigue.
- Zinc chloride based flux used for cooling water tube soldering was the cause of insulation failure.
