National Spherical Torus eXperiment Upgrade

Plasma Facing Components WBS 1.01.01

NSTX-U Recovery Project FDR – March 17-19, 2020

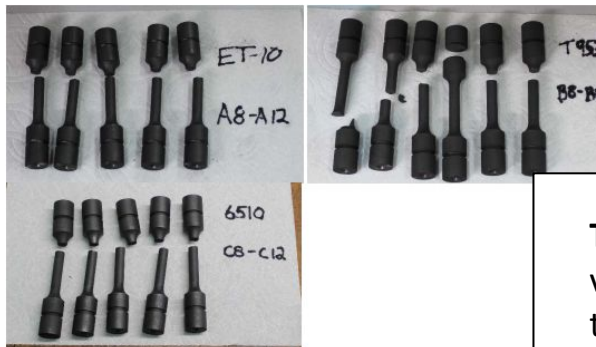
- No industrial standards for graphite grades
- Vendors unwilling to guarantee material properties
- All material purchased will be independently tested through ASTM standards
- Material certification through PMIC - benchmarked testing process

Figure 5. Tested UTS specimens.

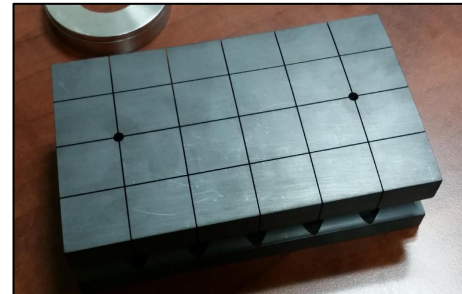
Castellated Manufacturing Prototype
