# Disruptions, eddy currents, tile damage, Hiro currents, and grounding of LLD

NSTX Research Forum

PPPL, Princeton NJ, March 16, 2011

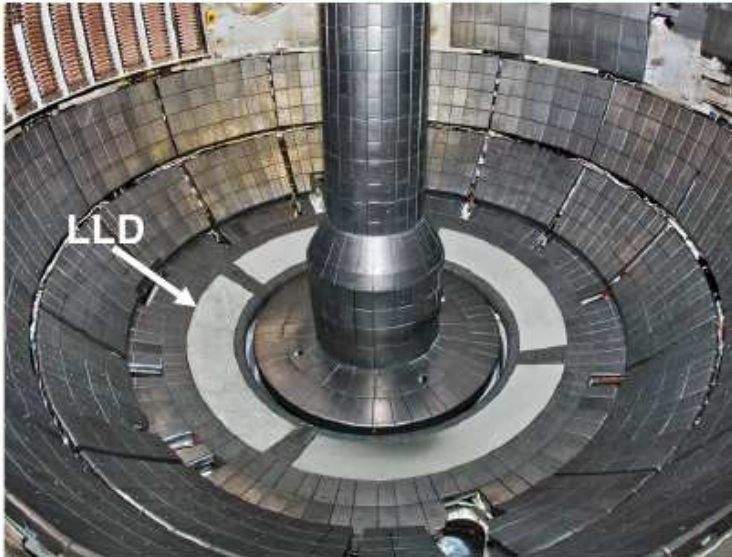
**Liquid lithium divertor target system commissioned**  
*Utilized in four LLD experimental proposals in three campaigns*

LLD plate covered with lithium  
Significant over-flow evident consistent  
with evaporating 2 x fill capacity

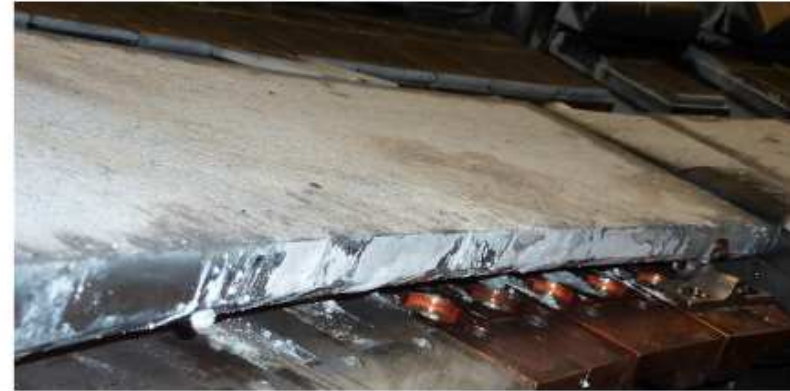
- Plasma surface heating raised the LLD surface temperature to  $\sim 200 - 250$  °C.
- No significant moly surface damage or moly influx observed.
- Damage discovered after operations. Plasma disruptions caused mechanical support and arcing damages. Explains why electrical heaters failed. Air heater has worked well but the heating tubes were arc damaged.
- LLD plates being reinstalled with improvements in the mechanical support structure and grounding. No active heaters but will utilize plasma heating.
